Full Refurbishment for Island Refinery

Decoking pump

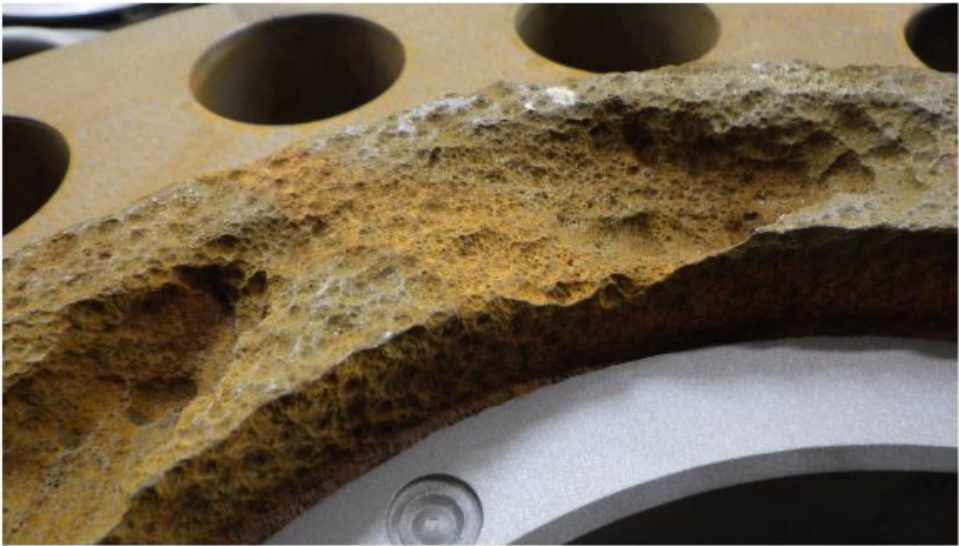
For the decoker pump, coke fines and water mixed together to create a highly acidic layer on the element. The element itself was also very old and had already suffered significant wear and tear, including:

- The shafts which had major corrosion;
- The impellers had corrosion and cavitation damage;
- The pump cover/casing also had erosion damage;
- The bearing housings needed cleaning;
- The bearing housing discharge head needed modification;

If they had placed the pump into installation, it would have failed immediately upon start-up (Figure 1).

- The shafts were replaced by going forward with a 410 forging instead of a rolled shaft so that the denser structure would avoid sagging;
- Using Direct Laser Deposition (DLD) laser cladding, the impellers were reversed engineered and then welded in order to fix the damage;
- The bearing houses needed to be cleaned and checked for parallel, concentricity and perpendicularity. The bearing housings' discharge also had to be modified from the discharge

head by cutting the carbon steel off the back and inserting some 309 stainless steel to prevent corrosion;

- The barrel itself needed to be set up and machined to remove the corrosion from the high-velocity areas. A weld overlay 309L was also used through laser DLD;
- The areas around the ring have been modified so the pump can now run hard-on-hard through the rings;
- The covers of the pump were also reverse-engineered. The diffusers in the return channels were in very bad shape. Those areas were welded to improve their condition, but should the need arise, the files are available to create an emergency part for installation/repair.
