Full Refurbishment for Island Refinery

Decoking pump

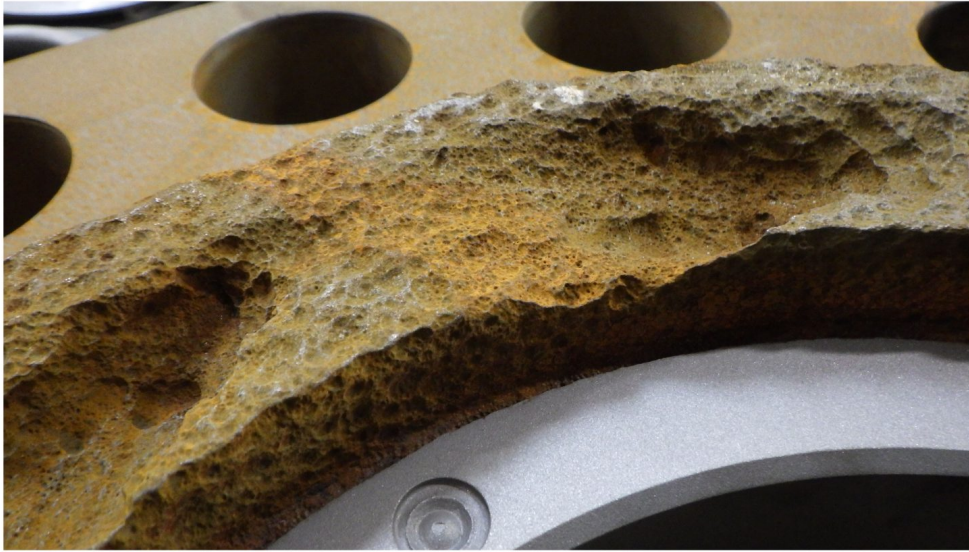
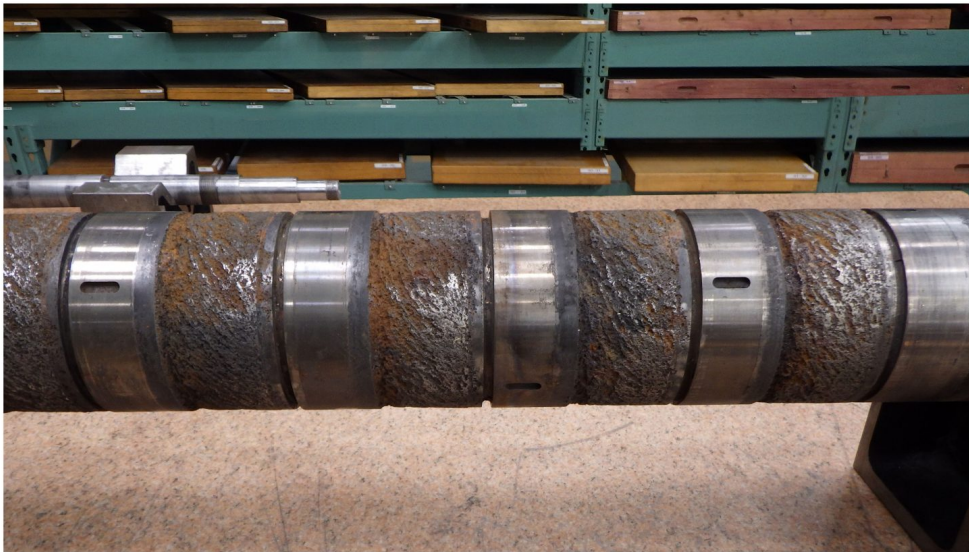
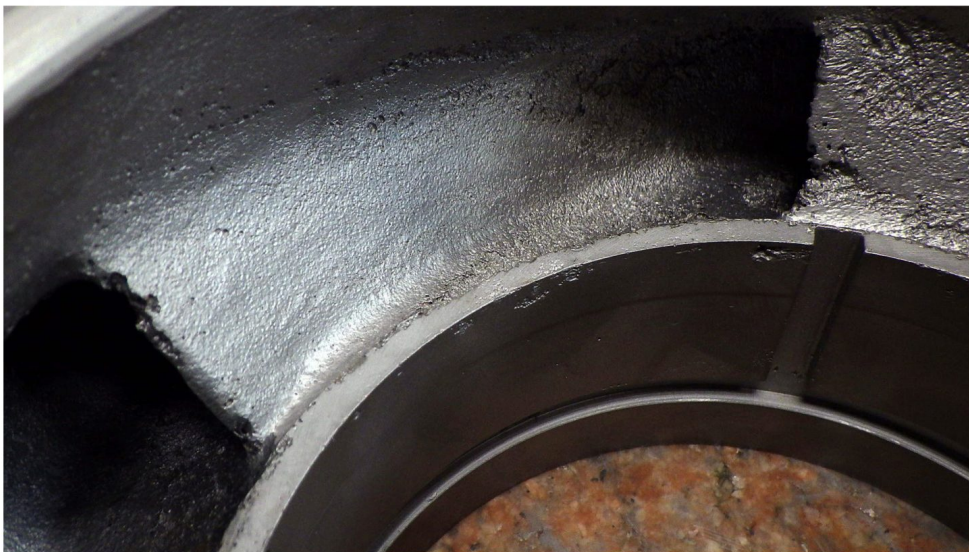
The process of reopening the plant had uncovered more than 500 pumps that needed considerable refurbishment and repair. The most important of these was a critical jet pump used for hydraulic decoking. It was badly damaged and sent to the original equipment manufacturer (OEM) for inspection. The OEM recommended that the refinery replace most of the pump parts, as well as a costly repair that would require 35 weeks to rebuild.

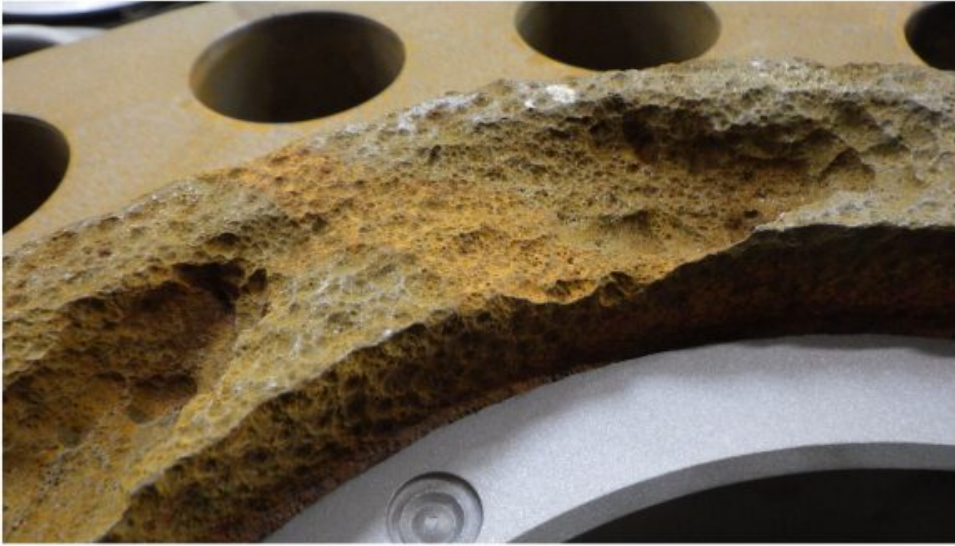
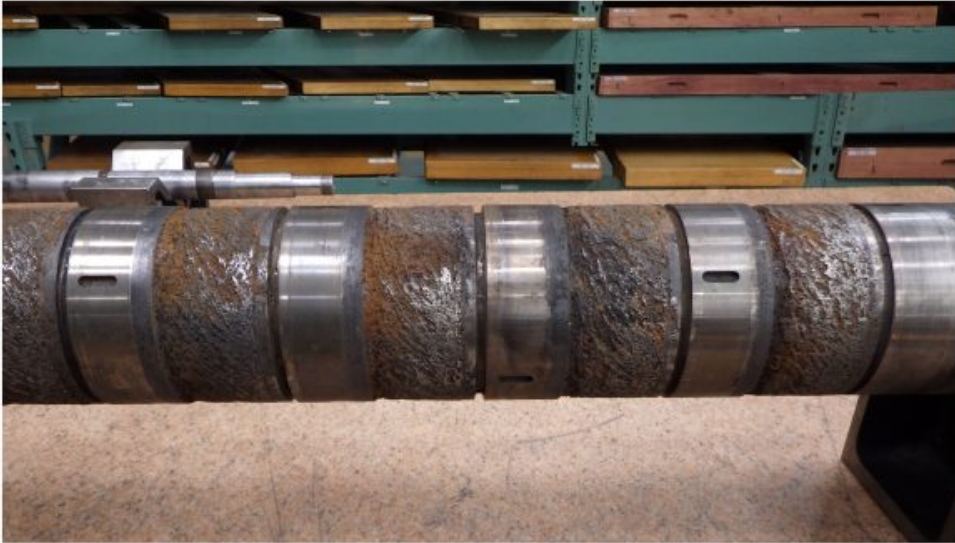
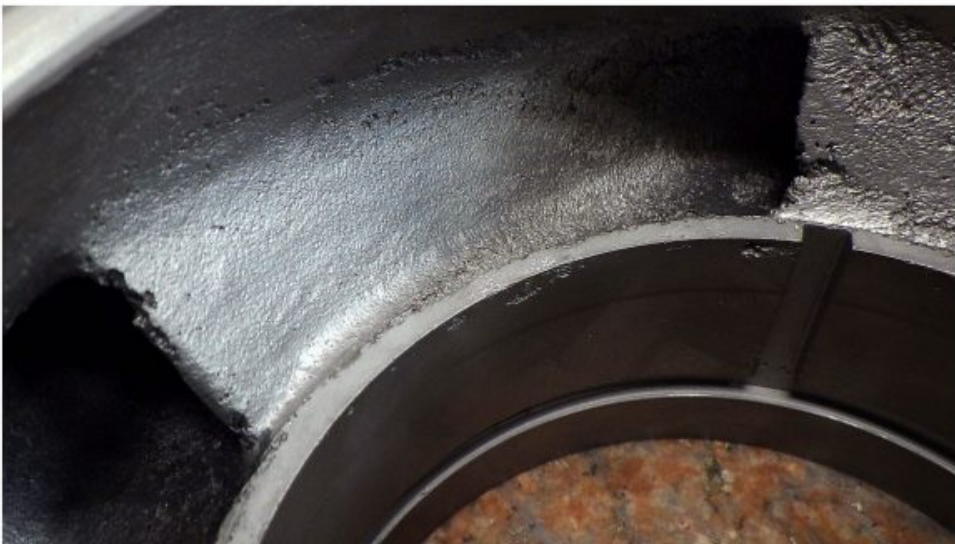
For the decoker pump, coke fines and water mixed together to create a highly acidic layer on the element. The element itself was also very old and had already suffered significant wear and tear, including:

- The shafts which had major corrosion;
- The impellers had corrosion and cavitation damage;
- The pump cover/casing also had erosion damage;
- The bearing housings needed cleaning;
- The bearing housing discharge head needed modification;

If they had placed the pump into installation, it would have failed immediately upon start-up (Figure 1).

- The shafts were replaced by going forward with a 410 forging instead of a rolled shaft so that the denser structure would avoid sagging;
- Using Direct Laser Deposition (DLD) laser cladding, the impellers were reversed engineered and then welded in order to fix the damage;
- The bearing houses needed to be cleaned and checked for parallel, concentricity and perpendicularity. The bearing housings' discharge also had to be modified from the discharge

head by cutting the carbon steel off the back and inserting some 309 stainless steel to prevent corrosion;

- The barrel itself needed to be set up and machined to remove the corrosion from the high-velocity areas. A weld overlay 309L was also used through laser DLD;
- The areas around the ring have been modified so the pump can now run hard-on-hard through the rings;
- The covers of the pump were also reverse-engineered. The diffusers in the return channels were in very bad shape. Those areas were welded to improve their condition, but should the need arise, the files are available to create an emergency part for installation/repair.
