Full Refurbishment for Island Refinery

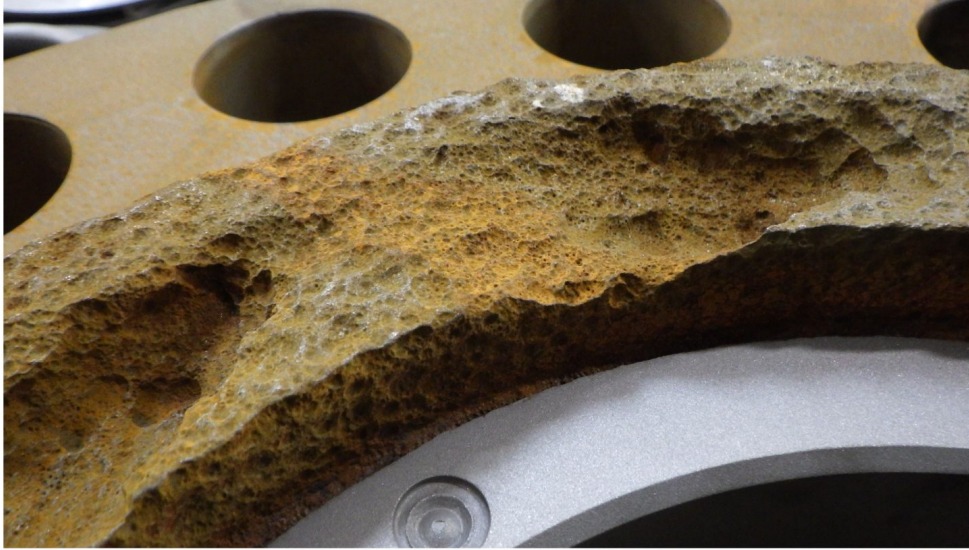
For the decoker pump, coke fines and water mixed together to create a highly acidic layer on the element. The element itself was also very old and had already suffered significant wear and tear, including:

- The shafts which had major corrosion;
- The impellers had corrosion and cavitation damage;
- The pump cover/casing also had erosion damage;
- The bearing housings needed cleaning;
- The bearing housing discharge head needed modification;

If they had placed the pump into installation, it would have failed immediately upon start-up (Figure 1).

- The shafts were replaced by going forward with a 410 forging instead of a rolled shaft so that the denser structure would avoid sagging;
- Using Direct Laser Deposition (DLD) laser cladding, the impellers were reverse engineered and then welded in order to fix the damage;

- The bearing houses needed to be cleaned and checked for parallel, concentricity and perpendicularity. The bearing housings' discharge also had to be modified from the discharge head by cutting the carbon steel off the back and inserting some 309 stainless steel to prevent corrosion;

- The barrel itself needed to be set up and machined to remove the corrosion from the high-velocity areas. A weld overlay 309L was also used through laser DLD;

- The areas around the ring have been modified so the pump can now run hard-on-hard through the rings;
- The covers of the pump were also reverse-engineered. The diffusers in the return channels were in very bad shape. Those areas were welded to improve their condition, but should the need arise, the files are available to create an emergency part for installation/repair.
