# Unearthing the Root Cause of Vibration Issues

A recently constructed fertilizer plant was experiencing significant vibration problems on their brand new UAN Solution pumps. This vibration forced the plant to take the equipment out of service.

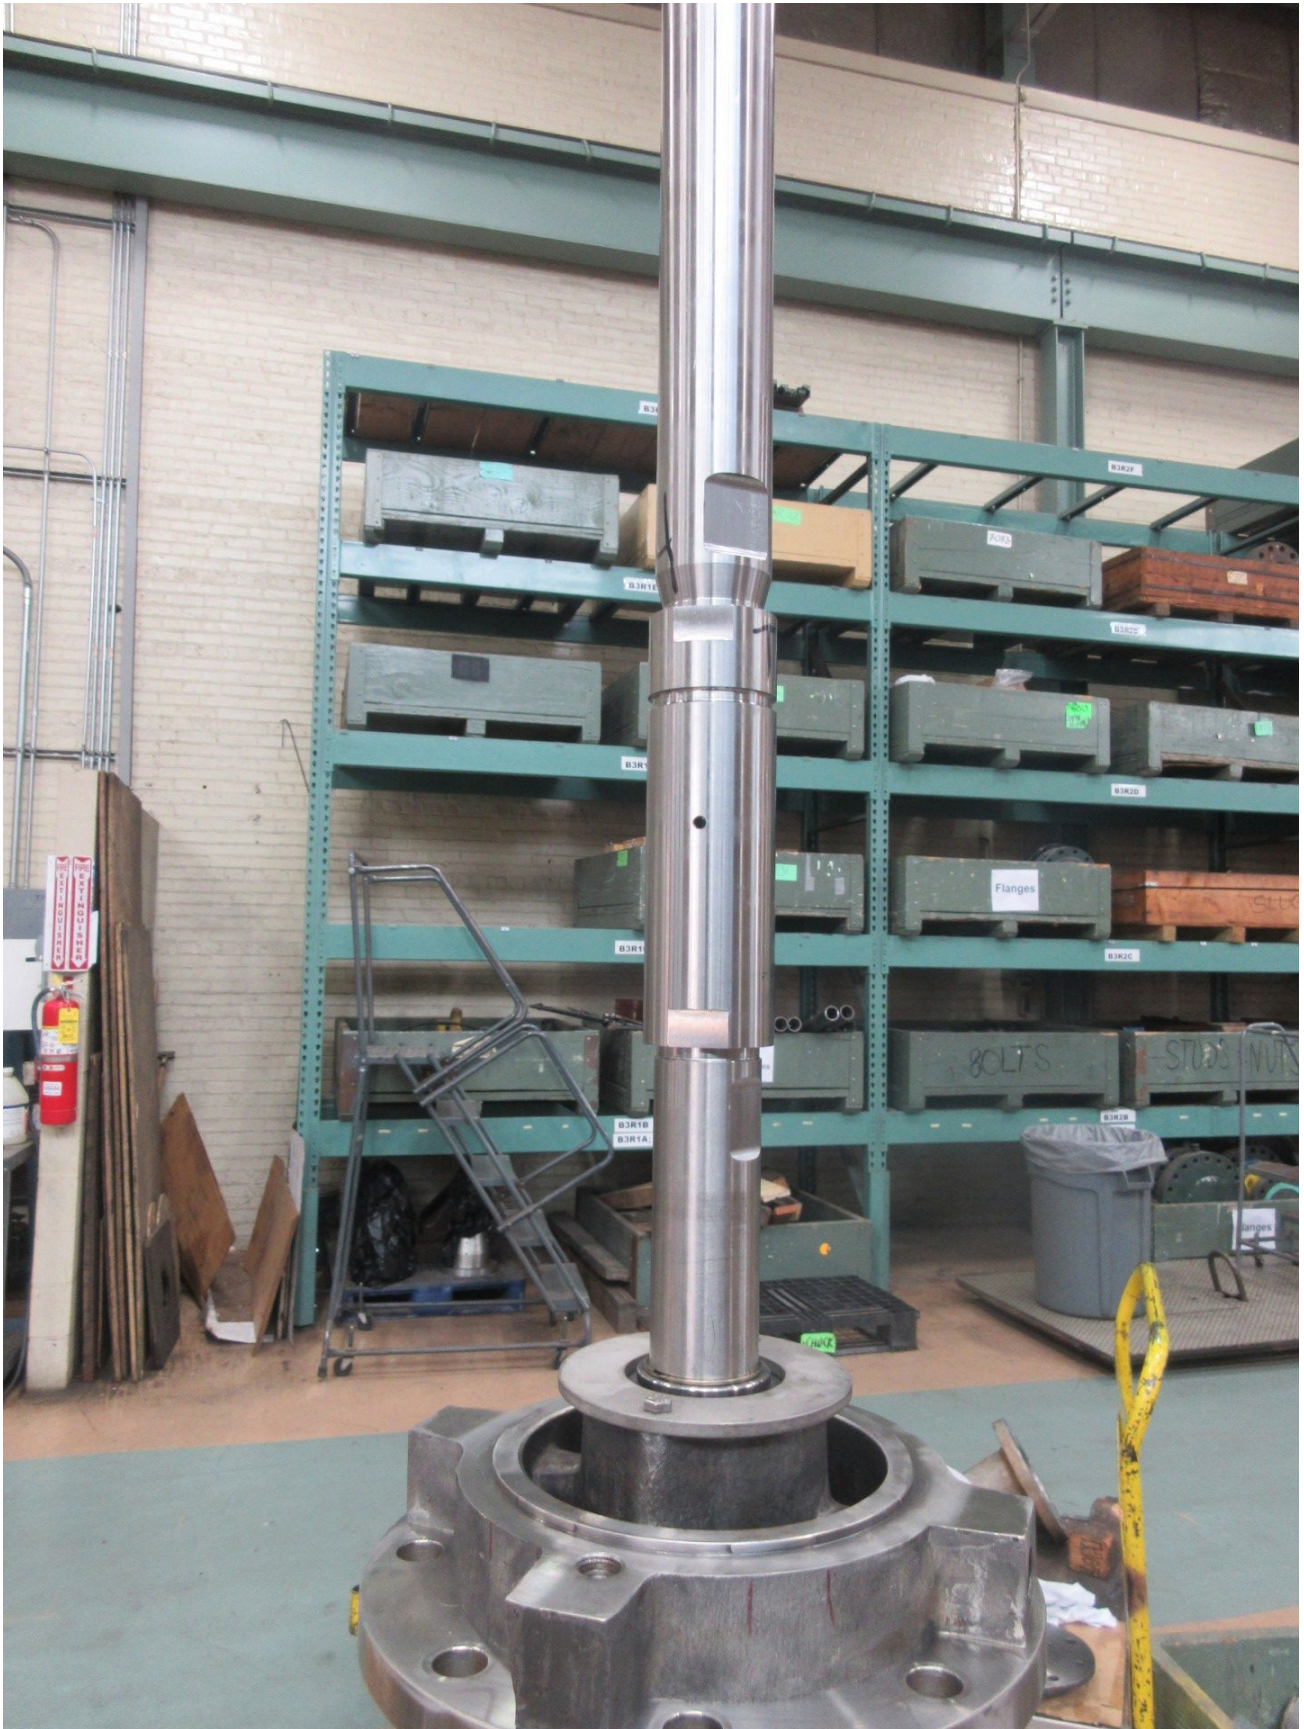
✘ The UAN Solution pumps are a single stage VS4 vertically suspended pump design and are installed in a process condensate tank. The pump is submerged in the UAN solution and takes suction through an axial suction nozzle equipped with a suction strainer.

The pump has a radial discharge nozzle located at the impeller centerline; this discharge continues through an elbow to a length of vertical pipe that exits the process condensate tank.

Above the impeller, a series of column pipes and lineshafts connect the hydraulic assembly to the motor assembly located on the tank top flange. The lineshafts are supported by three guide bushings located in column spiders.
