Engineering Pumps for
Better Performance and Longer Life

Unearthing the Root Cause of Vibration Issues

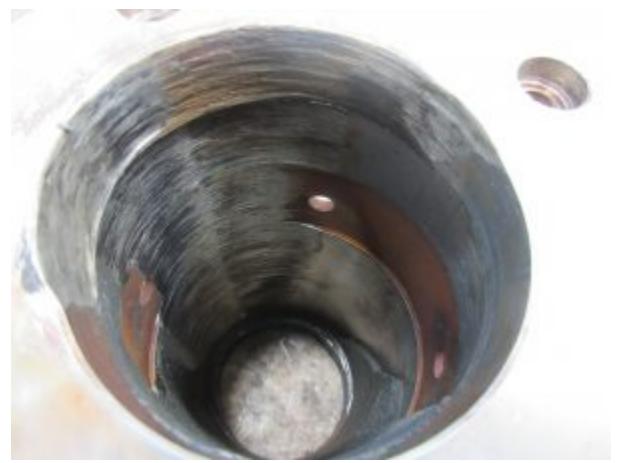
The high vibration and abnormal noise that caused the pump to be taken out of service was most likely due to the poor motor thrust bearing design. The original thrust bearing selected by the OEM was a single row angular contact bearing. This bearing was only capable of handling thrust in one direction.

It is suspected that the pump experienced a momentary upthrust upon start-up, resulting in the unseating of the bearing cage. This unseated bearing was unable to function properly even as

the pump reached its normal operating thrust. Because the bearing did not restrain the rotor in the upward direction, the rotor movement caused by the upthrust resulted in contact and damage at the mechanical seal axial sealing faces.

The double row deep groove ball bearing that was chosen to replace the angular contact bearing is able to handle axial loads in either direction and will not be at risk of unseating due to axial upthrust. This bearing design will also protect the mechanical seal by restricting rotor axial movement in both directions. In order to accommodate the new bearing, the bearing housing was modified.
