Unearthing the Root Cause of Vibration Issues

A recently constructed fertilizer plant was experiencing significant vibration problems on their brand new UAN Solution pumps. This vibration forced the plant to take the equipment out of service.

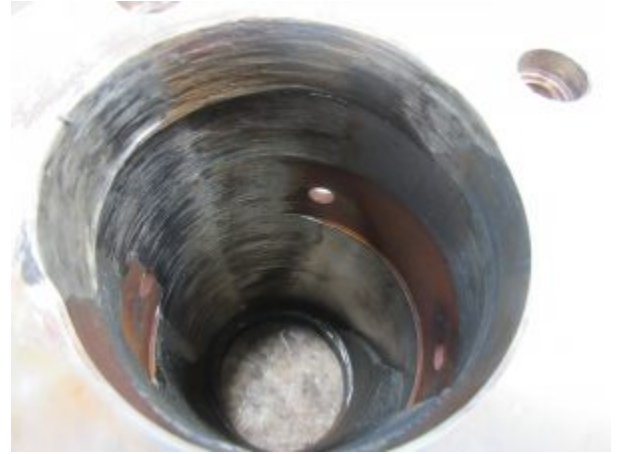
When the pump was disassembled, it was evident that there were significant problems at the motor bearing and guide bushing locations. The motor ball bearing cage had become unseated and was damaged. Inspection of the mechanical seal revealed damage to the sealing faces.

The DCI also revealed elliptical wear on the guide bushing bores that was biased to one side, indicating a misalignment problem. Galling was observed at the impeller and case rings.

- Excessive runout of the motor stand faces- runout was measured at 0.018" and should be a maximum of 0.002"
- Excessive clearance at the motor stand register to the baseplate- clearance was 0.015" and should be a maximum of 0.002"
- Motor flange face runout was 0.003", outside of the recommended maximum tolerance of 0.002"
- Lineshaft coupling tolerances were specified to a substandard class and resulted in excessive runout
- Column spiders that hold the guide bushings had excessive fit-ups at the registers and face runout, bore concentricity, and other tolerances were all outside of recommended maximum values
- Site inspection of the sole plate revealed that it was not level
