Re-engineering System Reliability

A US fertilizer plant was experiencing recurring reliability problems with its horizontal multistage boiler feed pumps. The series of repeat failures motivated the owner plant to consult with a widely-known unbiased aftermarket pump service provider. Previous experience with this company's Texas facility gave the plant confidence that they had the capability to troubleshoot the problem and provide a solution. This type of supplier has been classified as a "CPRS"— Competent Pump Repair Shop, because their worldwide affiliates are staffed by specialists who have the fullest support of pump engineers at the company headquarters.

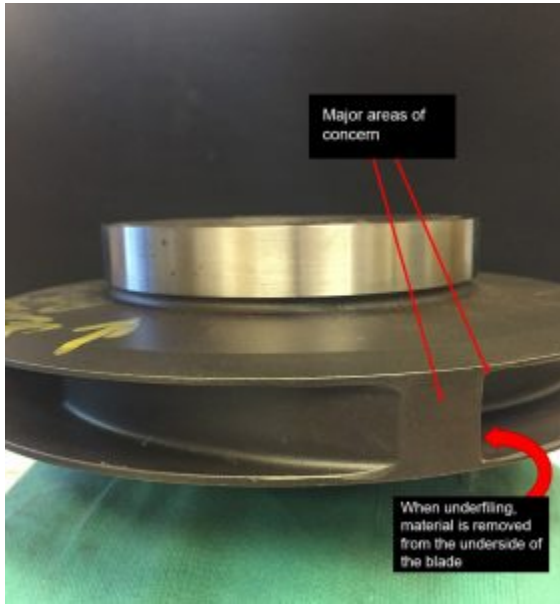
When the subject boiler feed pump was brought to the aftermarket service provider, a thorough inspection was provided to ascertain the root cause of the repeated failures. Inspection revealed evidence of recirculation both on the impellers and on the casing volutes.

Recirculation damage is highly indicative of operation away from the pump best efficiency point. At the BEP, the angle of the flow matches the angle of the stationary impeller blades and volute cutwaters. As pump operation diverges from the best efficiency flow, the angle of the flow and the blade angle are no longer compatible and the likelihood for fluid recirculation increases. The recirculated flow will cause component damage, localized pressure drops, and decreased rotor stability, resulting in degraded performance and high vibration.

The site was presented with two options: manufacture rerated impellers to optimize the pump for the system or underfile the existing impellers to provide more flow. Both of these options would return the site to operating with one 100% pump instead of requiring operation with both installed units.

While a hydraulic rerate would allow greater flexibility for future operation changes, the site was concerned about the risk presented by not having a spare onsite for the amount of time necessary to cast and machine new impellers. As such, the customer decided to underfile the existing impellers. When an impeller is underfiled, the material is taken away from the underside of the blade at the impeller outlet to increase the impeller passage size. This provides more flow at the same total developed head.
