Re-engineering System Reliability

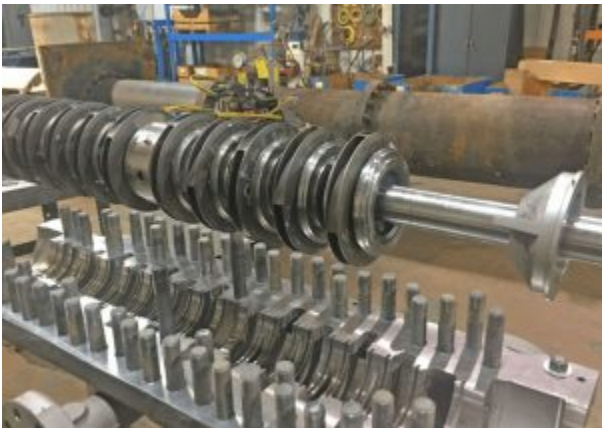
When the subject boiler feed pump was brought to the aftermarket service provider, a thorough inspection was provided to ascertain the root cause of the repeated failures. Inspection revealed evidence of recirculation both on the impellers and on the casing volutes.

Recirculation damage is highly indicative of operation away from the pump best efficiency point. At the BEP, the angle of the flow matches the angle of the stationary impeller blades and volute cutwaters. As pump operation diverges from the best efficiency flow, the angle of the flow and the blade angle are no longer compatible and the likelihood for fluid recirculation increases. The recirculated flow will cause component damage, localized pressure drops, and decreased rotor stability, resulting in

The service center completed the underfile modification and remediated the recirculation damage on the impellers and casing. As is typical for this service center, a full dimensional analysis was performed

and measures were taken to ensure the optimal fit-ups and tolerances for reliable operation of this high energy, multistage pump.
