## Re-engineering System Reliability

A US fertilizer plant was experiencing recurring reliability problems with its horizontal multistage boiler feed pumps. The series of repeat failures motivated the owner plant to consult with a widely-known unbiased aftermarket pump service provider. Previous experience with this company's Texas facility gave the plant confidence that they had the capability to troubleshoot the problem and provide a solution. This type of supplier has been classified as a "CPRS"— Competent Pump Repair Shop, because their worldwide affiliates are staffed by specialists who have the fullest support of pump engineers at the company headquarters.

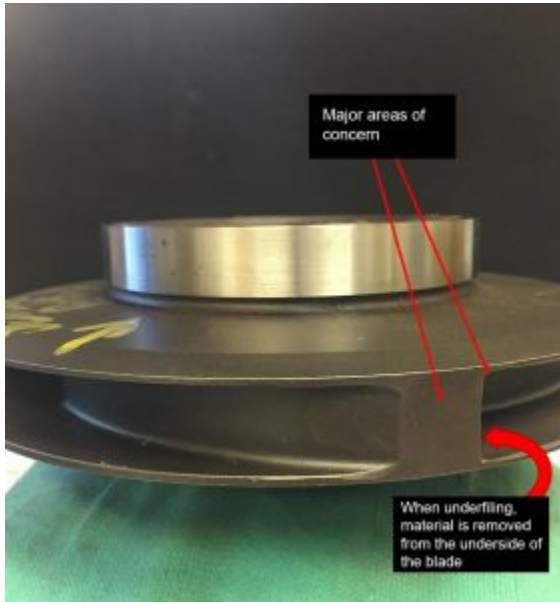
When the subject boiler feed pump was brought to the aftermarket service provider, a thorough inspection was provided to ascertain the root cause of the repeated failures. Inspection revealed evidence of recirculation both on the impellers and on the casing volutes.

Recirculation damage is highly indicative of operation away from the pump best efficiency point. At the BEP, the angle of the flow matches the angle of the stationary impeller blades and volute cutwaters. As pump operation diverges from the best efficiency flow, the angle of the flow and the blade angle are no longer compatible and the likelihood for fluid recirculation increases. The recirculated flow will cause component damage, localized pressure drops, and decreased rotor stability, resulting in degraded performance and high vibration.

The site was presented with two options: manufacture rerated impellers to optimize the pump for the system or underfile the existing impellers to provide more flow. Both of these options would return the site to operating with one 100% pump instead of requiring operation with both installed units.

While a hydraulic rerate would allow greater flexibility for future operation changes, the site was concerned about the risk presented by not having a spare onsite for the amount of time necessary to cast and machine new impellers. As such, the customer decided to underfile the existing impellers. When an impeller is underfiled, the material is taken away from the underside of the blade at the impeller outlet to increase the impeller passage size. This provides more flow at the same total developed head.
