Testing Brings a Long-Term Solution

When an oil and gas vertical firewater pump suffered heavy abrasion and wear due to significant sand and particulate matter from a nearby river, [HydroTex](#) Golden Triangle, based in Beaumont, Texas, solved the problem, meeting the hydraulic requirements of the firewater system.

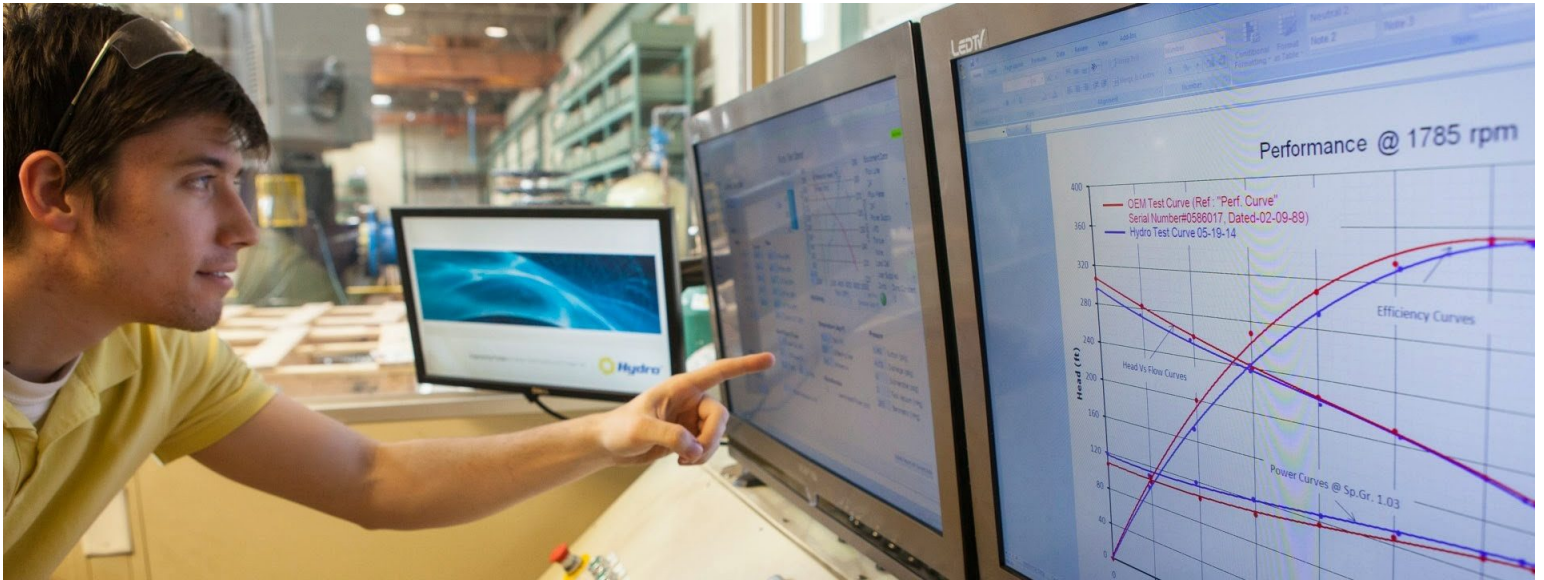
In this case, the impellers were severely worn, which meant that replacements and upgrades were needed if it was to meet the National Firewater Protection Agency (NFPA) hydraulic requirements. The critical pump was removed from service and classified as an emergency. The removal naturally resulted in downtime at the local site, so a quick turnaround was vital.

Three years later, in 2020, the pump was pulled out of operation again due to continued underperformance and critical failure. It was sent to Hydro, Inc.'s Houston service center for further - evaluation and analysis. A complete examination determined that the packing was too tight, wearing out the shaft prematurely.

The engineering analysis had uncovered that the packing was too tight, resulting in the formation of an hourglass shape on the shaft due to severe wear. The pump had not been in service for an extended time but pumping the abrasive sand had caused the overall damage. Further repairs by Hydro, Inc. included replacing the shafts, wear rings, bushings, and reclaiming registers in a complete pump rebuild.

Following the second test, the third set of impellers was also provided and tested. The third set tested correctly and met the NFPA hydraulic performance requirements. During each iteration of impellers tested, the pumps had to be disassembled, reassembled, and tested.

Hydro, Inc. further concluded that the sand damage would not be eliminated. However, the longevity of the equipment was provided by rerating the impellers to meet 110% of capacity.
