Condition Monitoring Uncovers Misalignment Issues

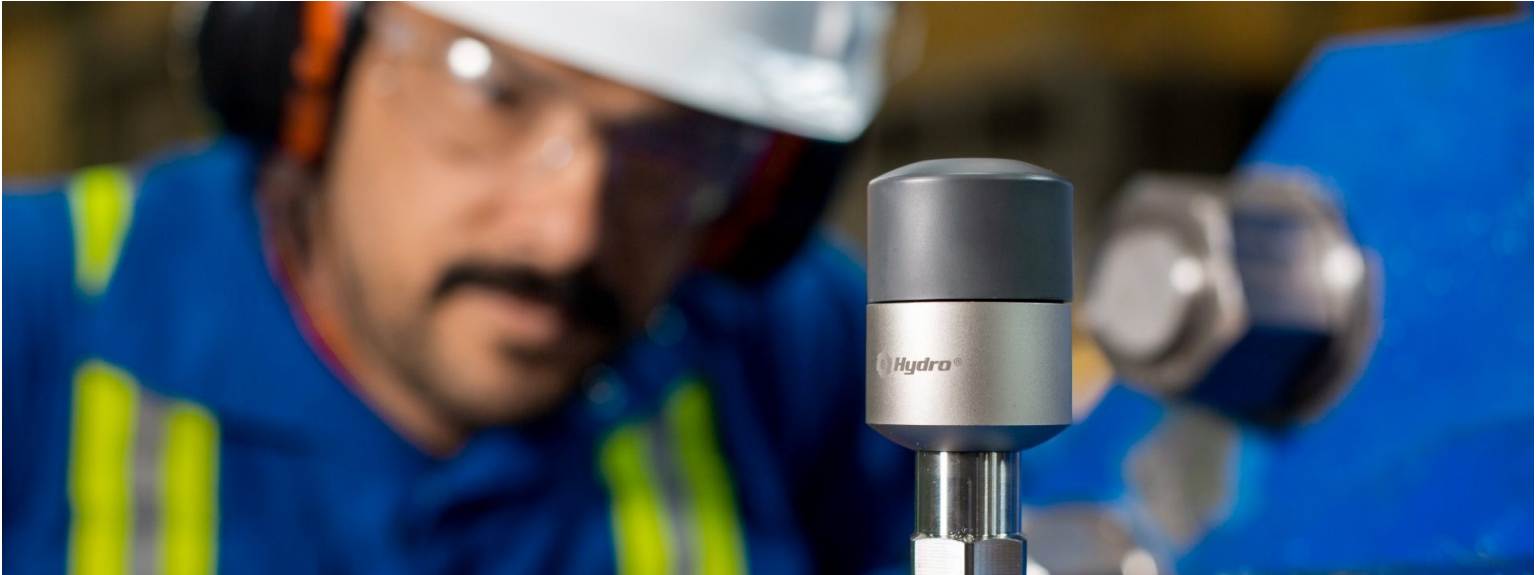
Alarm thresholds are chosen based on API standards. Hydro's monitoring software is programmed to automatically report any alarm or emergent issue to Hydro's engineering team and to the engineering team of the refinery. The graphs showcase a startup event with elevated vibration amplitude levels above the alarm 2 thresholds (>0.300 ips RMS) at the pump inboard and motor inboard sensor locations in the horizontal direction.

In this case, Hydro's engineering team suspected that the elevated vibration amplitude levels were a result of a misalignment condition. Misalignment occurs when the centerlines of the coupled shafts do not coincide, creating high radial forces across the coupling. In addition, misalignment is indicated by excessive amplitude levels of 1x RPM and 2x RPM response. The FFT Spectrum graphs below displays a dominant excitation frequency at 1x RPM (59.688Hz) and 2x RPM (119.37Hz) for both the pump inboard and motor inboard sensor locations.

Phase analysis has been performed on the pump inboard and motor inboard sensor locations to allow Hydro's engineers to further confirm the diagnosis of misalignment. Misalignment is characterized by a phase difference of $180^{\circ} \pm 30^{\circ}$ between the coupled components. Referencing the

phase difference chart, the phase difference between the pump inboard and motor inboard sensor locations is 195° , within range of the $180^\circ \pm 30^\circ$ phase rule.

Following the analysis, Hydro's engineering team notified the customer of the apparent issue and recommended that the machine train be inspected and realigned at the earliest convenience. Hydro will reassess the vibration amplitude levels of the machine train once the alignment has been complete.
