Condition Monitoring Uncovers Misalignment Issues

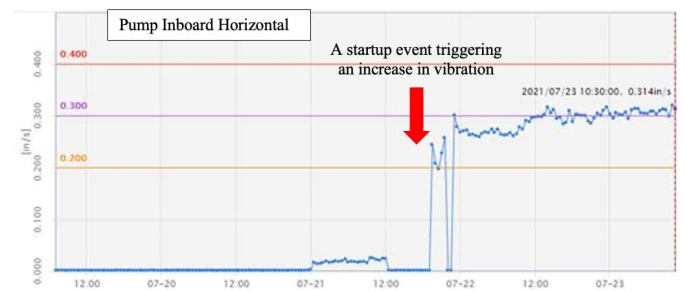
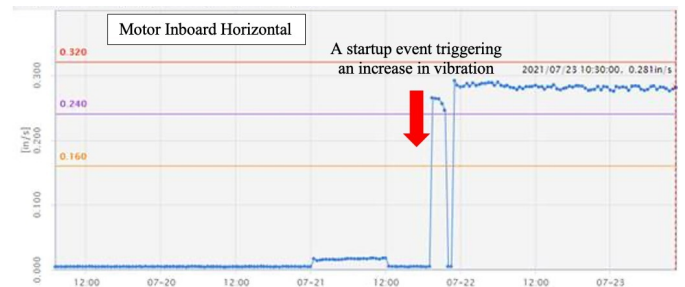
Alarm thresholds are chosen based on API standards. Hydro's monitoring software is programmed to automatically report any alarm or emergent issue to Hydro's engineering team and to the engineering team of the refinery. The graphs showcase a startup event with elevated vibration amplitude levels above the alarm 2 thresholds (>0.300 ips RMS) at the pump inboard and motor inboard sensor locations in the horizontal direction.

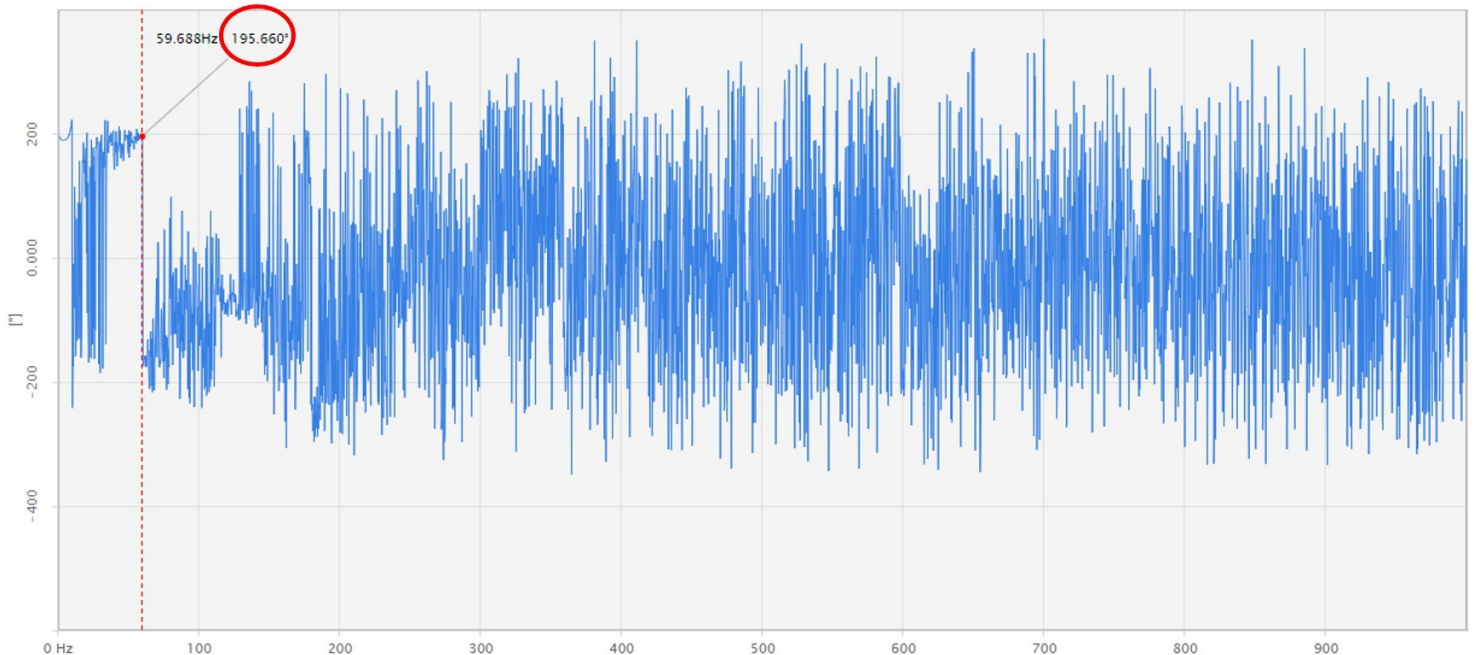
Phase analysis has been performed on the pump inboard and motor inboard sensor locations to allow Hydro's engineers to further confirm the diagnosis of misalignment. Misalignment is characterized by a phase difference of $180^\circ \pm 30^\circ$ between the coupled components. Referencing the phase difference chart, the phase difference between the

pump inboard and motor inboard sensor locations is 195° , within range of the $180^\circ \pm 30^\circ$ phase rule.

Following the analysis, Hydro's engineering team notified the customer of the apparent issue and recommended that the machine train be inspected and realigned at the earliest convenience. Hydro will reassess the vibration amplitude levels of the machine train once the alignment has been complete.
