Condition Monitoring Uncovers Misalignment Issues

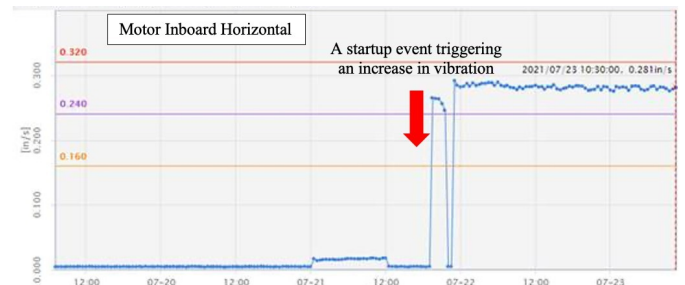
Alarm thresholds are chosen based on API standards. Hydro's monitoring software is programmed to automatically report any alarm or emergent issue to Hydro's engineering team and to the engineering team of the refinery. The graphs showcase a startup event with elevated vibration amplitude levels above the alarm 2 thresholds (>0.300 ips RMS) at the pump inboard and motor inboard sensor locations in the horizontal direction.
