Hydro, Inc.'s Centaur IIoT Solution Detects Cracked Coupling at Municipal Wastewater Treatment Plant

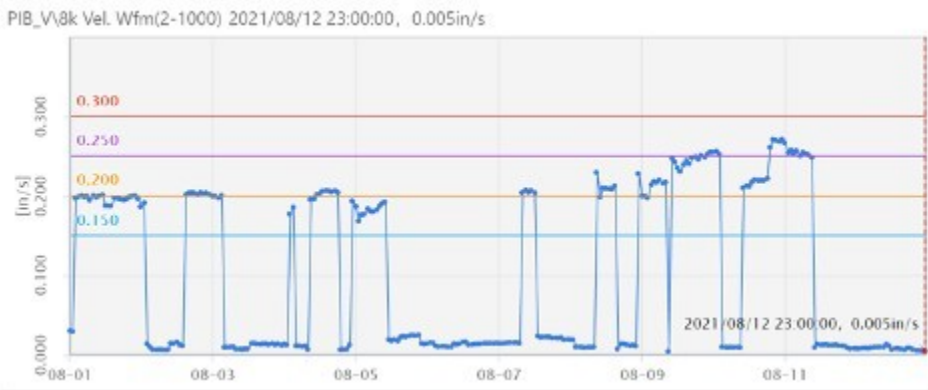
Using Hydraulic Institute standards, specifically ANSI/HI 9.6.4 for BB (between-bearing) and OH (overhung) pumps, Hydro assisted the end user in establishing alarm thresholds for each machine. Centaur's web-based software platform was then configured to send automated email alerts to the Centaur team and the end-user when a targeted alarm threshold is crossed. In early August, the Alarm 2 threshold (>0.250 ips RMS) was crossed at the pump inboard bearing location in the vertical direction. The trend plot below shows the upward trend in vibration amplitude levels and the Alarm 2 level (shown in purple).

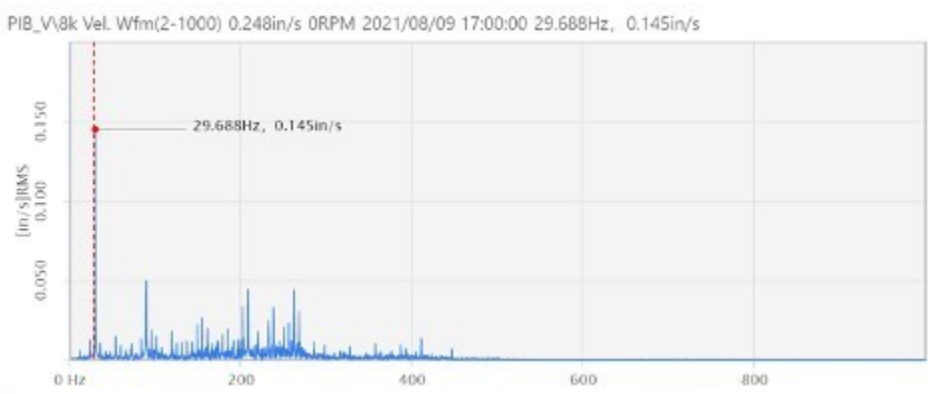
The monitored data identified a dominant excitation frequency at 1x run speed (29.688Hz) with harmonics. The team at Hydro's Monitoring & Diagnostic Center suspected that misalignment may be the root cause of the elevated vibration amplitude readings.

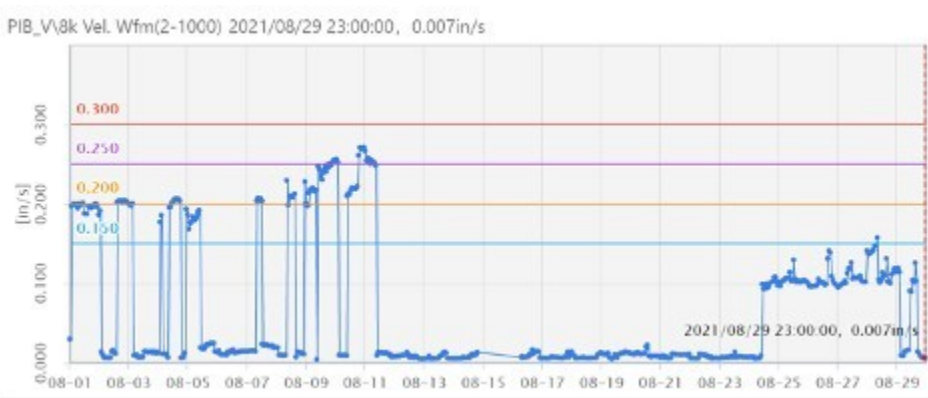
To confirm our suspicions, Hydro reached out to on-site personnel and asked for additional information that could help validate the misalignment theory. While gathering information, the site scheduled maintenance on the pump and found that the inboard coupling was cracked. Upon replacing the coupling, the vibration amplitude levels dropped below the warning threshold (<0.150 ips RMS), as shown in the trend plot below.
