## Hydro, Inc.'s Centaur IIoT Solution Detects Cracked Coupling at Municipal Wastewater Treatment Plant

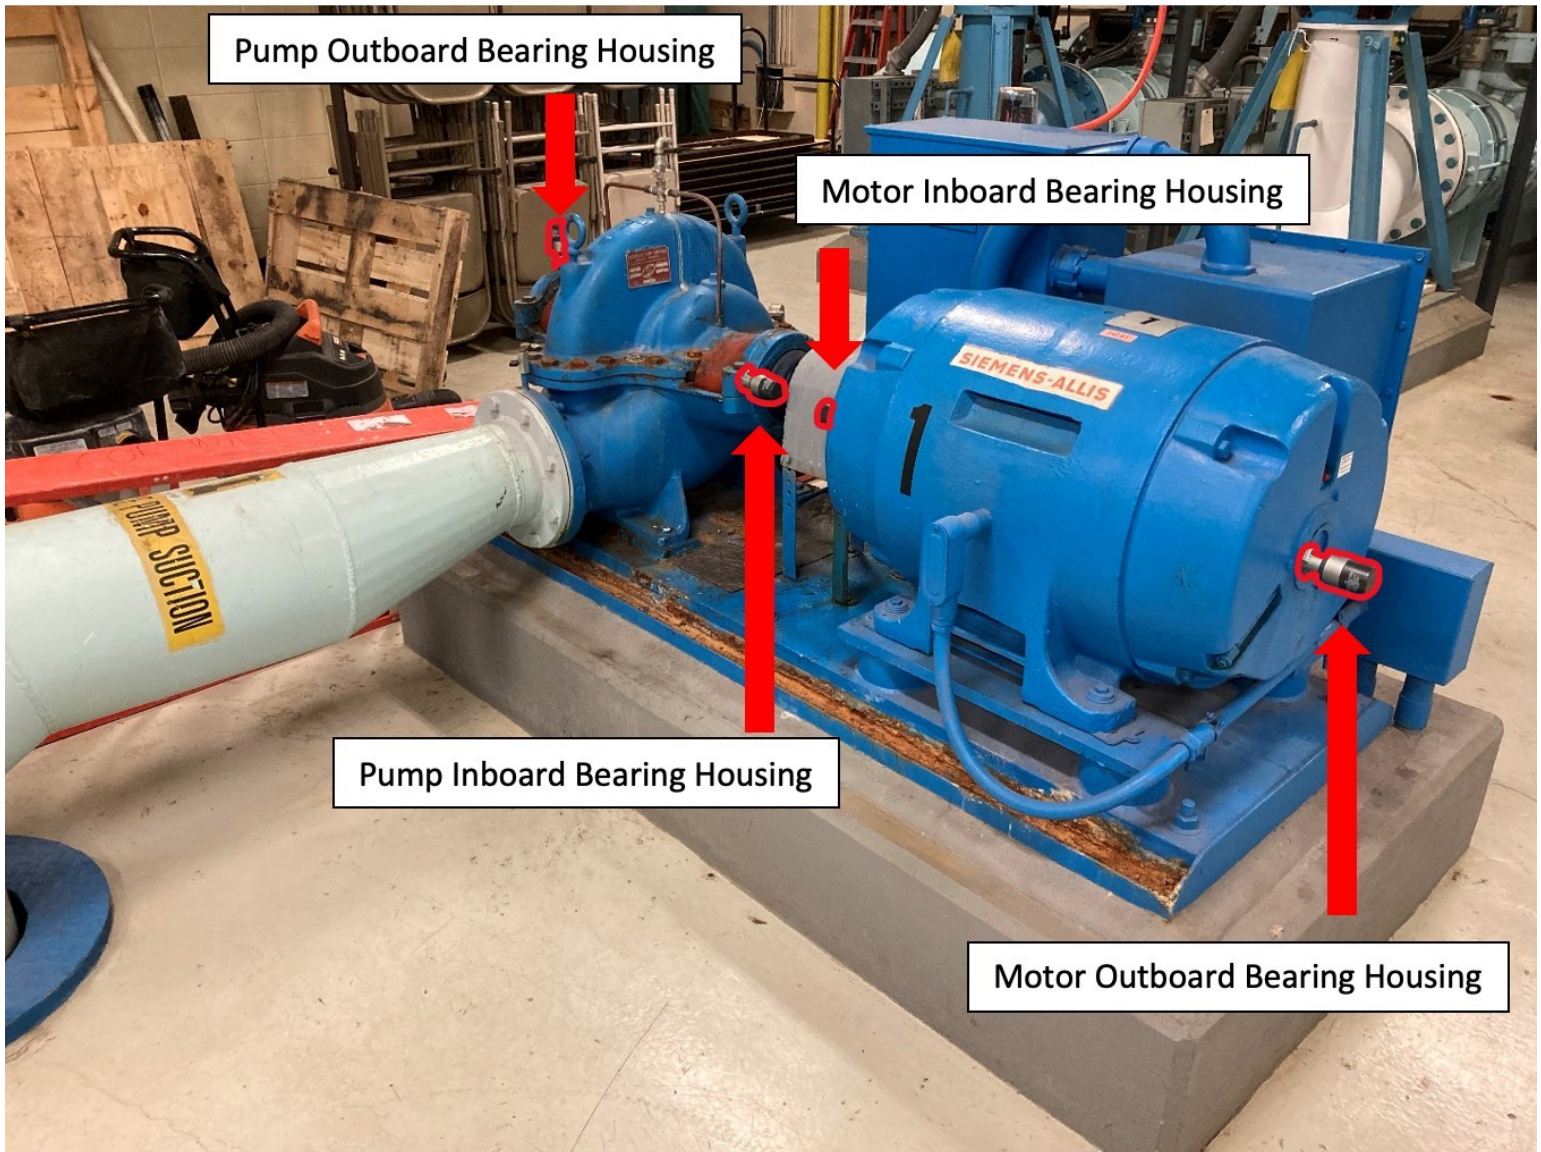
For this installation, the Centaur engineering team outfitted wireless accelerometers at specific points on multiple machine trains. The monitored locations include the motor outboard bearing housing, motor inboard bearing housing, pump inboard bearing housing, and pump outboard bearing housing, as shown below.

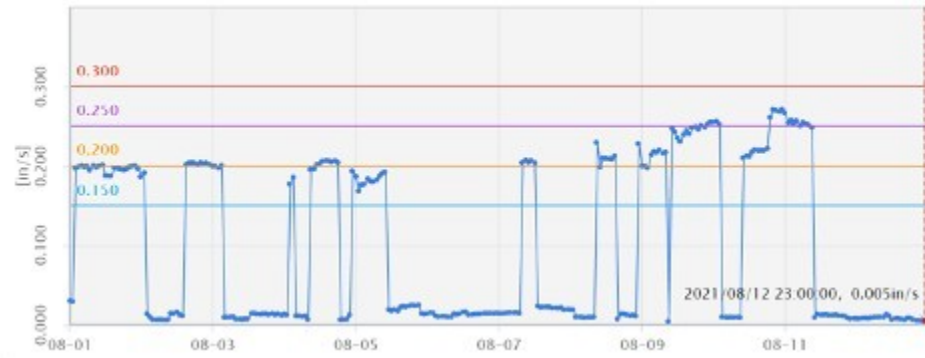
PIB\_V\8k Vel. Wfm(2-1000) 2021/08/12 23:00:00, 0.005in/s

Using Hydraulic Institute standards, specifically ANSI/HI 9.6.4 for BB (between-bearing) and OH (overhung) pumps, Hydro assisted the end user in establishing alarm thresholds for each machine. Centaur's web-based software platform was then configured to send automated email alerts to the Centaur team and the end-user when a targeted alarm threshold is crossed. In early August, the Alarm 2 threshold ( $>0.250$  ips RMS) was crossed at the pump inboard bearing location in the vertical direction. The trend plot below shows the upward trend in vibration amplitude levels and the Alarm 2 level (shown in purple).

The monitored data identified a dominant excitation frequency at 1x run speed (29.688Hz) with harmonics. The team at Hydro's Monitoring & Diagnostic Center suspected that misalignment may be the root cause of the elevated vibration amplitude readings.

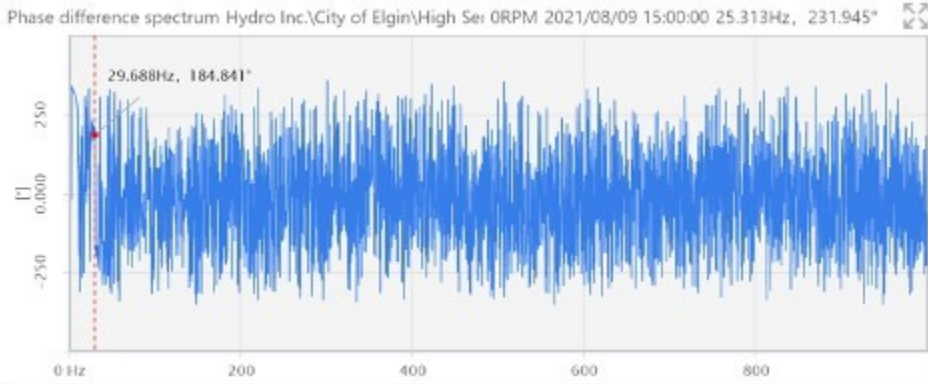
Phase analysis was performed between the pump inboard sensor location and the motor inboard sensor location. The phase angle is an important parameter to monitor, as it indicates relative motion between two locations of measurement.

The phase difference, shown in the chart below, revealed a 184.841° phase difference between the pump inboard sensor and the motor inboard sensor. This phase angle is indicative of a potential misalignment condition between the coupled components.

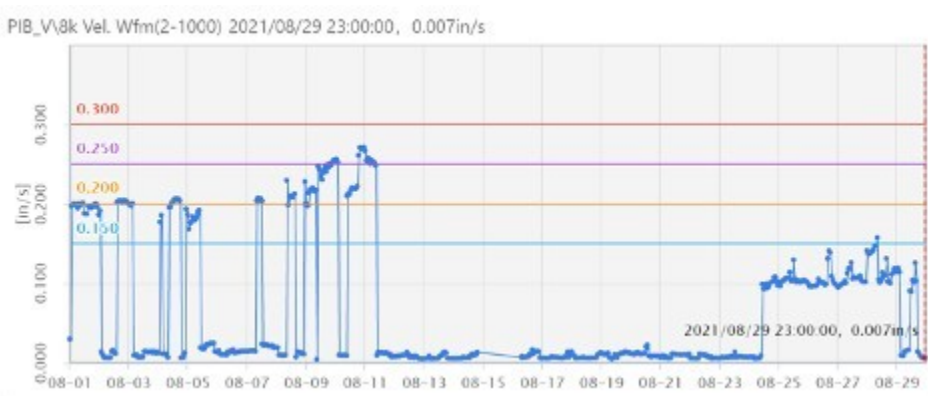
To confirm our suspicions, Hydro reached out to on-site personnel and asked for additional information that could help validate the misalignment theory. While gathering information, the site scheduled maintenance on the pump and found that the inboard coupling was cracked. Upon replacing the coupling, the vibration amplitude levels dropped below the warning threshold (<0.150 ips RMS), as shown in the trend plot below.
