# Throwback: Expedited Vertical Pump Repair & Engineered Upgrade

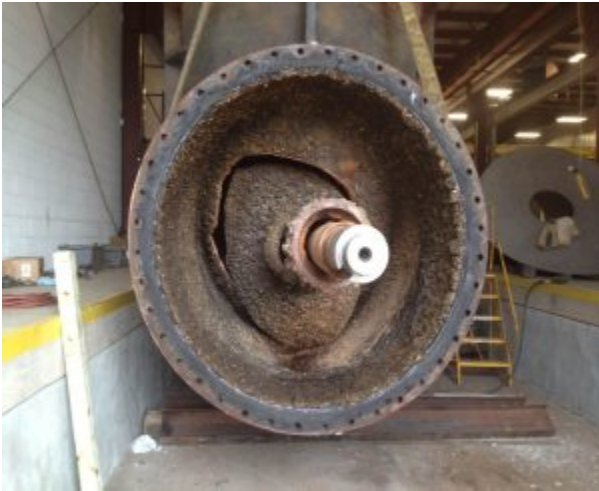
A critical vertical pump for a 750 MW unit was sent to [Hydro South](#) in mid-December 2012 for inspection and repair. The massive pump weighed more than 66,000 lbs. and was 32 feet long and 12 feet tall. When the pump was disassembled, Hydro South's engineers discovered that a large 42" x 68" section of the discharge elbow was broken, allowing direct flow to bypass the turning section and flow directly into the stuffing box area.

The discharge elbow was made of casted cast iron and could not be welded. A replacement of this size would take around eight months to order and receive.

Hydro's in-house engineering team worked with the customer to create a repair plan that could be completed in a 4-to-5-week time frame. The plan included manufacturing three steel plates to be inserted into the damaged area. Each plate would be .500 inches thick and was rolled and contoured to match the original contours of the elbow. The plates were installed and bolted to the damaged section of the elbow with each of the mating sections welded together. In addition, the backside was reinforced with gussets to effectively produce more than 155,000 gallons at 20 ft of head.

Following the installation of all the plates and gussets, the entire internal section of the elbow was coated to protect and improve the water flow. The pump was returned to the customer in early February 2013 and remains in operation today.
