## Throwback: Expedited Vertical Pump Repair & Engineered Upgrade

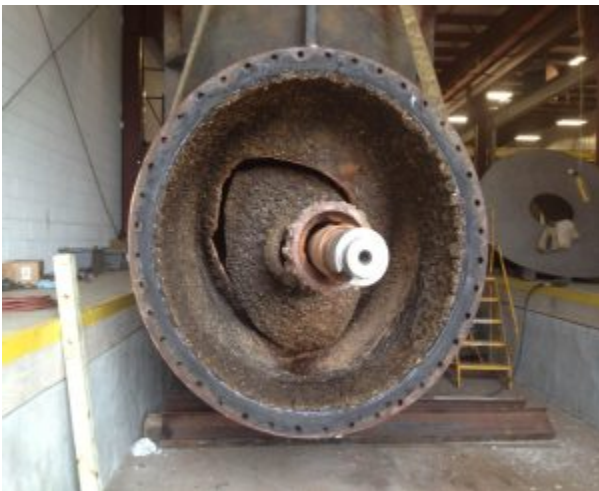
A critical vertical pump for a 750 MW unit was sent to [Hydro South](#) in mid-December 2012 for inspection and repair. The massive pump weighed more than 66,000 lbs. and was 32 feet long and 12 feet tall. When the pump was disassembled, Hydro South's engineers discovered that a large 42" x 68" section of the discharge elbow was broken, allowing direct flow to bypass the turning section and flow directly into the stuffing box area.

The discharge elbow was made of casted cast iron and could not be welded. A replacement of this size would take around eight months to order and receive.

Hydro's in-house engineering team worked with the customer to create a repair plan that could be completed in a 4-to-5-week time frame. The plan included manufacturing three steel plates to be inserted into the damaged area. Each plate would be .500 inches thick and was rolled and contoured to match the original contours of the elbow. The plates were installed and bolted to the damaged section of the elbow with each of the mating sections welded together. In addition, the backside was reinforced with gussets to effectively produce more than 155,000 gallons at 20 ft of head.

Following the installation of all the plates and gussets, the entire internal section of the elbow was coated to protect and improve the water flow. The pump was returned to the customer in early February 2013 and remains in operation today.
