Fertilizer Focus: Resolving Design Flaws in UAN Solution Pump

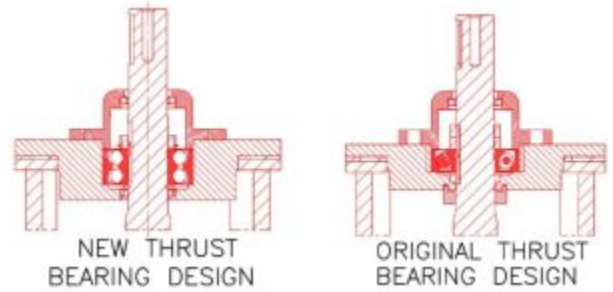
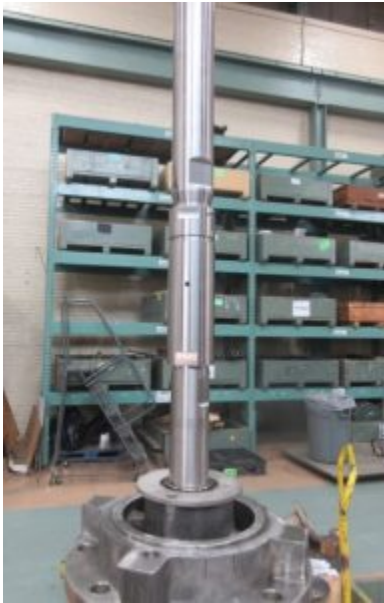
Inspection of the motor thrust bearing revealed that the ball bearing cage had become unseated and was damaged. During Hydro's analysis, it was determined that the motor thrust bearing was unsuitable for the service. The OEM chose a single row, angular contact bearing that could only handle thrust in one direction. During start-up, when the pump experienced an upthrust, the bearing became unseated. The unseated bearing was unable to function properly, even when the pump reached its normal operating thrust. This unrestrained upward motion of the shaft also caused damage to the mechanical seal faces.

Another problem detected during the DCI was elliptical wear of the bearing bores. In this pump, the lineshaft couplings were located under the guide bushings, which is very atypical. Lineshaft couplings are areas where the greatest runout often occurs, resulting in a greater probability of contact and wear in this area. This problematic design was coupled with excessive tolerances on the columns, spiders, sole plate, and motor flange that affected centerline compatibility of the components.

The pump was upgraded to a new design that included a relocation of the lineshaft couplings, a new thrust bearing that could handle load in both directions, and an improvement of all component tolerances to minimize the possibility of component misalignment. Almost 70% of the pump was redesigned; this work was completed on an emergency schedule of only 2-3 weeks. Since reinstallation, the pump has operated successfully with reduced vibration.
