## Fertilizer Focus: Resolving Design Flaws in UAN Solution Pump

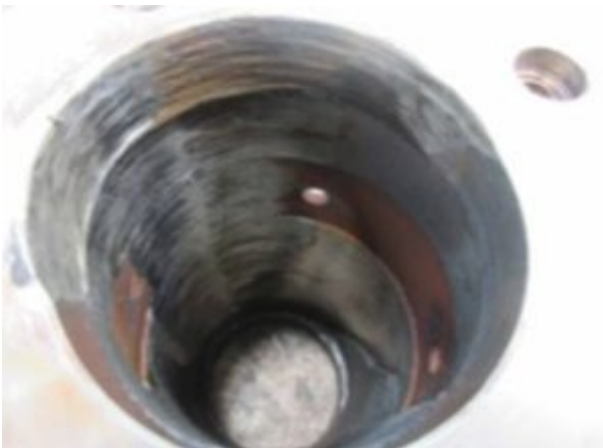
A newly commissioned US fertilizer plant was experiencing recurring vibration problems with their vertical UAN Solution pump. The VSF vertically suspended pump was removed from service and sent to Hydro for a full inspection and investigation of the vibration source. When the pump was disassembled, it was evident that there were significant problems at the motor bearing and guide bushing locations. These design flaws that were affecting reliable operation of the pump.

Inspection of the motor thrust bearing revealed that the ball bearing cage had become unseated and was damaged. During Hydro's analysis, it was determined that the motor thrust bearing was unsuitable for the service. The OEM chose a single row, angular contact bearing that could only handle thrust in one direction. During start-up, when the pump experienced an upthrust, the bearing became unseated. The unseated bearing was unable to function properly, even when the pump reached its normal operating thrust. This unrestrained upward motion of the shaft also caused damage to the mechanical seal faces.

Another problem detected during the DCI was elliptical wear of the bearing bores. In this pump, the lineshaft couplings were located under the guide bushings, which is very atypical. Lineshaft couplings are areas where the greatest runout often occurs, resulting in a greater probability of contact and wear in this area. This problematic design was coupled with excessive tolerances on the columns, spiders, sole plate, and motor flange that affected centerline compatibility of the components.

The pump was upgraded to a new design that included a relocation of the lineshaft couplings, a new thrust bearing that could handle load in both directions, and an improvement of all component tolerances to minimize the possibility of component misalignment. Almost 70% of the pump was redesigned; this work was completed on an emergency schedule of only 2-3 weeks. Since reinstallation, the pump has operated successfully with reduced vibration.
