Fertilizer Focus: Resolving Design Flaws in UAN Solution Pump

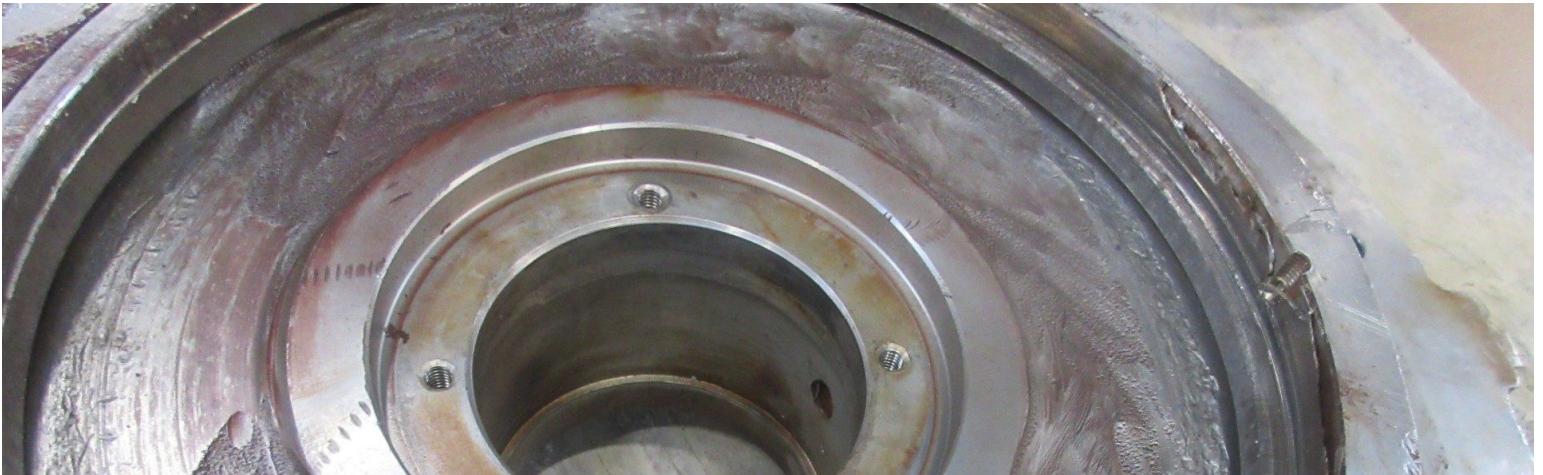
A newly commissioned US fertilizer plant was experiencing recurring vibration problems with their vertical UAN Solution pump. The VSF vertically suspended pump was removed from service and sent to Hydro for a full inspection and investigation of the vibration source. When the pump was disassembled, it was evident that there were significant problems at the motor bearing and guide bushing locations. These design flaws that were affecting reliable operation of the pump.

Inspection of the motor thrust bearing revealed that the ball bearing cage had become unseated and was damaged. During Hydro's analysis, it was determined that the motor thrust bearing was unsuitable for the service. The OEM chose a single row, angular contact bearing that could only handle thrust in one direction. During start-up, when the pump experienced an upthrust, the bearing became unseated. The unseated bearing was unable to function properly, even when the pump reached its normal operating thrust. This unrestrained upward motion of the shaft also caused damage to the mechanical seal faces.

Another problem detected during the DCI was elliptical wear of the bearing bores. In this pump, the lineshaft couplings were located under the guide bushings, which is very atypical. Lineshaft couplings are areas where the greatest

runout often occurs, resulting in a greater probability of contact and wear in this area. This problematic design was coupled with excessive tolerances on the columns, spiders, sole plate, and motor flange that affected centerline compatibility of the components.

The pump was upgraded to a new design that included a relocation of the lineshaft couplings, a new thrust bearing that could handle load in both directions, and an improvement of all component tolerances to minimize the possibility of component misalignment. Almost 70% of the pump was redesigned; this work was completed on an emergency schedule of only 2-3 weeks. Since reinstallation, the pump has operated successfully with reduced vibration.
