Fertilizer Focus: Volute Reprofilng Resolves Vane Pass Vibration

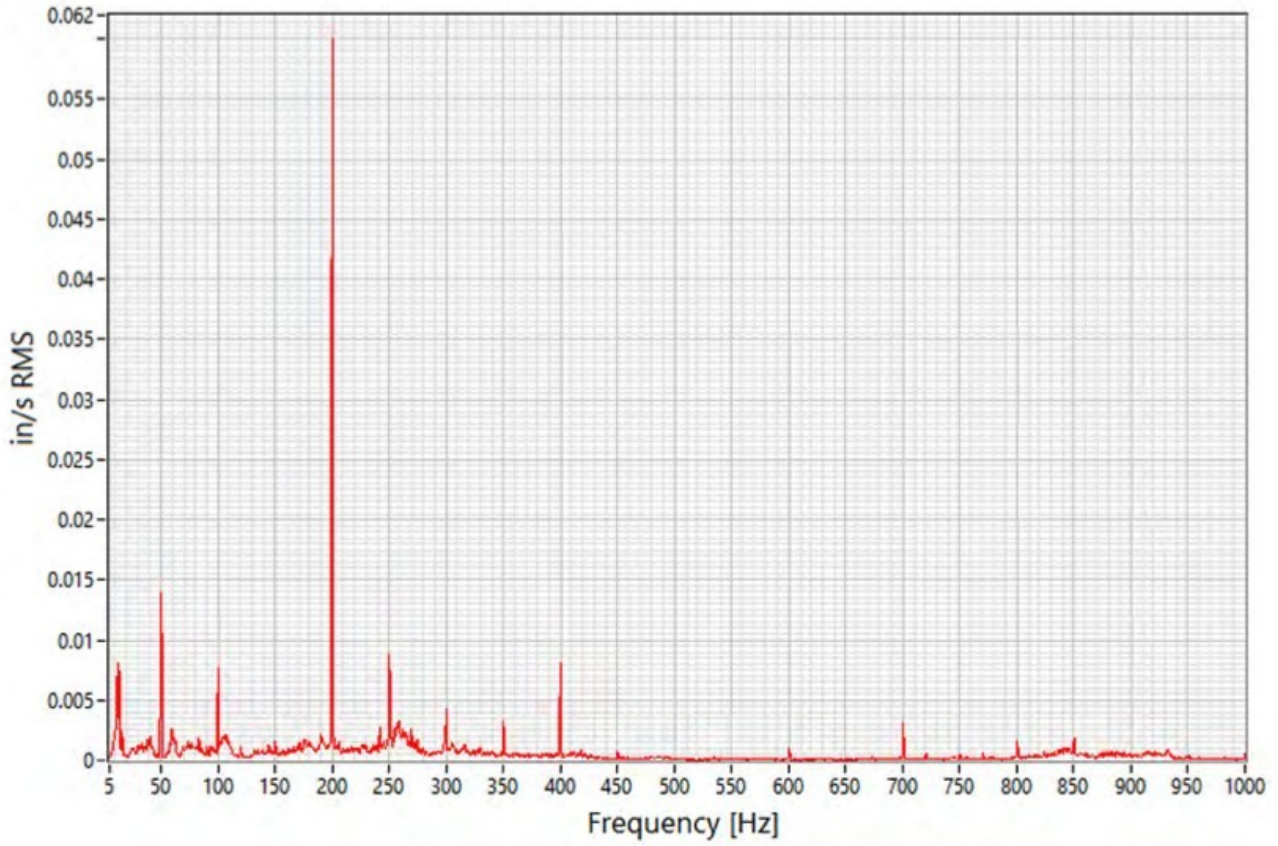
The upgraded design was tested in [Hydro's performance test lab](#). This gave the end user confidence that the hydraulic performance of the pump had not been negatively affected by the volute lip geometry modification. It also verified that the vibration amplitudes had been reduced. After successful testing, the modified pump was returned to the field, where it continues to run smoothly.

1. Reduced Vane Pass Vibration Observed During Testing
