Phase Measurements Used to Diagnose Compressor Misalignment

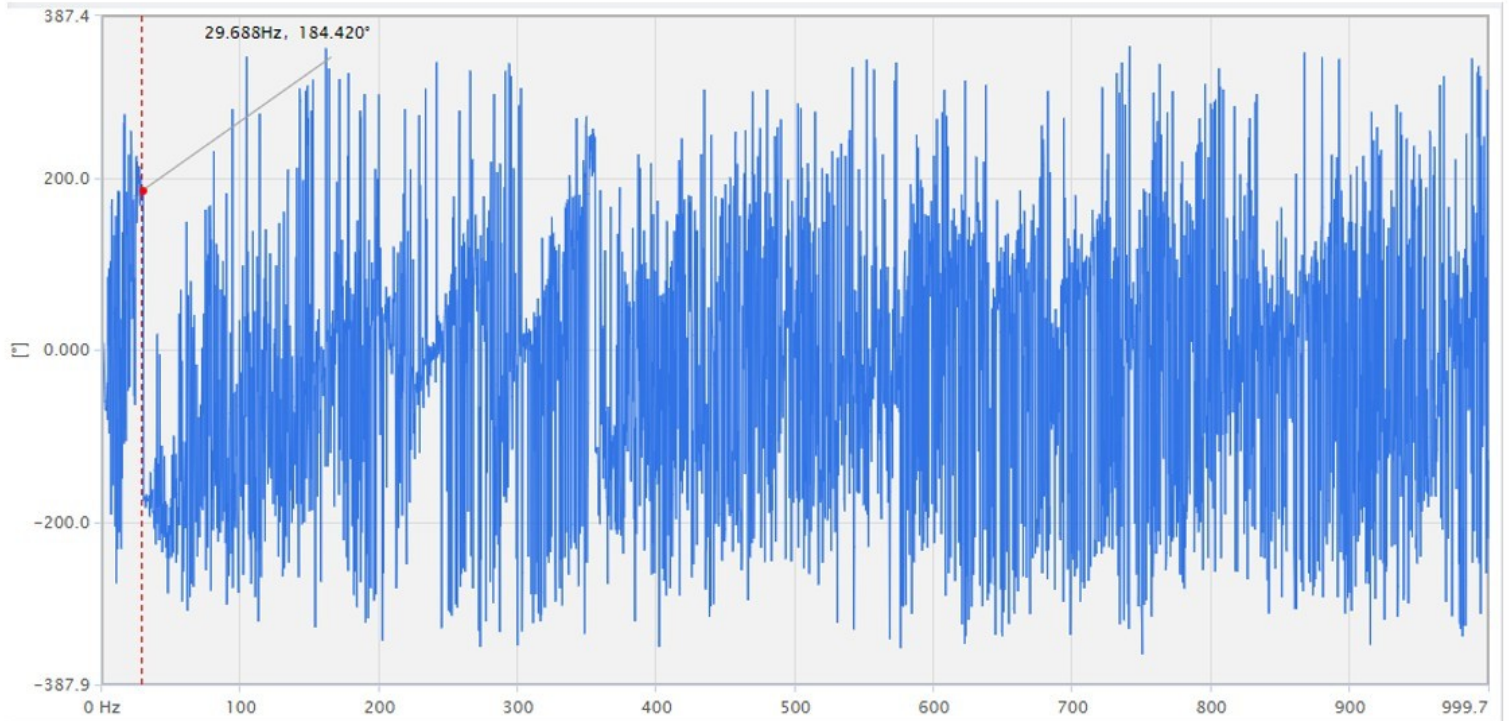
looked at the phase data collected. The phase analysis performed between the compressor inboard sensor location and the motor inboard sensor showed a significant difference in phase between the two locations. The phase difference chart below shows a 184.420° phase difference between the compressor inboard sensor and the motor inboard sensor. The phase angle is indicative of a potential misalignment condition being present between the coupled components.

To confirm our suspicions, Hydro reached out to the end user's on-site personnel and suggested that the alignment be checked. Site personnel checked the alignment and confirmed that the compressor and motor were out of alignment and corrected the issue.
