# Phase Measurements Used to Diagnose Compressor Misalignment

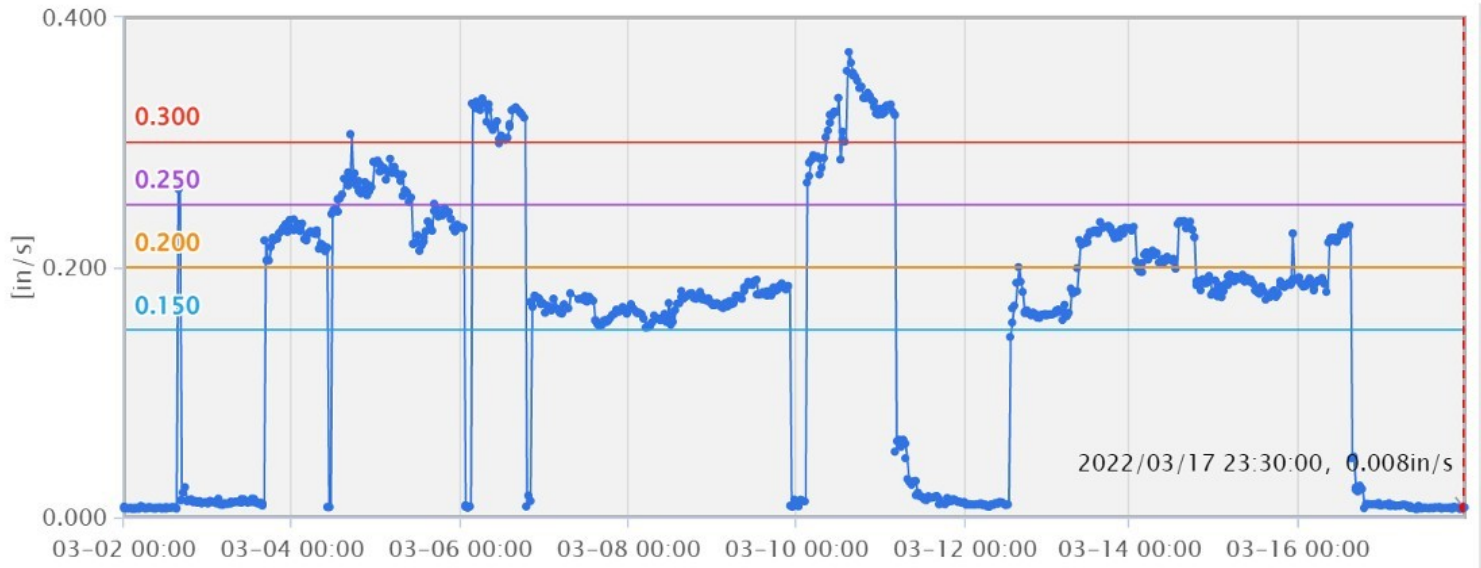
In mid-March, the purple alarm 2 threshold ( $>0.250$  ips RMS) and the red alarm 3 threshold ( $>0.300$  ips RMS) were crossed by multiple sensors in multiple directions. The trend plot below shows an upward trend in vibration amplitude levels on the monitored compressor.

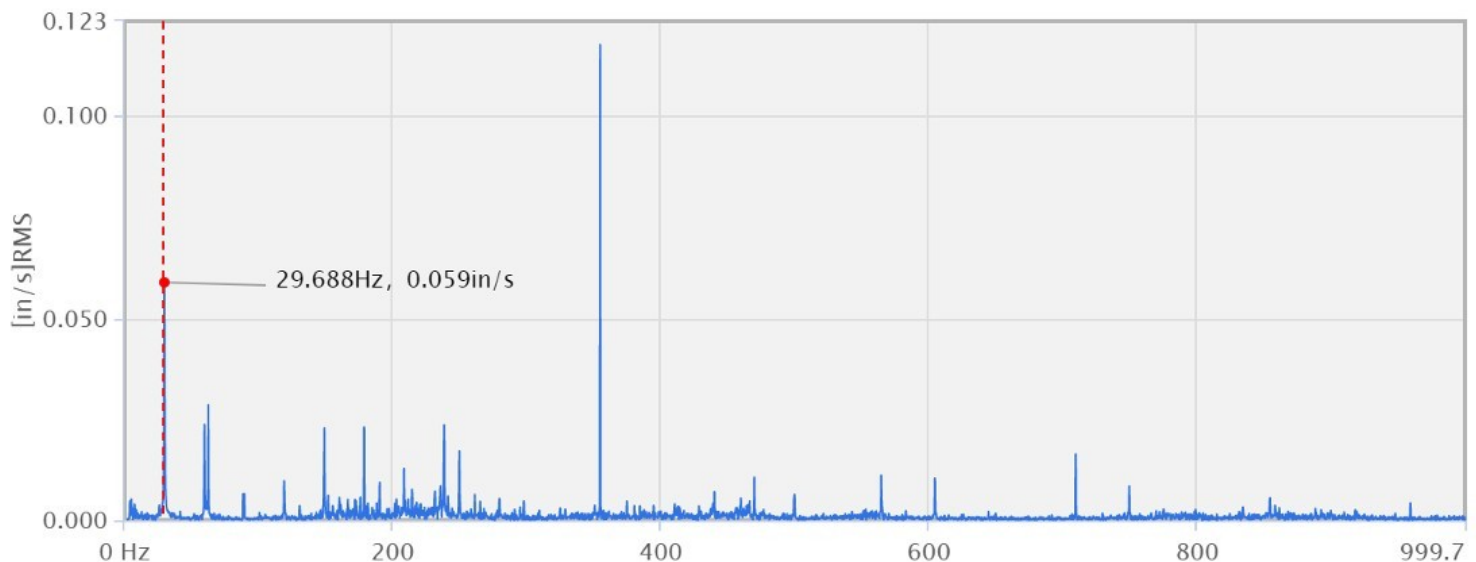
When the Centaur engineers reviewed the vibration data, they identified a dominant excitation frequency at 1x run speed (29.688Hz) with harmonics present. Knowing that the compressor skid, including the compressor and motor bases, were never fully grouted, they suspected that misalignment may be the root cause of the elevated vibration amplitude readings. Misalignment occurs when there is an offset between the centerlines of the driving component and the driven component. It can result in high radial forces, high axial forces, or a combination of both.

To confirm our suspicions, Hydro reached out to the end user's on-site personnel and suggested that the alignment be checked. Site personnel checked the alignment and confirmed that the compressor and motor were out of alignment and corrected the issue.

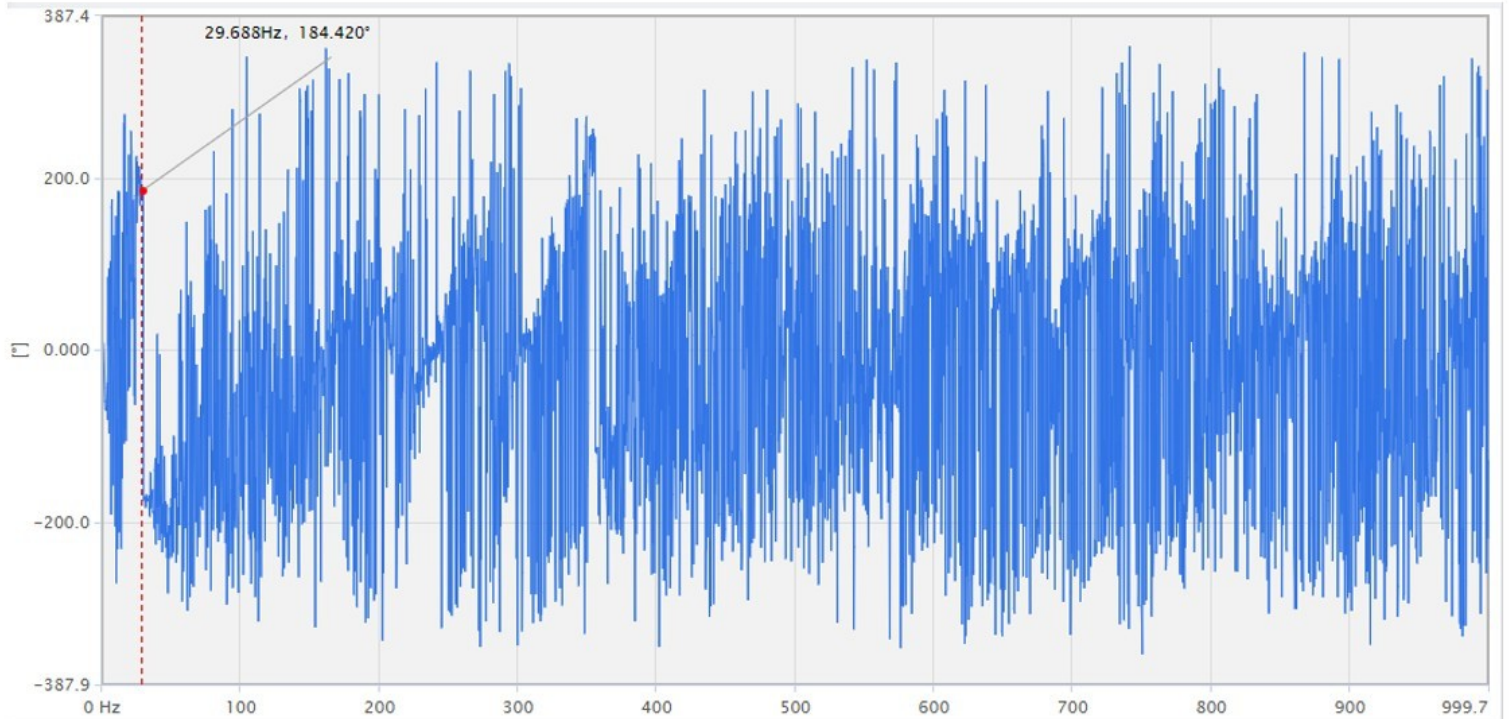
looked at the phase data collected. The phase analysis performed between the compressor inboard sensor location and the motor inboard sensor showed a significant difference in phase between the two locations. The phase difference chart below shows a  $184.420^\circ$  phase difference between the compressor inboard sensor and the motor inboard sensor. The phase angle is indicative of a potential misalignment condition being present between the coupled components.
