Phase Measurements Used to Diagnose Compressor Misalignment

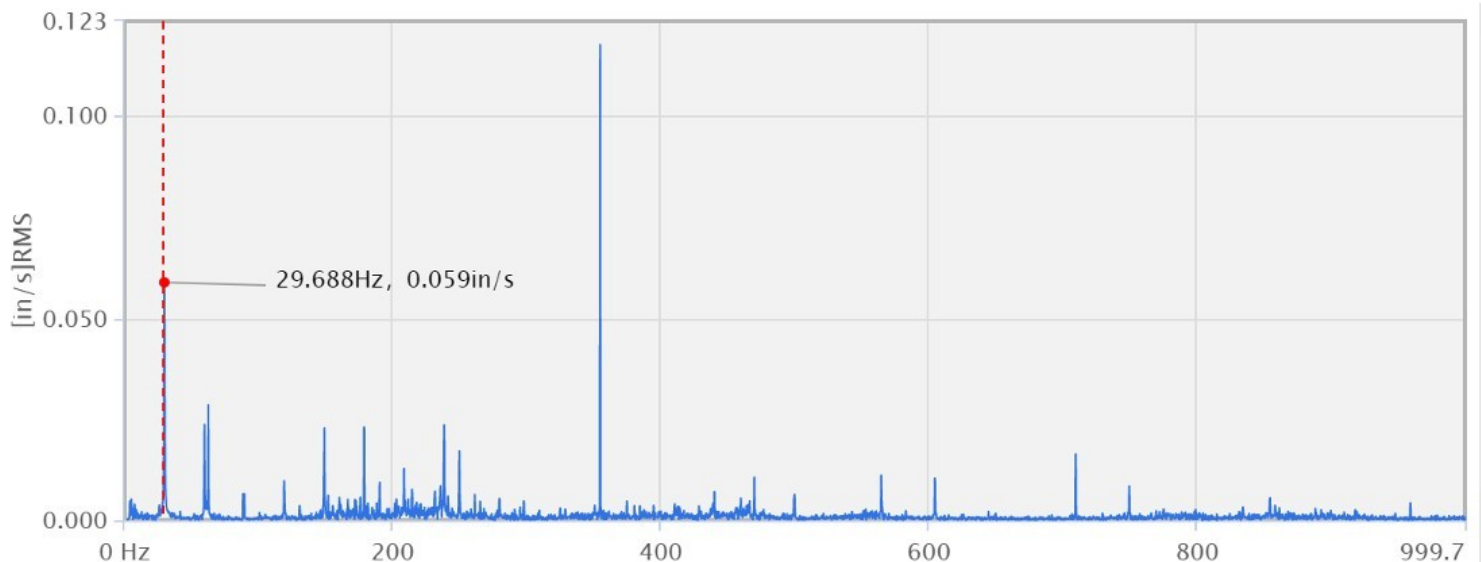
When the Centaur engineers reviewed the vibration data, they identified a dominant excitation frequency at 1x run speed (29.688Hz) with harmonics present. Knowing that the compressor skid, including the compressor and motor bases, were never fully grouted, they suspected that misalignment may be the root cause of the elevated vibration amplitude readings. Misalignment occurs when there is an offset between the centerlines of the driving component and the driven component. It can result in high radial forces, high axial forces, or a combination of both.

To confirm our suspicions, Hydro reached out to the end user's on-site personnel and suggested that the alignment be checked. Site personnel checked the alignment and confirmed that the compressor and motor were out of alignment and corrected the issue.
