Blower Outboard Bearing Failure Identified through Advanced Condition Monitoring

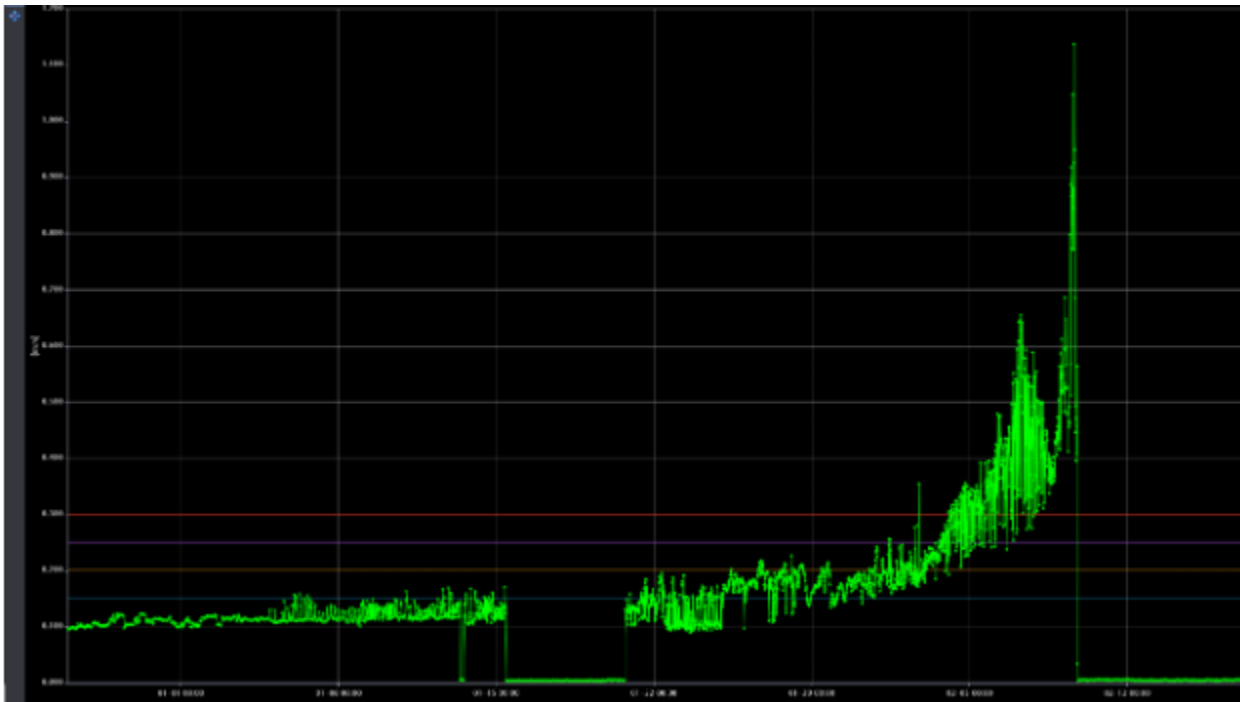
Figure 1: Velocity Amplitude as Several Alarm Thresholds Breached

When elevated vibration amplitudes were first detected on the problematic blower, they were in the Blower Outboard Bearing in the vertical direction (BOBV). The velocity amplitude shown below crossed the warning threshold on January 06, 2024, alerting both Hydro and the end user's site engineers that a condition was present and in blower was in the early stages of degradation. The observation was discussed during the weekly touchpoint between Hydro and the plant, where Hydro would review the health of all monitored assets and address any alarm events captured using Centaur with site stakeholders.

The vibration velocity amplitudes continued to climb, and on January 25, 2024 they crossed the Alarm #1 threshold. The Alarm #2 threshold was breached on February 01, 2024. Continual touchpoint meetings highlighted the worsening conditions and provided an analysis of the suspected failure mode(s) affecting the blower mechanical condition. The below multi-spectrum chart shows the spectra at the BOBV location at various points along the trend – mapping the signature of the degradation.

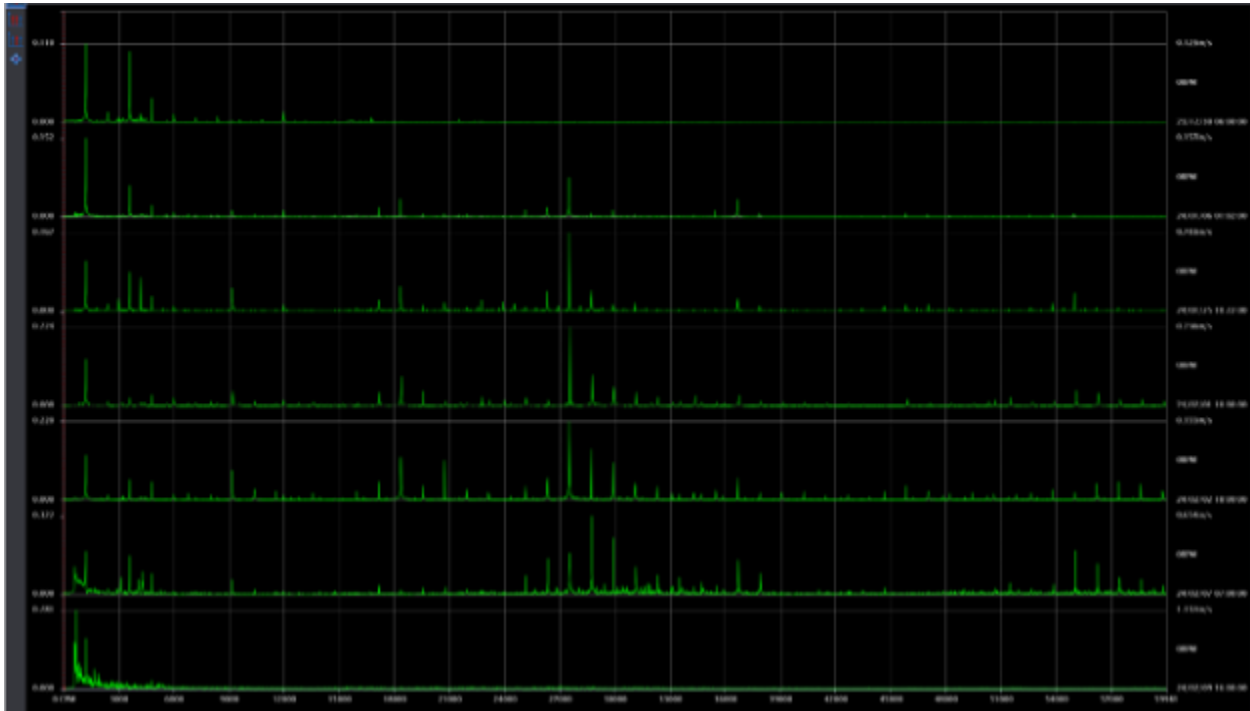
Figure 2: Multi-Spectrum Chart of BOBV Location

The chart starts with the spectra during "normal" conditions, prior to the observed degradation. Peaks at 1X and several harmonics are present with an amplitude less than 0.15 ips RMS. As the problem is observed and continues to worsen, bearing fault frequencies and harmonic excitation appear and continue to get worse. The lowest spectrum in the chart shows vibration velocity amplitude during the final sample, when it is greater than 1 ips RMS – very severe. At this point, all the energy has moved to 1X or less than 1X frequencies – a common occurrence when a failure mode is in its final stages.

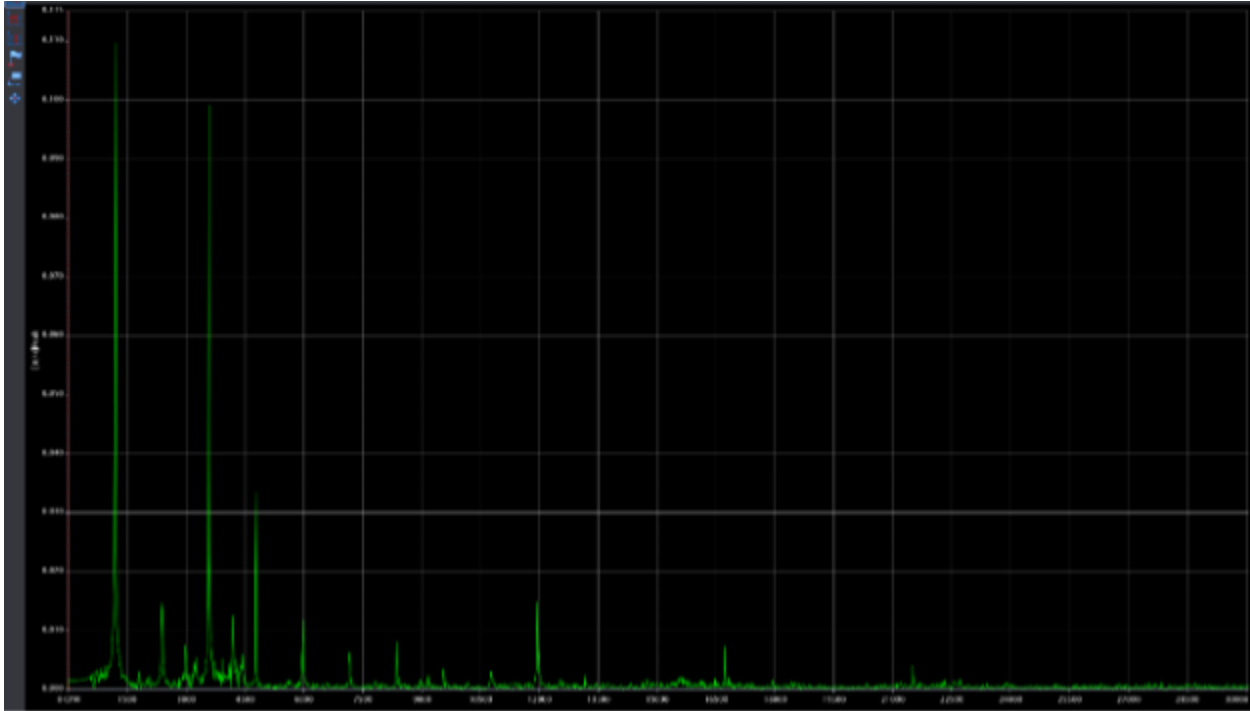
Figure 3: Initial Conditions

The following two spectra charts take a closer look at the condition, one chart showing the initial conditions prior to degradation and the other closer to the end of operation where bearing fault frequencies and harmonic excitation can be detected.

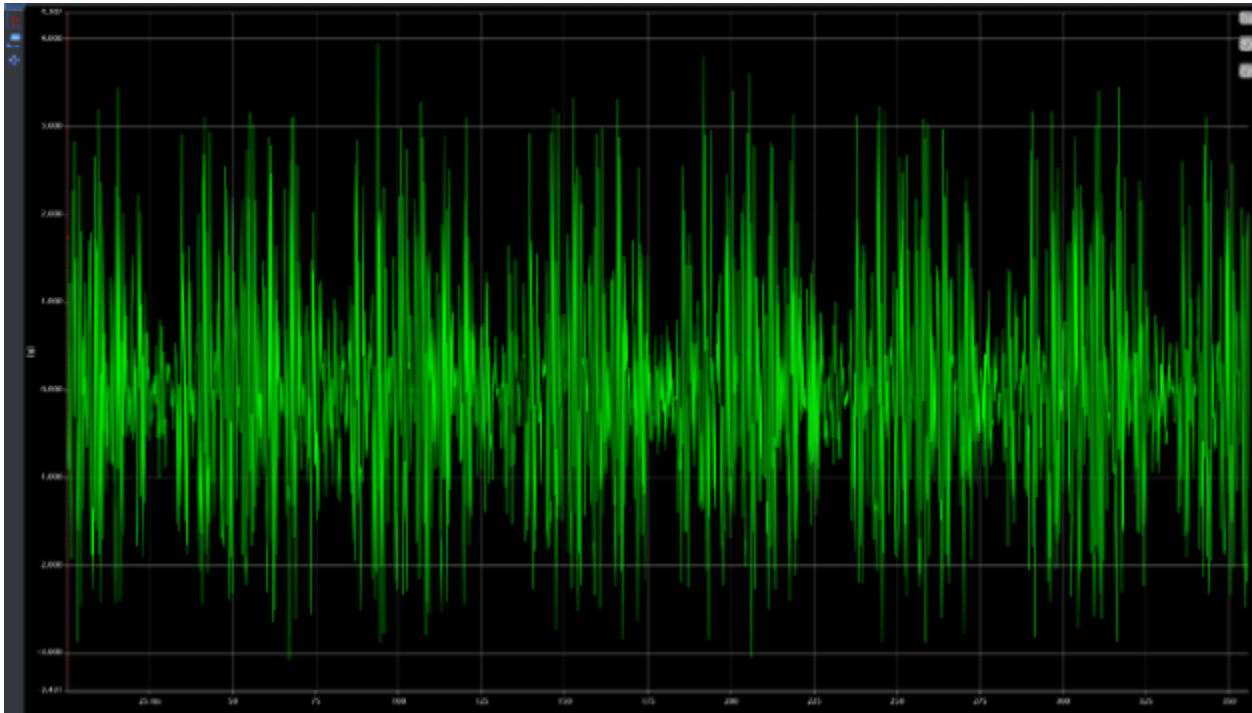
Figure 6: Waveform- Early Stage of Failure

The following four charts show the spectra and waveform data for acceleration readings at two points during the degradation period. The first two charts show the early stages of failure with peak-to-peak amplitudes of ~6 g's and harmonic excitation in the spectrum. The second two show acceleration data at a later stage of degradation with peak-to-peak amplitudes at ~30 g's and increased discrete frequency amplitudes in the spectrum.

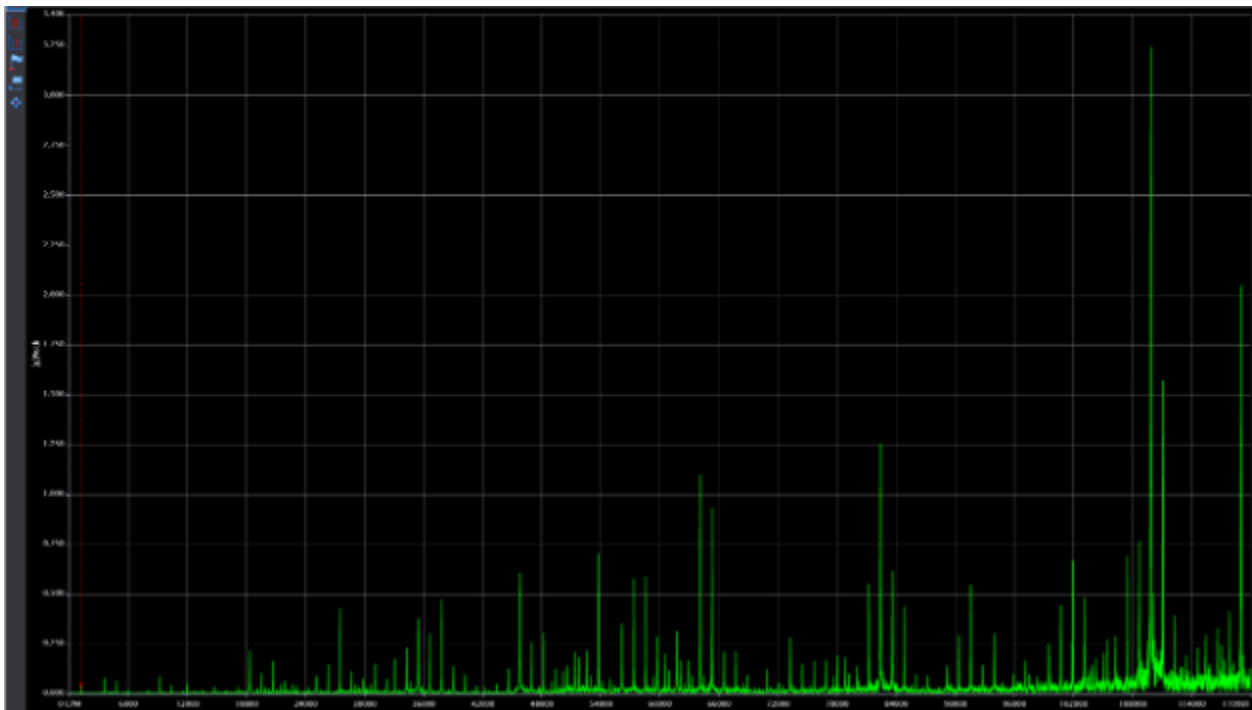
Figure 9: Spectrum- Late Stages of Degradation

The observation noted throughout was that the blower outboard bearing was failing. Failure of this bearing could also translate to damage to the shaft and other blower components if not addressed in a timely manner.
