# Blower Outboard Bearing Failure Identified through Advanced Condition Monitoring

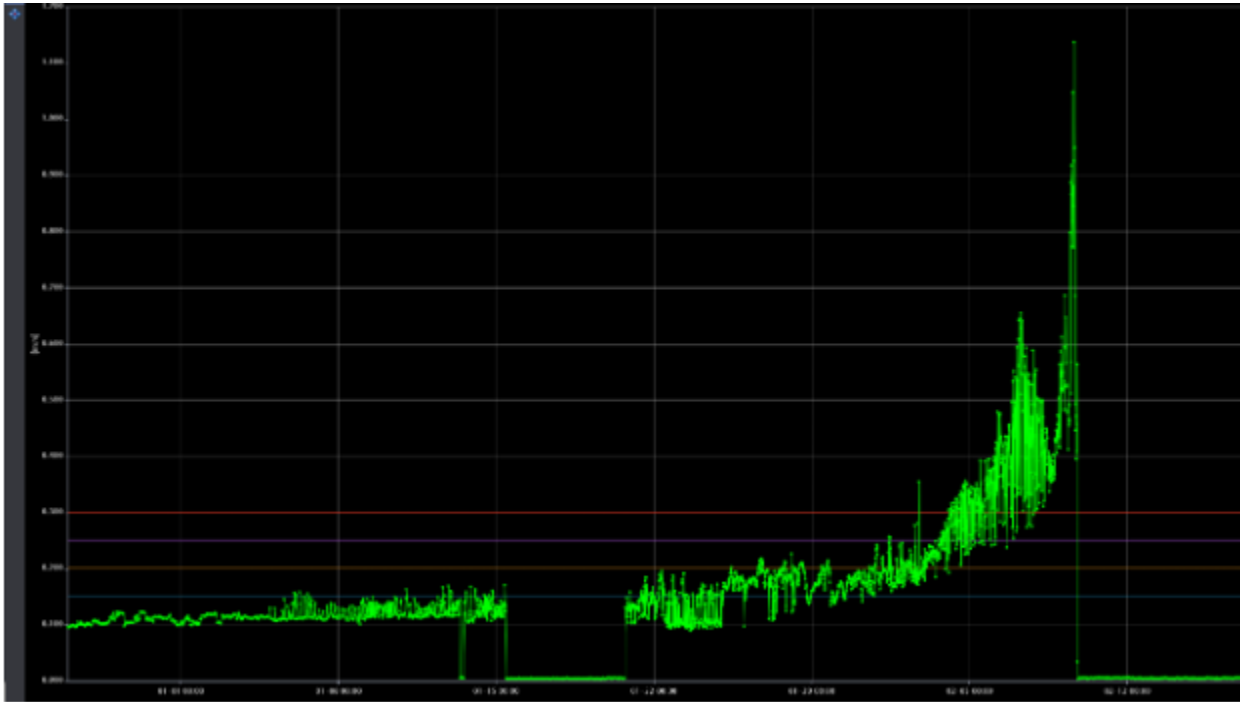
*Figure 1: Velocity Amplitude as Several Alarm Thresholds Breached*

When elevated vibration amplitudes were first detected on the problematic blower, they were in the Blower Outboard Bearing in the vertical direction (BOBV). The velocity amplitude shown below crossed the warning threshold on January 06, 2024, alerting both Hydro and the end user's site engineers that a condition was present and in blower was in the early stages of degradation. The observation was discussed during the weekly touchpoint between Hydro and the plant, where Hydro would review the health of all monitored assets and address any alarm events captured using Centaur with site stakeholders.

The vibration velocity amplitudes continued to climb, and on January 25, 2024 they crossed the Alarm #1 threshold. The Alarm #2 threshold was breached on February 01, 2024. Continual touchpoint meetings highlighted the worsening conditions and provided an analysis of the suspected failure mode(s) affecting the blower mechanical condition. The below multi-spectrum chart shows the spectra at the BOBV location at various points along the trend – mapping the signature of the degradation.

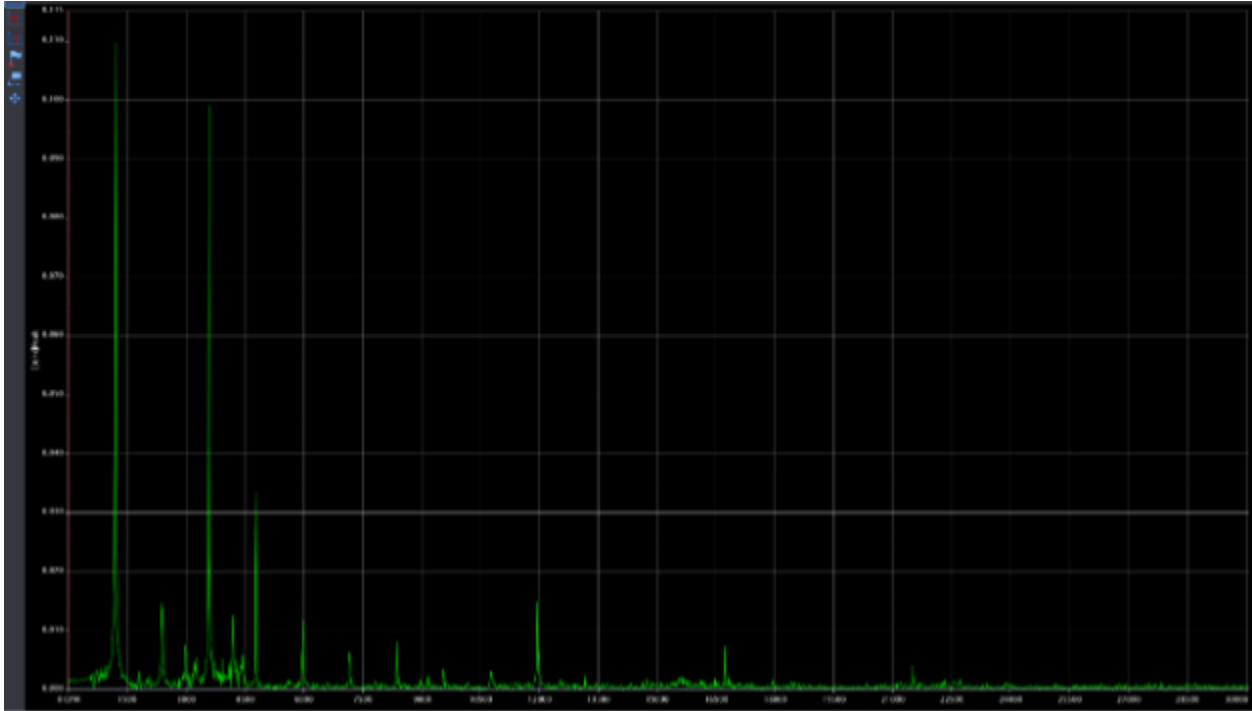
*Figure 3: Initial Conditions*

The following two spectra charts take a closer look at the condition, one chart showing the initial conditions prior to degradation and the other closer to the end of operation where bearing fault frequencies and harmonic excitation can be detected.

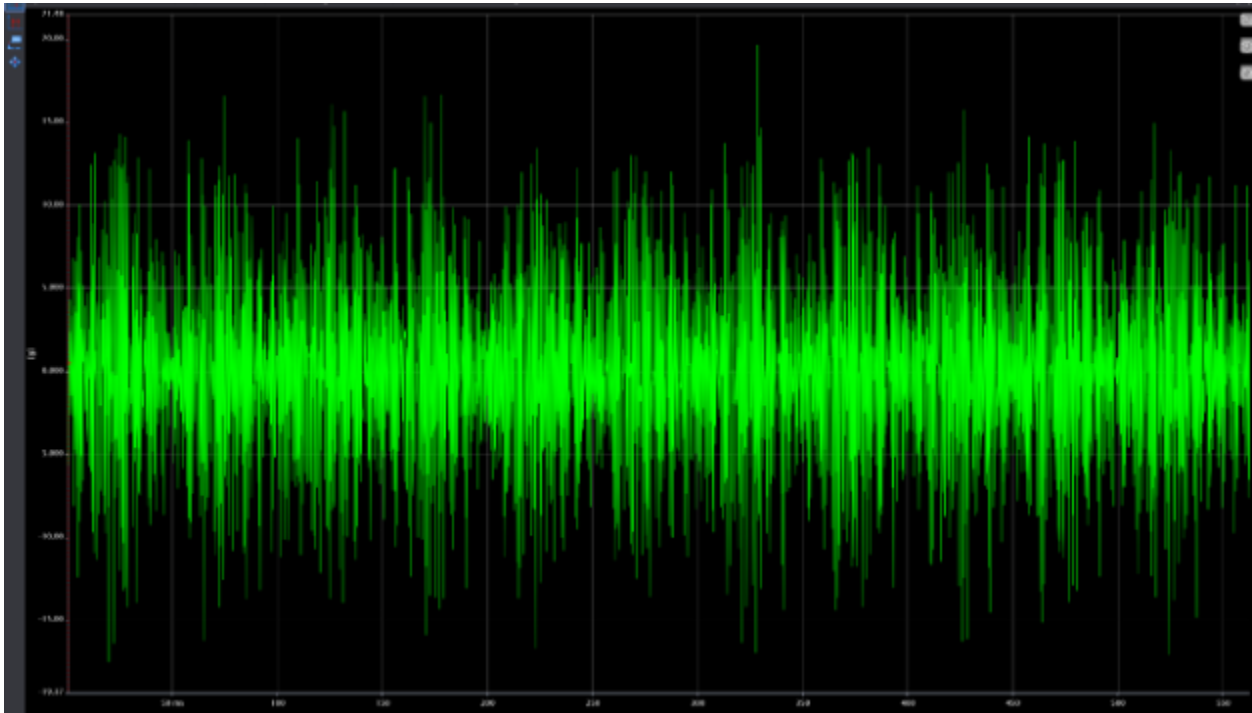
Figure 8: Waveform- Late Stages of Degradation

The following four charts show the spectra and waveform data for acceleration readings at two points during the degradation period. The first two charts show the early stages of failure with peak-to-peak amplitudes of ~6 g's and harmonic excitation in the spectrum. The second two show acceleration data at a later stage of degradation with peak-to-peak amplitudes at ~30 g's and increased discrete frequency amplitudes in the spectrum.

The observation noted throughout was that the blower outboard bearing was failing. Failure of this bearing could also translate to damage to the shaft and other blower components if not addressed in a timely manner.

The root cause of the issue was found to be contamination. This PVC unit created a fine dust byproduct that was found in the atmosphere, with large quantities accumulating around the blower units. Over time, the fine PVC dust would penetrate the bearings, compromising the effectiveness of the lubrication and reducing the tolerance inside of the bearings. Plans for remediation included relocating the machines or redesigning the bearing and housing to eliminate the possibility of contamination. The plant ultimately decided relocation was not an option and consulted the bearing manufacturer for an improved design that included a sealed housing.

Hydro continues to monitor these units, with ongoing reviews of the oil quality, level, and possibility of contamination from moisture, metal, or other sources. In parallel, Hydro also recommended reviewing the load handled by this blower and the rated load of the specified bearings, as improper loading may contribute to premature bearing failure.
