Blower Outboard Bearing Failure Identified through Advanced Condition Monitoring

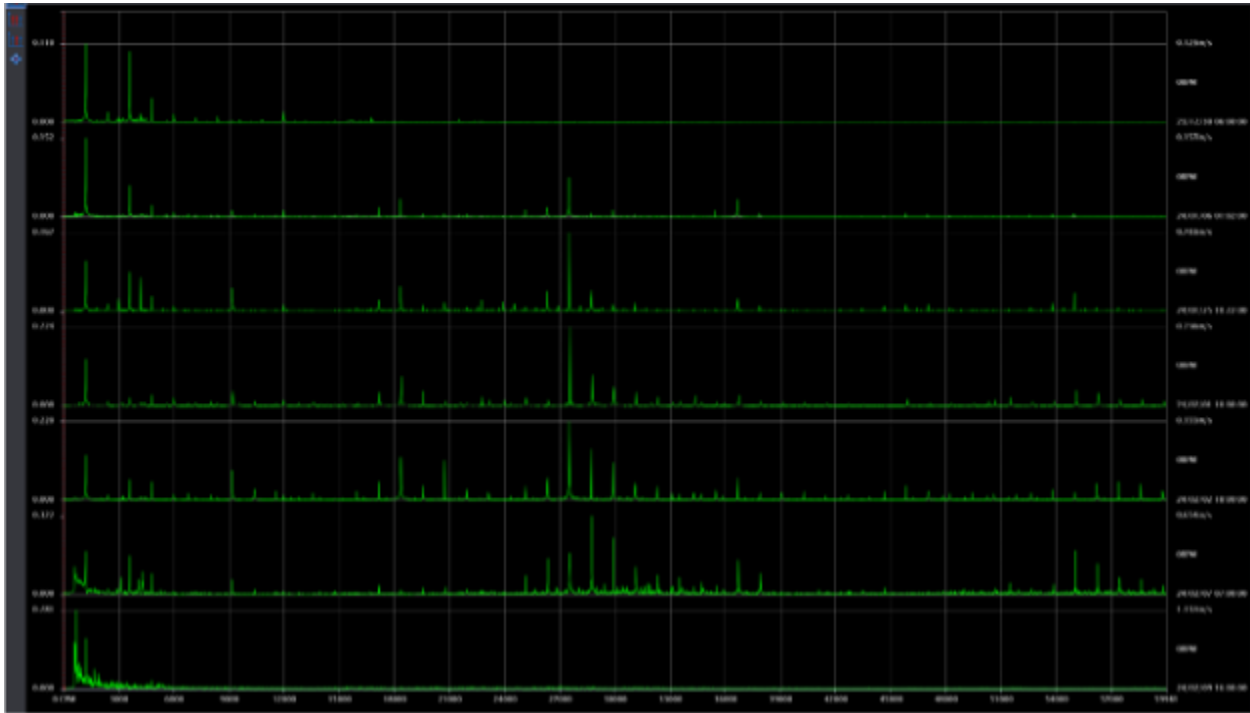
Figure 2: Multi-Spectrum Chart of BOBV Location

The chart starts with the spectra during "normal" conditions, prior to the observed degradation. Peaks at 1X and several harmonics are present with an amplitude less than 0.15 ips RMS. As the problem is observed and continues to worsen, bearing fault frequencies and harmonic excitation appear and continue to get worse. The lowest spectrum in the chart shows vibration velocity amplitude during the final sample, when it is greater than 1 ips RMS – very severe. At this point, all the energy has moved to 1X or less than 1X frequencies – a common occurrence when a failure mode is in its final stages.
