# Reliability Enhancement for Circulating Water Pump

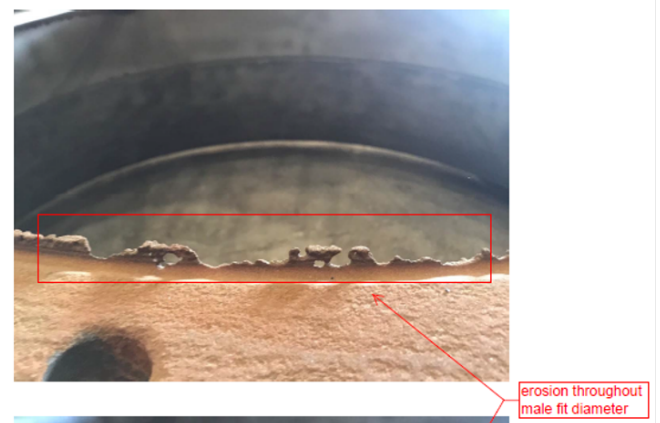
Fit-ups of the stationary assembly were excessive with average fit-ups measuring in the range of 0.010 – 0.030"; for reference, Hydro's typical acceptance criteria are 0.001 – 0.003". Critical faces and bores were also found out of acceptable tolerance, with concentricity, parallelism, and perpendicularity measuring in the range of 0.005 – 0.015", where acceptance is usually held less than 0.002". Not only did the out of tolerance fits contribute to overall misalignment, they provided a leak path that resulted in erosion of the column pipes at the fit areas.

To improve the alignment of all components within the stationary assembly, any out of tolerance fits and bores were welded up and machined to best-in-class tolerances and fits.

Vertical pumps are especially susceptible to misalignment since they have a large number of stacked components. Large fit-ups between each component can easily stack-up to a large offset at the bottom of the assembly that exceeds the bearing clearance. By restoring recommended fits and tolerances, non-centerline compatibility between the stationary and rotating elements would be greatly decreased.
