Reliability Enhancement for Circulating Water Pump

A large Midwestern coal-fired power plant had been experiencing vibration issues and premature failures with their large Kirloskar 130 BHM circulating water pumps. The plant has two operating units, with three circulating water pumps installed in each unit. The average life of the equipment was 6 months, which is far below the industry standard for a large vertical turbine pump in this service. The pumps were sent to Hydro's HydroAire 40th Street service center for a causal analysis and remediation of any problems that were found during the investigation.

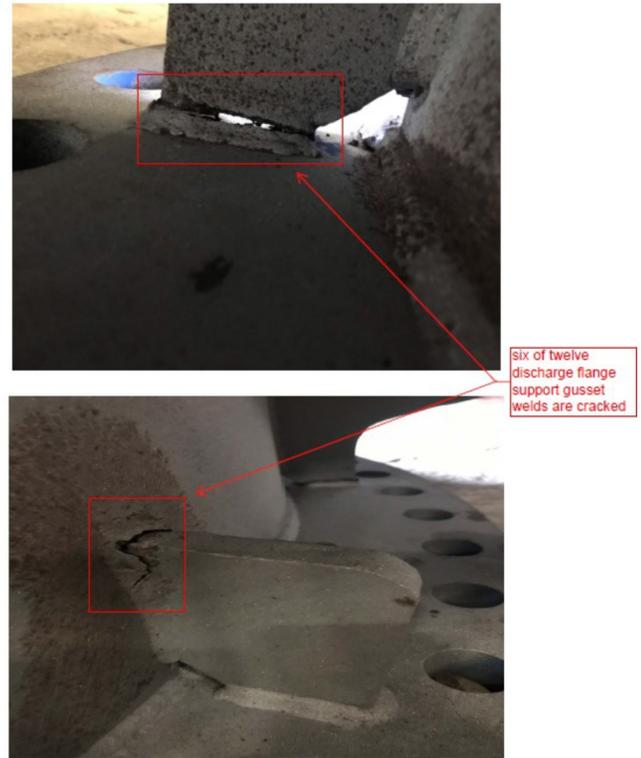
Upon disassembly, it became apparent that there were several critical issues that needed to be addressed to increase the reliability and mean-time-between-repairs for this equipment. The discharge head gussets were heavily eroded clear cracks and dislocation, which weakened the discharge head assembly and made it susceptible to high vibration.

Modifications were designed to provide structural reinforcement to the discharge head and to eliminate the factors causing premature wear of the bearings and shaft sleeves. The eroded gussets were removed and replaced with thicker, more robust gusset to enhance the structural integrity of the components. The new gussets and lifting lugs were fabricated from carbon steel and installed using precision welding. A PT inspection was completed to ensure weld integrity. The eroded stuffing box was also repaired using weld restoration techniques.

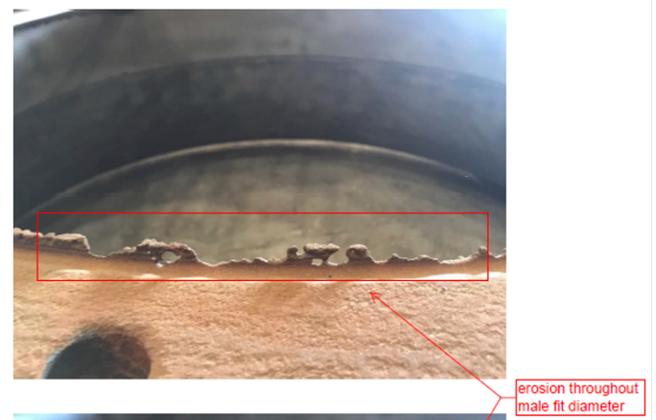
Fit-ups of the stationary assembly were excessive with average fit-ups measuring in the range of 0.010 – 0.030"; for reference, Hydro's typical acceptance criteria are 0.001 – 0.003". Critical faces and bores were also found out of acceptable tolerance, with concentricity, parallelism, and perpendicularity measuring in the range of 0.005 – 0.015", where acceptance is usually held less than 0.002". Not only did the out of tolerance fits contribute to overall misalignment, they provided a leak path that resulted in erosion of the column pipes at the fit areas.

To improve the alignment of all components within the stationary assembly, any out of tolerance fits and bores were welded up and machined to best-in-class tolerances and fits.

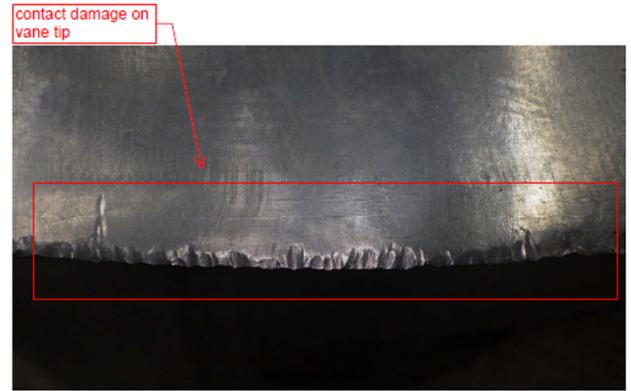
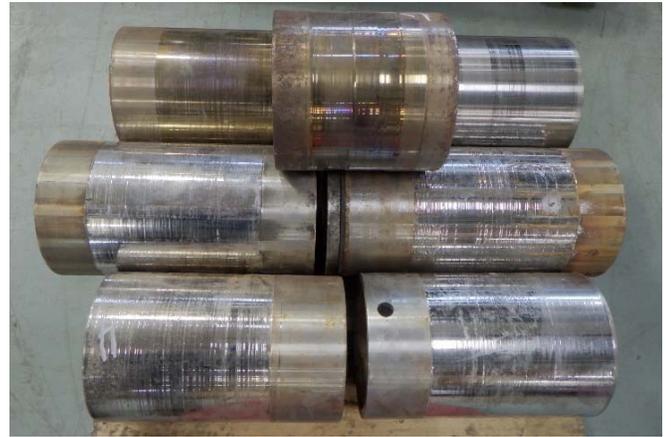
Excessive wear was also found on the impeller vanes and the impeller liner surface, indicating contact between these two components. This contact was likely caused by both the overly loose impeller fit and non-concentricity of the rotor and stator, as mentioned above. The impeller vane wear would have increased rotor imbalance, further increasing vibration. The opening of this clearance would have also reduced the pump efficiency, causing it to lose performance and require more energy to operate.

The impeller was laser scanned to create a solid model of the component that could be used to establish the correct vane profile of the component before it had been worn. This model was used to create the vane profile machining drawing that was used during impeller refurbishment. The solid model was also used post-machining to confirm that the machined component conformed to the expected dimensions during as-built inspection. The impeller bore was also corrected to provide the appropriate fit-up to the shaft.
