## Phase Measurements Used to Diagnose Compressor Misalignment

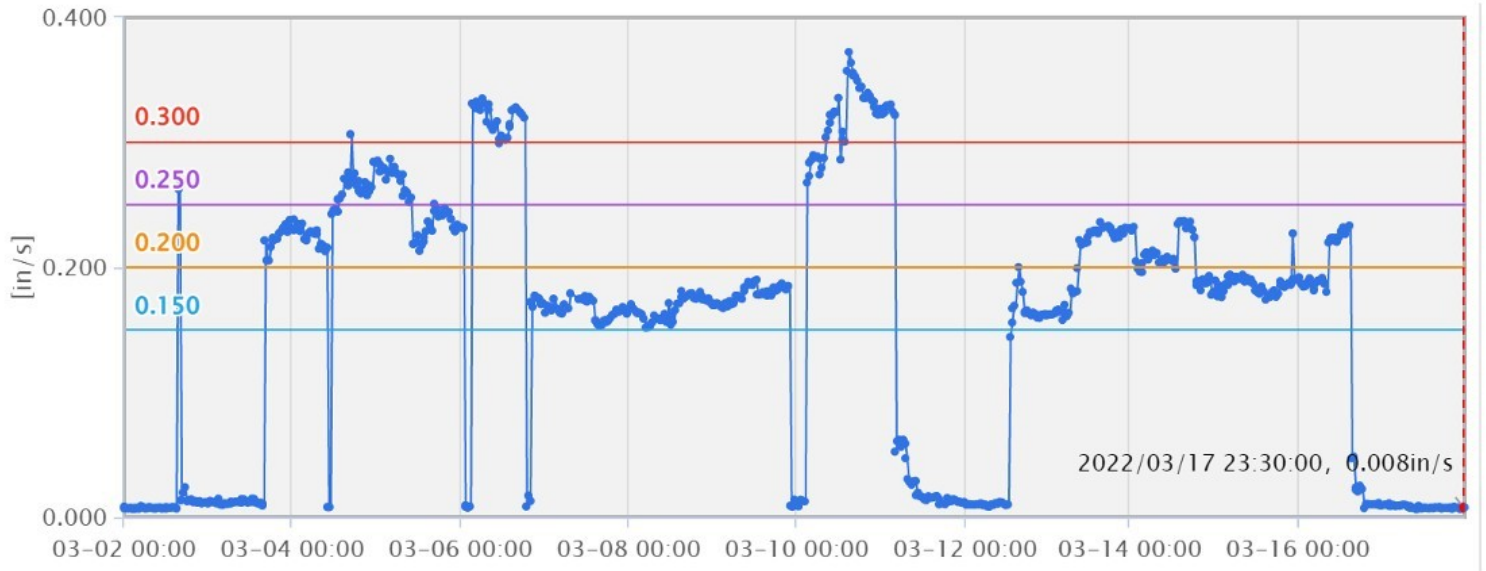
In mid-March, the purple alarm 2 threshold ( $>0.250$  ips RMS) and the red alarm 3 threshold ( $>0.300$  ips RMS) were crossed by multiple sensors in multiple directions. The trend plot below shows an upward trend in vibration amplitude levels on the monitored compressor.

To confirm our suspicions, Hydro reached out to the end user's on-site personnel and suggested that the alignment be checked. Site personnel checked the alignment and confirmed that the compressor and motor were out of alignment and corrected the issue.

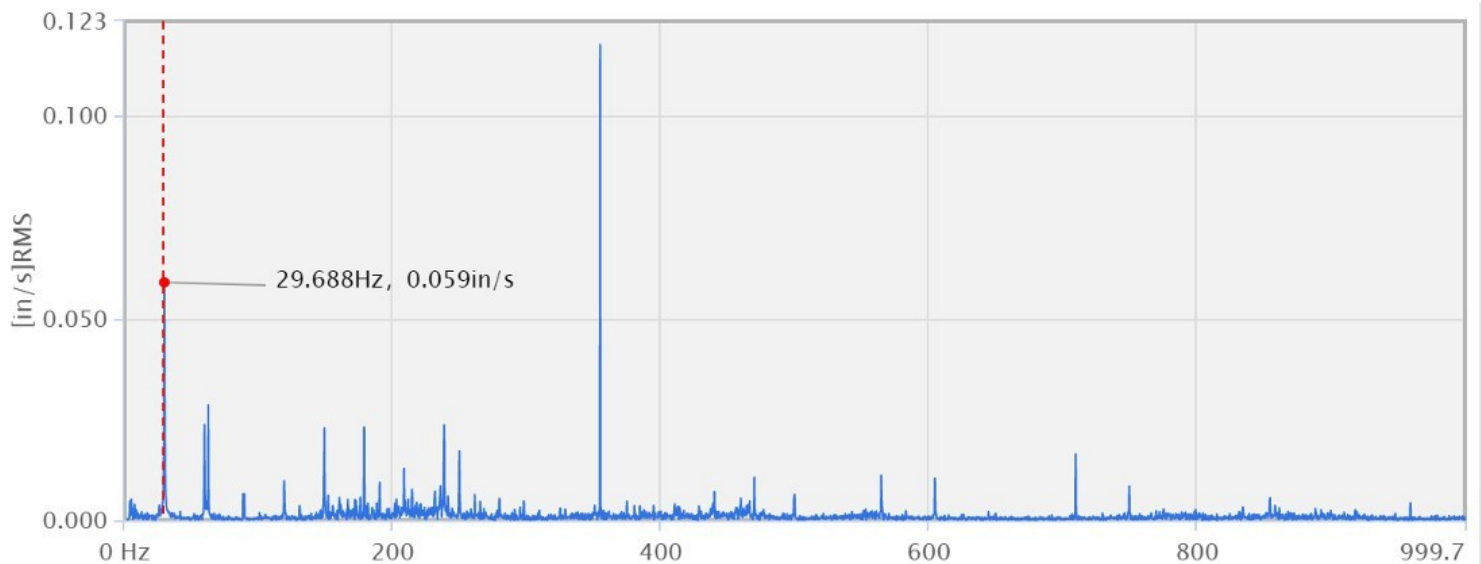
When the Centaur engineers reviewed the vibration data, they identified a dominant excitation frequency at 1x run speed (29.688Hz) with harmonics present. Knowing that the compressor skid, including the compressor and motor bases, were never fully grouted, they suspected that misalignment may be the root cause of the elevated vibration amplitude readings. Misalignment occurs when there is an offset between the centerlines of the driving component and the driven component. It can result in high radial forces, high axial forces, or a combination of both.

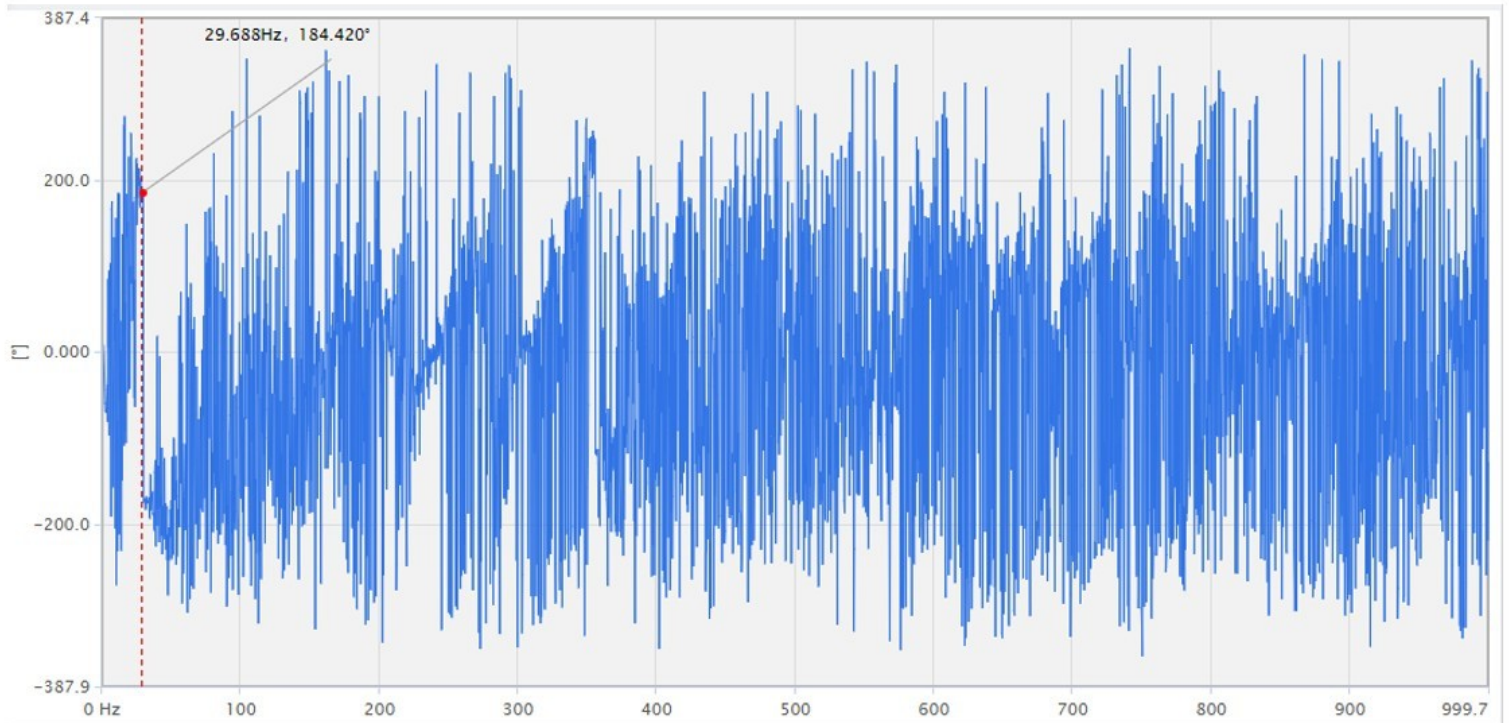
looked at the phase data collected. The phase analysis performed between the compressor inboard sensor location and the motor inboard sensor showed a significant difference in phase between the two locations. The phase difference chart below shows a  $184.420^\circ$  phase difference between the compressor inboard sensor and the motor inboard sensor. The phase angle is indicative of a potential misalignment condition being present between the coupled components.
