# Quality Inspection Uncovers Impending Short-Term Failure

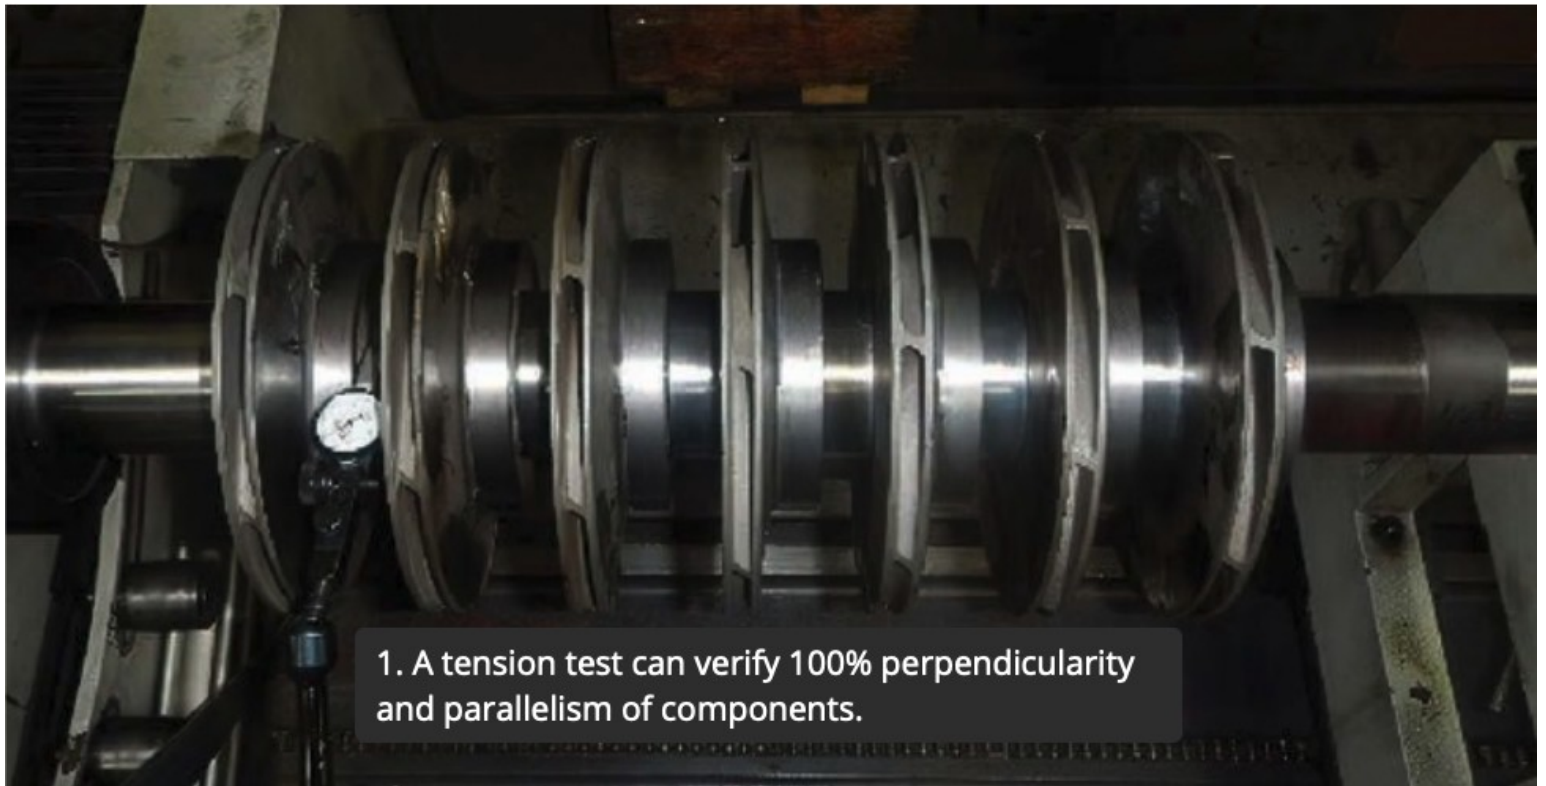
Prior to disassembling the recently rebuilt pump, the aftermarket pump service provider performed a visual inspection to see if there was any evidence of incorrect assembly procedures. The most apparent defect was observed on the outboard side of the pump. The shaft sleeve should have .250" minimum clearance between its face and the labyrinth seal, but the sleeve had been rammed into the lab seal making the pump shaft impossible to turn.

Before shipping any rebuilt pump, it's essential to perform a quality assurance check to confirm the shaft turns freely. However, in this case, a few critical steps may have been overlooked during the pump's previous maintenance work.

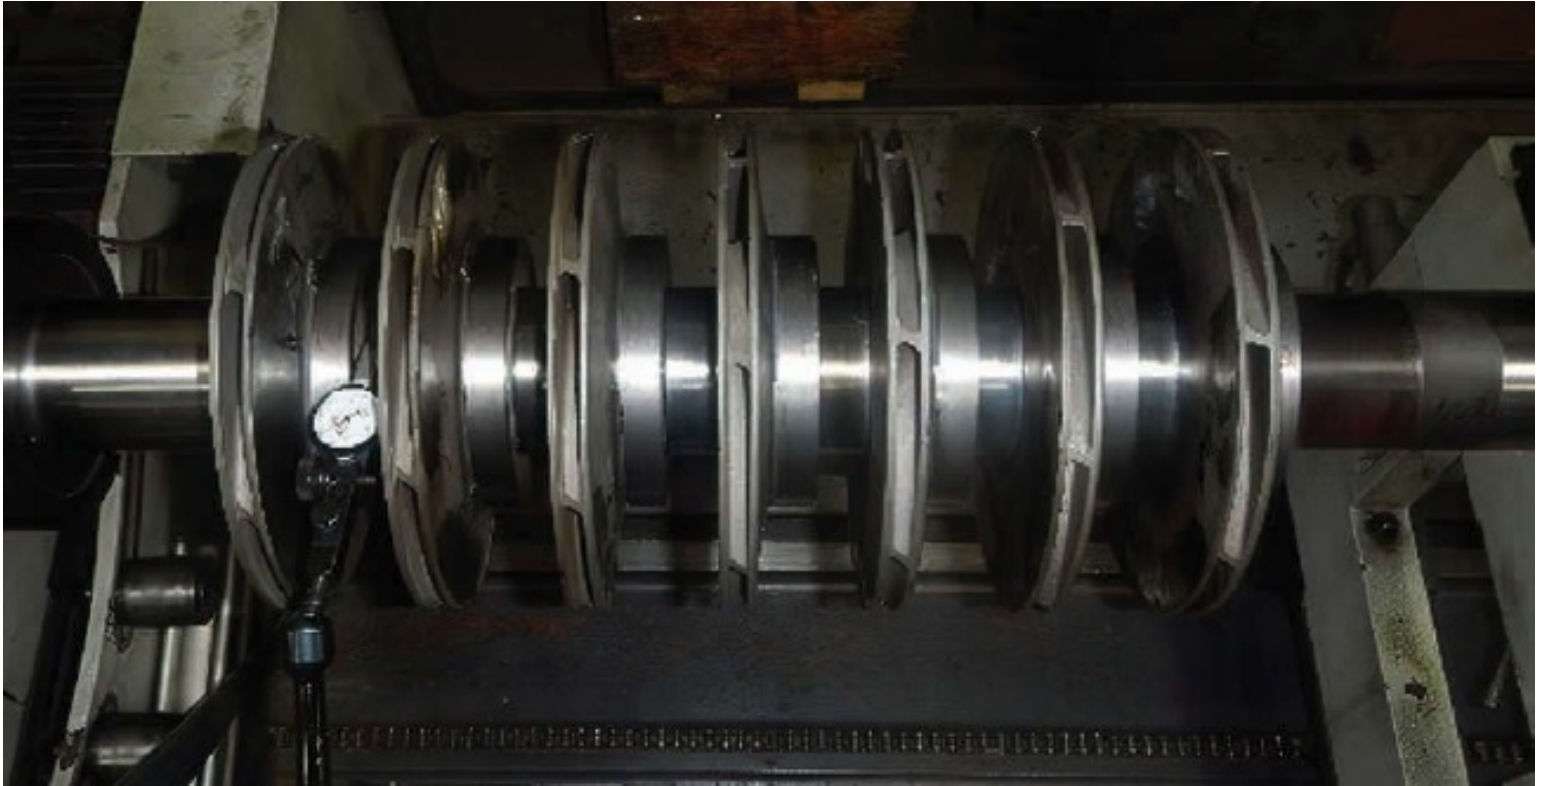
1. A tension test can verify 100% perpendicularity and parallelism of components.
