# Service Center Engineering for a Power Plant

## **Circulating Water Pump Fails**

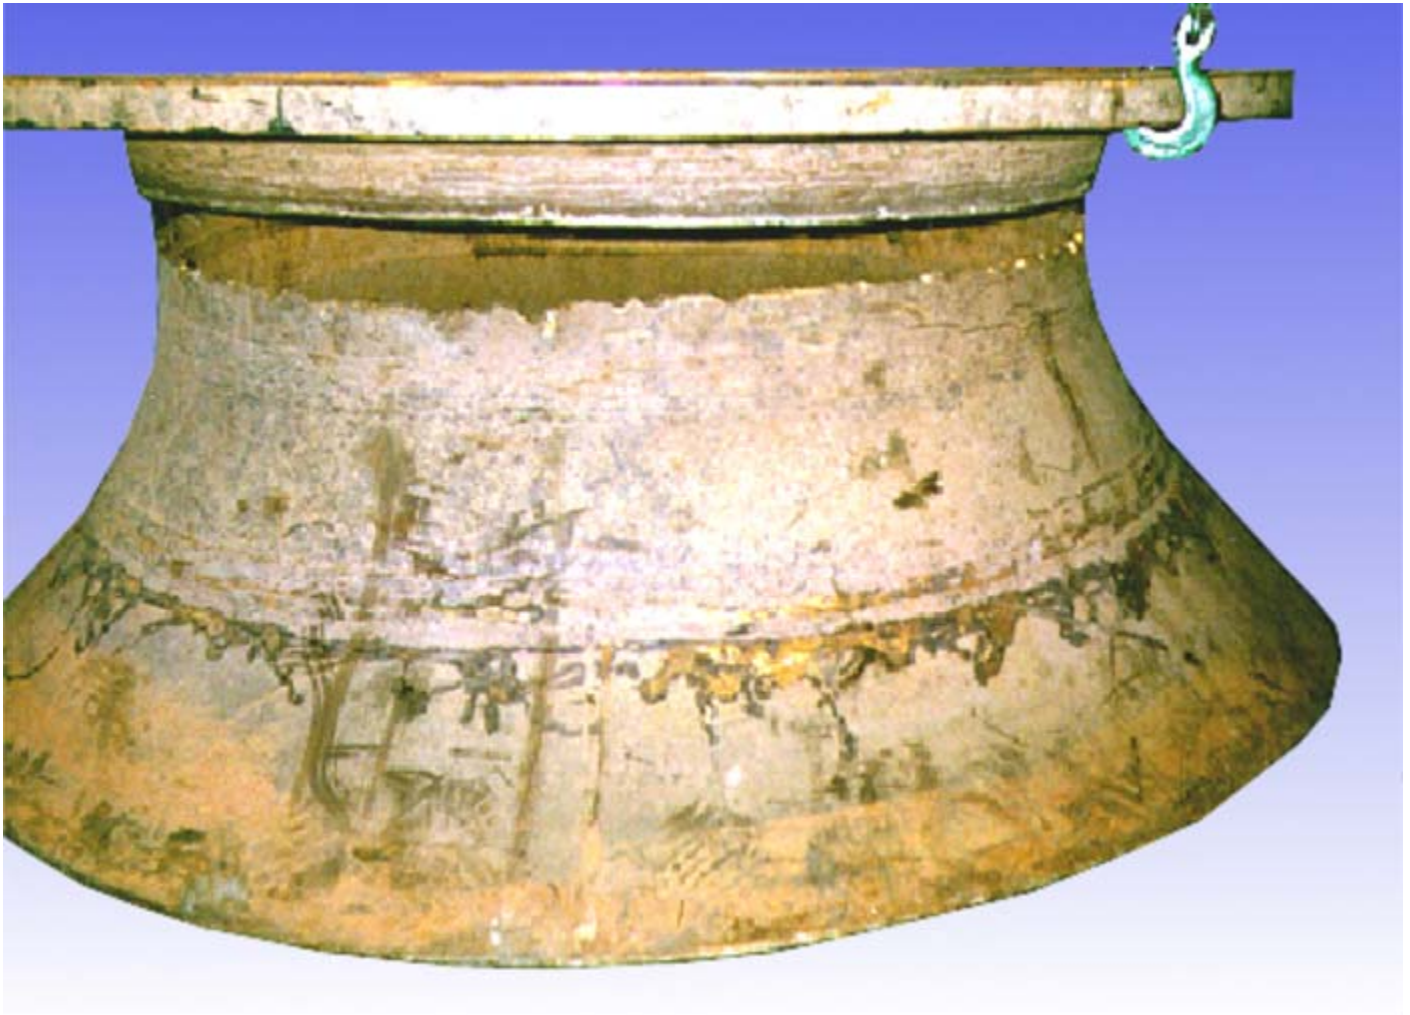
Inspection of the pump revealed that the existing suction bell was not in accord with the pump's original design. The severely damaged bell had a straight wall (probably a section of standard column pipe was used in the previous repair), which did not meet the contoured wall of the original design. The straight-wall did not have the proper contour to match the impeller profile. The reduction of the gap between the impeller and the wall of the suction bell affected the pump's flow and served as the basis for poor overall performance. Moreover, the wall thickness of the existing bell was only 0.080-in. In some areas, the wall had been further weakened by improper machining, which reduced the thickness of the wall to only 0.020-in.

The service center engineers believed that the improper contour and reduced wall thickness had significantly weakened the component's strength. It was likely that higher than normal vibration had affected the weakened component, causing the fabricated bell to break apart into two sections while in operation. This failure severely damaged the impeller, almost completely destroying the impeller blades.

When the pump arrived at the service center, the suction bell was in two pieces. A new cast bell could not be procured within the time frame required by the plant. Employing proven engineering principles and geometry, the service center's engineers designed two separate cones that would be welded together to form the new suction bell. For durability, the material was upgraded from cast iron to a specially rolled stainless steel material to meet the pump's configuration requirements.

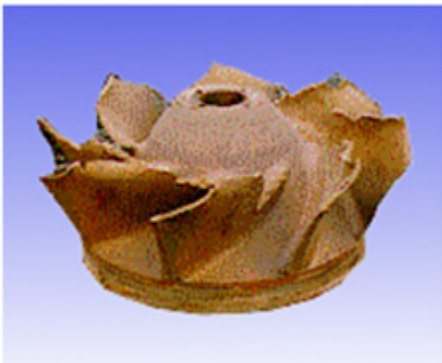
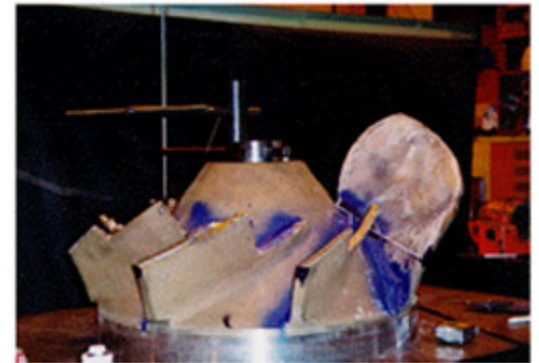
The impeller proved an even greater challenge. The existing impeller blades had been virtually destroyed when the suction bell broke into two pieces. As a result, the hydraulic profile was not available. In addition, the impeller had been cast in a special high lead content bronze, which was not available from local foundries. The use of special bronze alloys was common 40 to 50 years ago when the pump was designed and manufactured.

The service center's hydraulic design engineers analyzed the performance requirements of the original design using CFD (computational fluid design) and data that was available from the existing impeller to recreate the impeller's hydraulic profile. A CAD drawing was developed and electronically transferred to the foundry for the mold used to cast the impeller vanes.

Because the engineers' solution involved welding new blades to the existing impeller hub, it was essential to manufacture the blades from precisely the same material as the hub. A metallurgical analysis had to be performed on the original impeller so new vanes could be cast of the special bronze alloy material. The service center sent samples of the unusual bronze material out for analysis and worked with a smelter to duplicate the original material composition exactly. The ingots they produced were then transferred to a foundry where they were used to cast the newly designed blades. What remained of the old blades were carefully plasma arc removed. The new blades were then welded (using base metal welding material to ensure a high degree of strength) to the original impeller hub.
