# Technologies and Practices to Solve Chronic Problems

## *A nuclear power plant case study...*

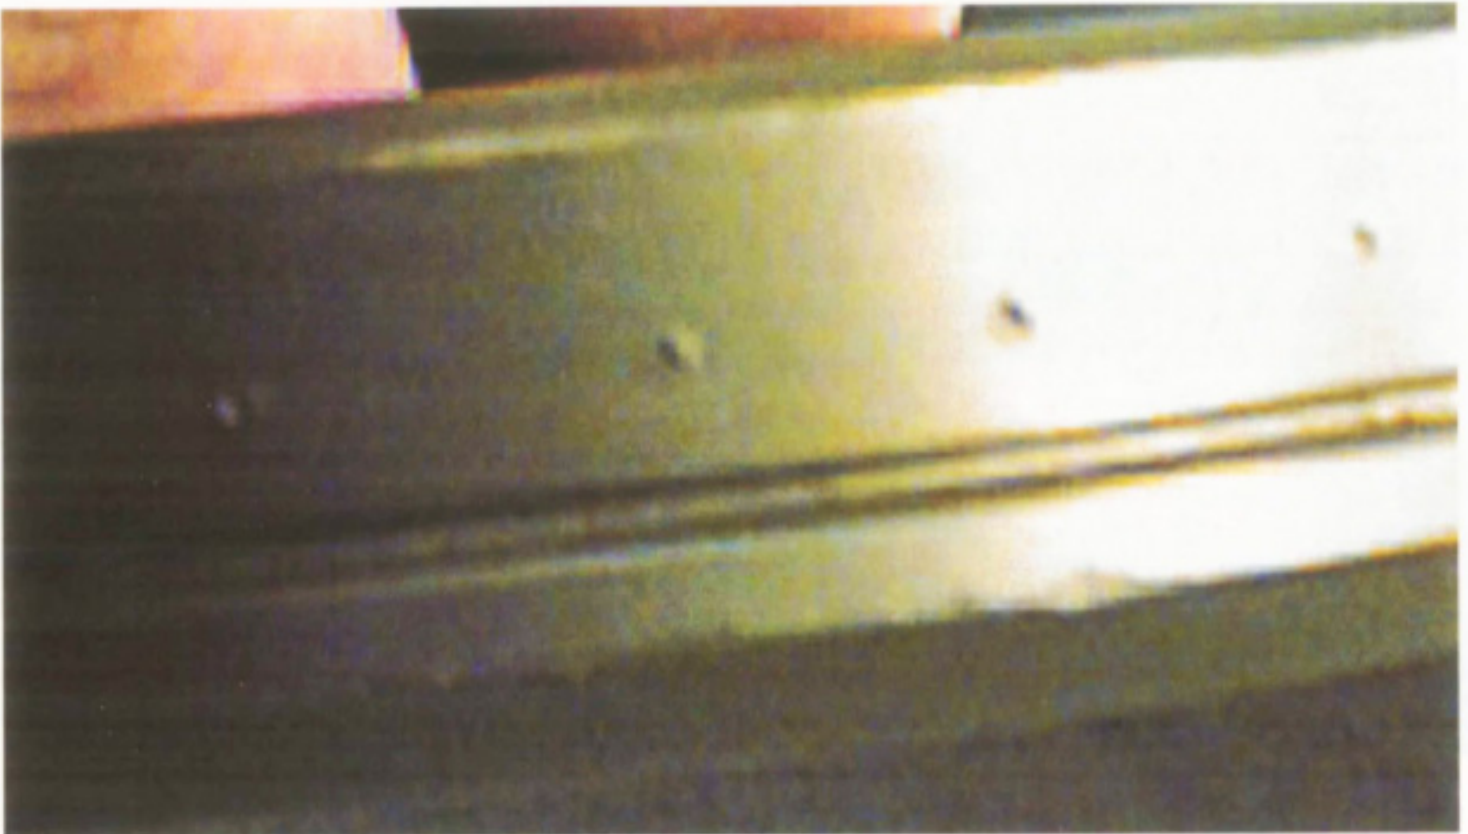
Figure 1. Return-channel bushing with punching to make fit

A detailed design review, disassembly and inspection found numerous issues that could be the source of the problems. These included inadequate/improper impeller-to-diffuser hydraulic parameters and overlaps, poor rotor centralization and wear-ring material compatibility issues. A return-channel bushing with loose fit had been centered-punched 19 times to make it fit securely in its return channel (see Figure 1). While in service, the bushing became loose and released into the eye of the next stage impeller.

- Upgrading diffusers and return channels that were damaged beyond repair from cast iron to stainless steel
- Upgrading impeller wear rings and return-channel bushings from 416 to 420F stainless steel;
- Changing impeller wear-ring hardness criteria to less than 300 HB (see Figure 2 showing an impeller wear ring that broke because hardness criteria had been modified and was too high for the tension);
- Changing return-channel bushing hardness criteria to greater than 400 HB;
- Balancing rotors to a maximum of 1W/N;
- Setting minimum impeller hardness at 16 HRC, and maximum at 22 HRC.
