## Throwback: Expedited Vertical Pump Repair & Engineered Upgrade

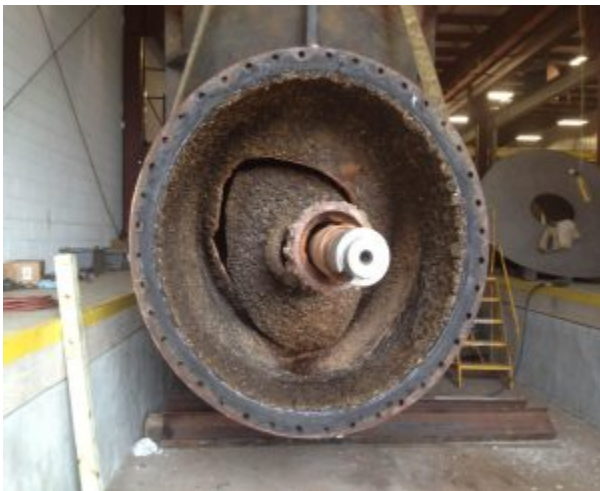
A critical vertical pump for a 750 MW unit was sent to [Hydro South](https://www.hydroinc.com) in mid-December 2012 for inspection and repair. The massive pump weighed more than 66,000 lbs. and was 32 feet long and 12 feet tall. When the pump was disassembled, Hydro South's engineers discovered that a large 42" x 68" section of the discharge elbow was broken, allowing direct flow to bypass the turning section and flow directly into the stuffing box area.

The discharge elbow was made of casted cast iron and could not be welded. A replacement of this size would take around eight months to order and receive.

Hydro's in-house engineering team worked with the customer to create a repair plan that could be completed in a 4-to-5-week time frame. The plan included manufacturing three steel plates to be inserted into the damaged area. Each plate would be .500 inches thick and was rolled and contoured to match the original contours of the elbow. The plates were installed and bolted to the damaged section of the elbow with each of the mating sections welded together. In addition, the backside was reinforced with gussets to effectively produce more than 155,000 gallons at 20 ft of head.
