Unearthing the Root Cause of Vibration Issues

A recently constructed fertilizer plant was experiencing significant vibration problems on their brand new UAN Solution pumps. This vibration forced the plant to take the equipment out of service.

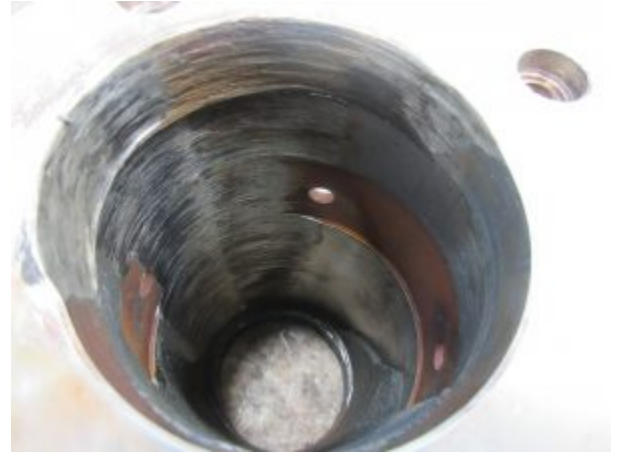
The high vibration and abnormal noise that caused the pump to be taken out of service was most likely due to the poor motor thrust bearing design. The original thrust bearing selected by the OEM was a single row angular contact bearing. This bearing was only capable of handling thrust in one direction.

It is suspected that the pump experienced a momentary upthrust upon start-up, resulting in the unseating of the bearing cage. This unseated bearing was unable to function properly even as

the pump reached its normal operating thrust. Because the bearing did not restrain the rotor in the upward direction, the rotor movement caused by the upthrust resulted in contact and damage at the mechanical seal axial sealing faces.

The double row deep groove ball bearing that was chosen to replace the angular contact bearing is able to handle axial loads in either direction and will not be at risk of unseating due to axial upthrust. This bearing design will also protect the mechanical seal by restricting rotor axial movement in both directions. In order to accommodate the new bearing, the bearing housing was modified.
