## Fertilizer Focus: Volute Reprofilng Resolves Vane Pass Vibration

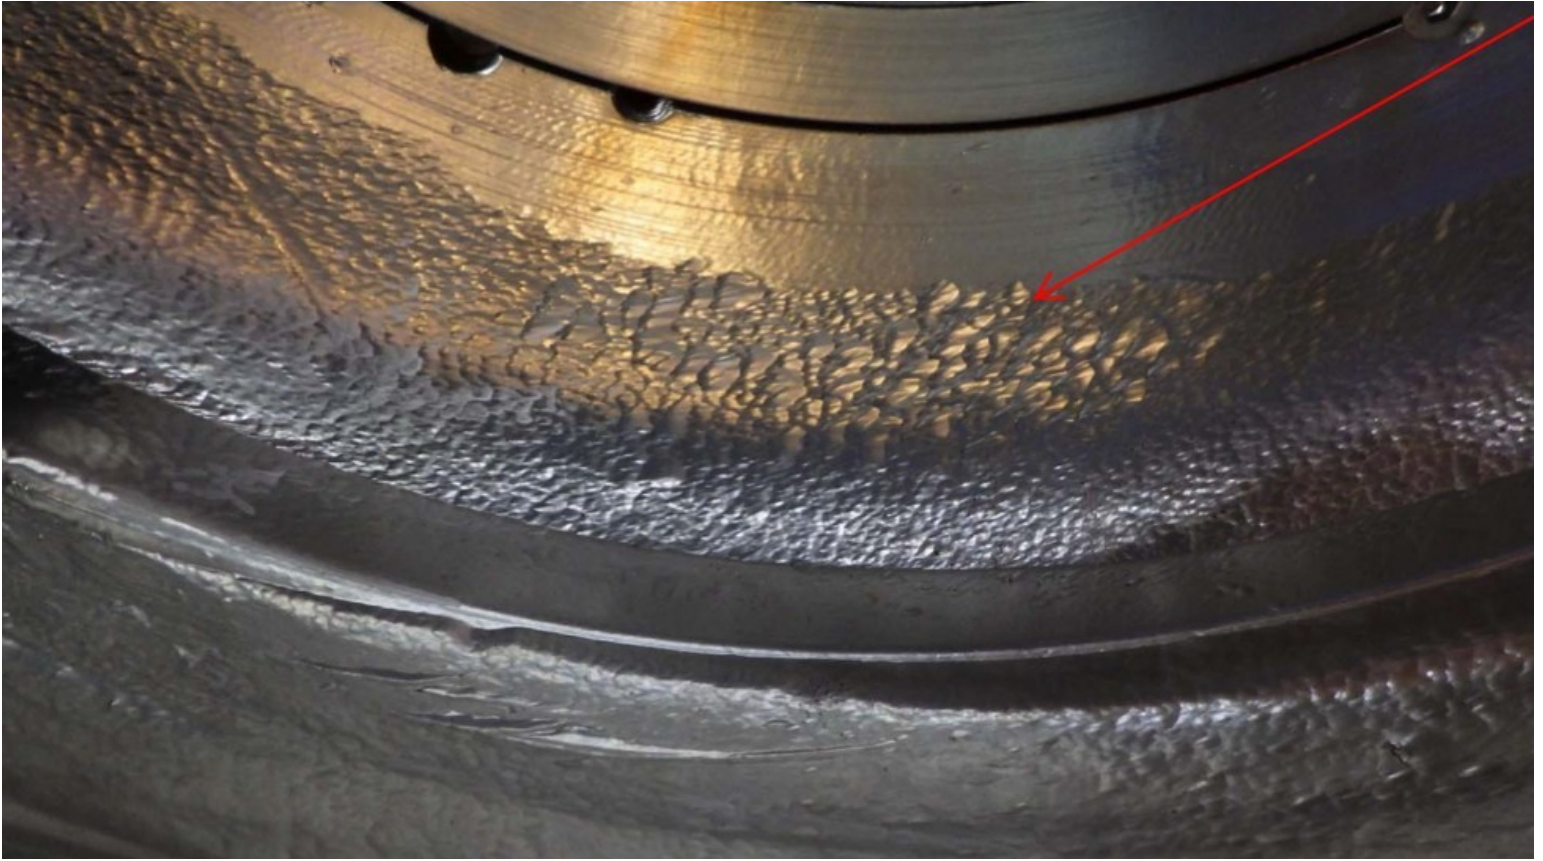
When the vibration and performance indicated that it was time to take the pump out of service for refurbishment, it was sent to [Hydro's Chicago service center](#) for inspection and analysis. The inspection showed significant damage caused by component contact and erosion.

After reviewing the inspection data, an engineering analysis was completed on the design to determine what could be done to eliminate the vibration. The engineering team determined that the vane pass vibration was related to shock waves caused by the high energy fluid impacting the volute lip. This was intensified in the first stage, where the 4-vane impeller was discharging into a dual volute. The volute lip was reprofiled to reduce this impact and provide a smoother transition from the impeller exit into the volute passage.

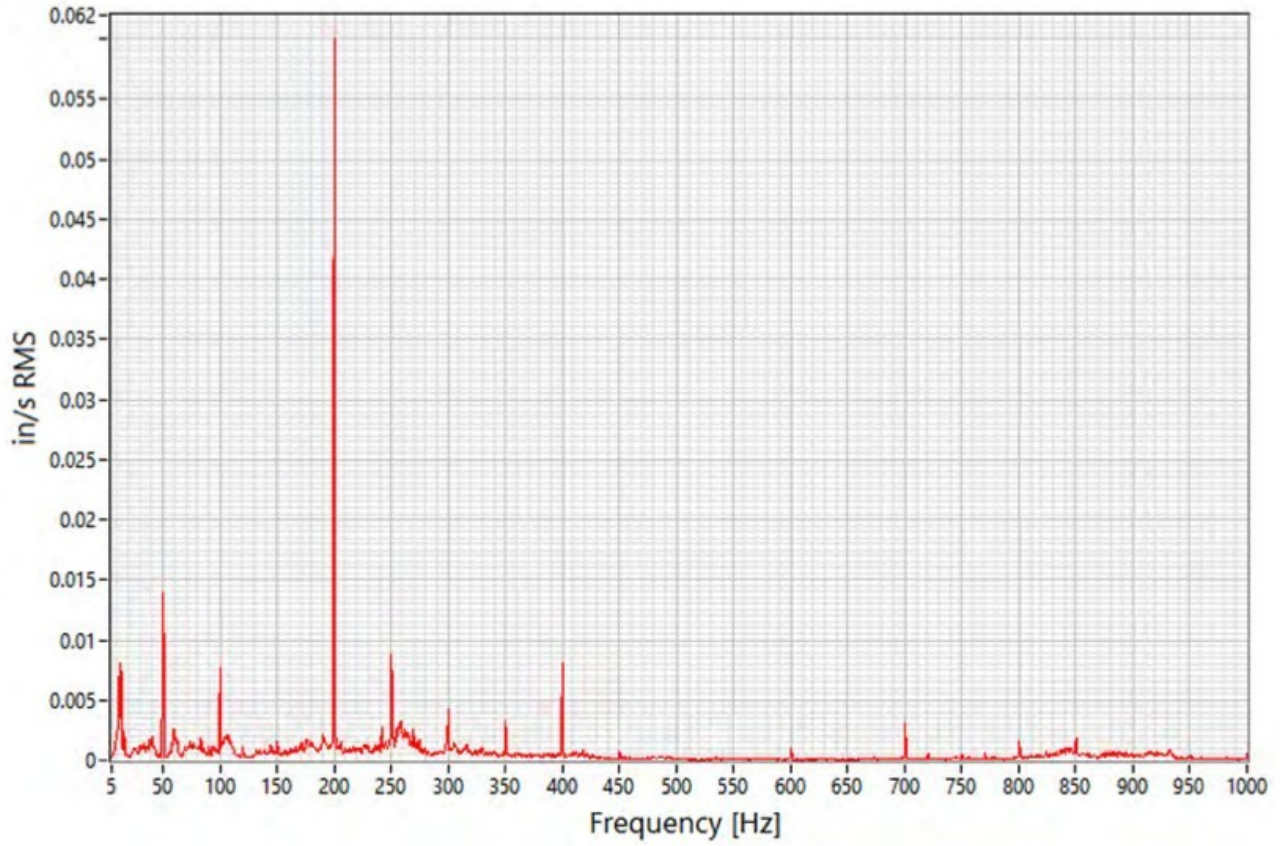
1. Reduced Vane Pass Vibration Observed During Testing

The upgraded design was tested in [Hydro's performance test lab](#). This gave the end user confidence that the hydraulic performance of the pump had not been negatively affected by the volute lip geometry modification. It also verified that the vibration amplitudes had been reduced. After successful testing, the modified pump was returned to the field, where it continues to run smoothly.
