10 Steps to Repair a Failing Vertical Pump

Aftermarket services help extend MTBR from three to 10 years.

KYLE BOWLIN & GLEN POWELL | Hydro Reliability Services

MARCH 2021 REPRINT

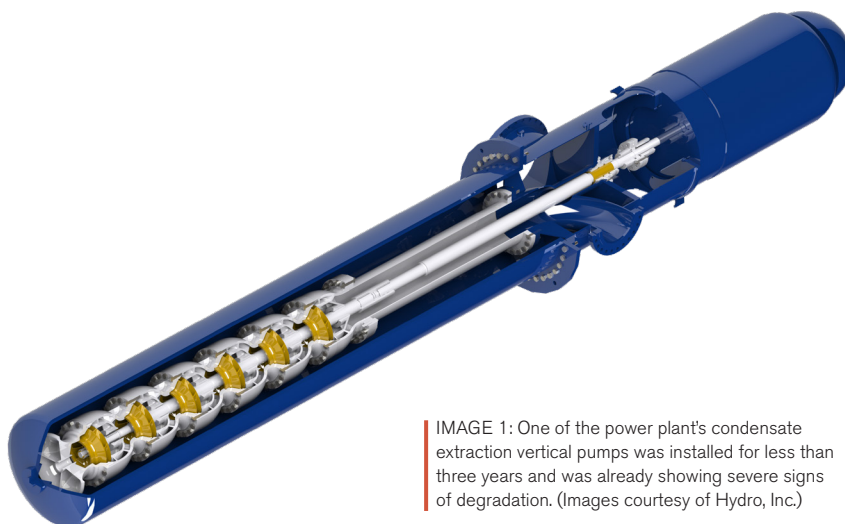
IMAGE 1: One of the power plant's condensate extraction vertical pumps was installed for less than three years and was already showing severe signs of degradation. (Images courtesy of Hydro, Inc.)

data. One pump was found to be nearly 10% lower on total developed head compared to the OEM performance curve and had much higher vibration than the sister pump (>0.6 inches per second [in/sec] peak).

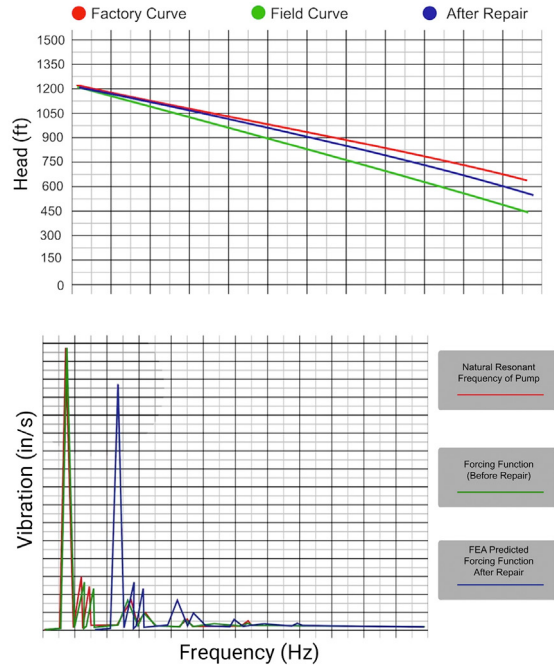
Based on the collected vibration data, the aftermarket service provider's field engineers suspected that the pump was suffering from resonant excitation, which occurs when an operational frequency or forcing function closely approaches the natural frequency of a component (resonance always requires a forcing function to excite). In this case, the service provider determined that the forcing function was bearing whirl, characterized

by vibration energy in the range of 0.4x to 0.48x revolutions per minute (rpm). Bearing whirl is an operating condition wherein fluid inside the pump bearings can begin to “push” the pump rotor at a frequency slower than that of operating speed (subsynchronous vibration).

IMAGE 2: During the health audit and troubleshooting phase, field engineers observed resonant excitation.

As a result of the finite element analysis, it was determined to add additional stiffening ribs to the pump discharge head to increase the margin of separation between the frequency of the forcing function and the natural frequency. To prevent resonant excitation, it is ideal to have a +/- 15% separation margin of these frequencies. Based on the FEA modifications, the service provider predicted that the unit would obtain nearly a 20% margin of separation (previously, a 3.8% margin of separation of the frequencies existed).

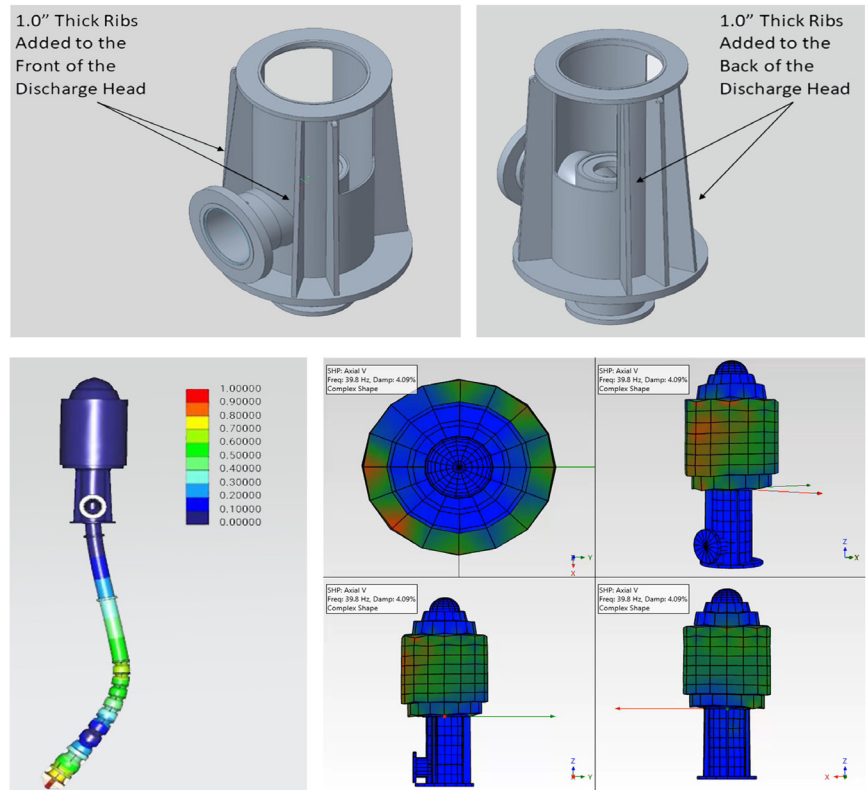
The preliminary results were discussed with the user and the service provider recommended a modal analysis, which is a structural natural frequency study that involves instrumenting the structure with numerous tri-axial accelerometers and impacting it with a calibrated modal hammer that is equipped with a force transducer. This testing aims to identify the structural natural frequencies present and the associated mode shape of each resonance. The collected vibration data is then imported into a software that can animate each identified natural frequency’s resonant mode shape—understanding the mode shapes and their damping characteristics helps to better understand how to modify the structure to shift the offending resonance out of excitation. The modal analysis data confirmed that a structural resonance was within 3.8% of the bearing whirl forcing function.

IMAGE 3: The preliminary results were discussed with the customer, and the service provider recommended a modal analysis, a finite element analysis and structural modifications.

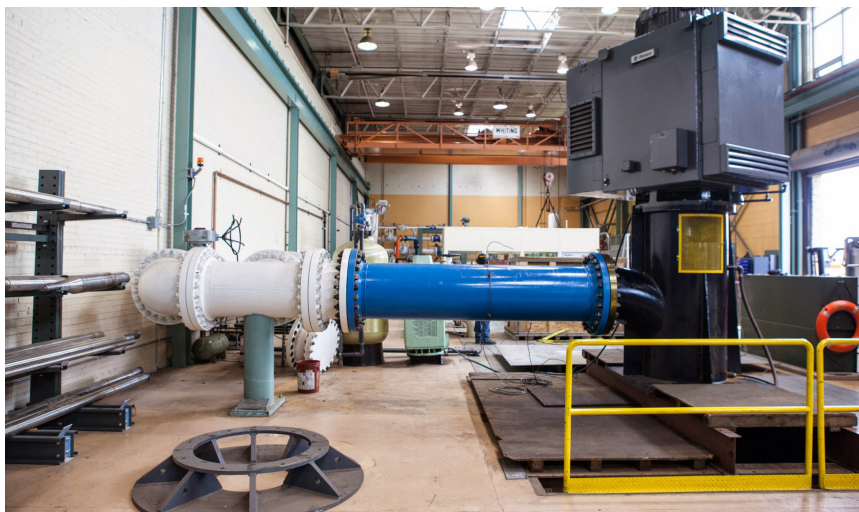
To prove that the bearing whirl forcing function had been adequately reduced and to validate that the hydraulic performance deficiencies were resolved, the service provider tested the pump at its performance test lab. The performance test results showed that the subsynchronous bearing whirl vibration was reduced to acceptable amplitude levels. Hydraulically, the service provider found the pump to perform acceptably according to the Hydraulic Institute standards.

IMAGE 4: The performance test results showed that the subsynchronous bearing whirl vibration was reduced to acceptable amplitude levels.
