Close Inspection Solves High Thrust Bearing Temperature Problem

Careful analysis identified the issue with this multistage, oil transfer pump.

Written by: Gary Dyson (Hydro, Inc.) Publisher: Pumps & Systems / August 2014

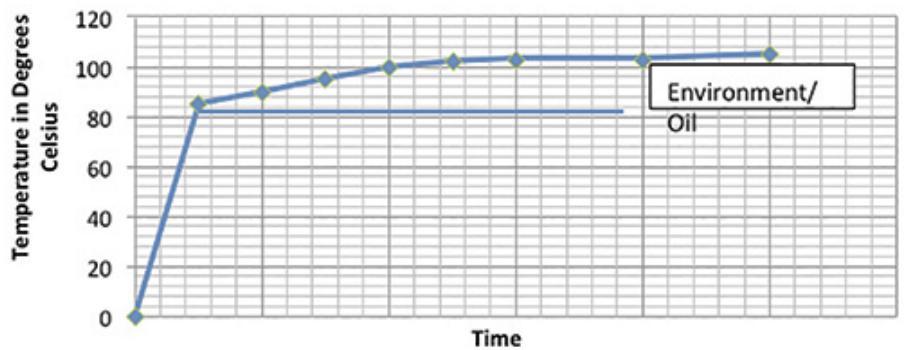
The behavior of thrust bearing pads during startup is seldom investigated. The temperature rise of the pads can be attributed to two distinct causes—thrust developed during startup and environmental and oil conditions (see Figure 1).

The significant finding from this data was the temperature rise associated with thrust. The pump could not achieve the temperatures measured prior to maintenance in its current condition. The total thrust bearing temperature includes the oil temperature and environmental conditions.

Based on comparisons with previous site data, both the thrust and oil cooling had altered. Analysis of the temperature data at the motor bearings, which were experiencing oil temperature increases of 10 to 15 C, further supported the conclusion.

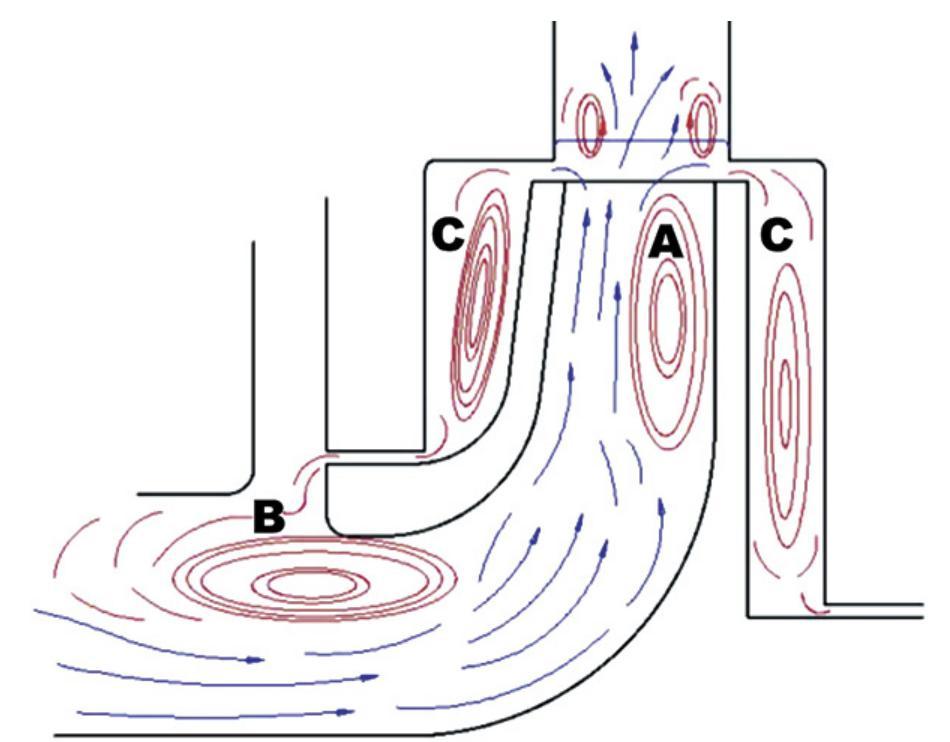
Traditionally, this flow regime interaction has been illustrated as in Figure 2 in the meridional plane. Although this image is helpful in understanding the flow physics, the true picture is far more complex.

The meridional view clearly depicts these two unstable flow interactions with the vortex that exists within the gap between the channel ring and impeller shroud (see Point C in Figure 2).

This vortex accounts for the developed thrust within this pocket. Any disruption to this vortex leads to a more unpredictable thrust regime.

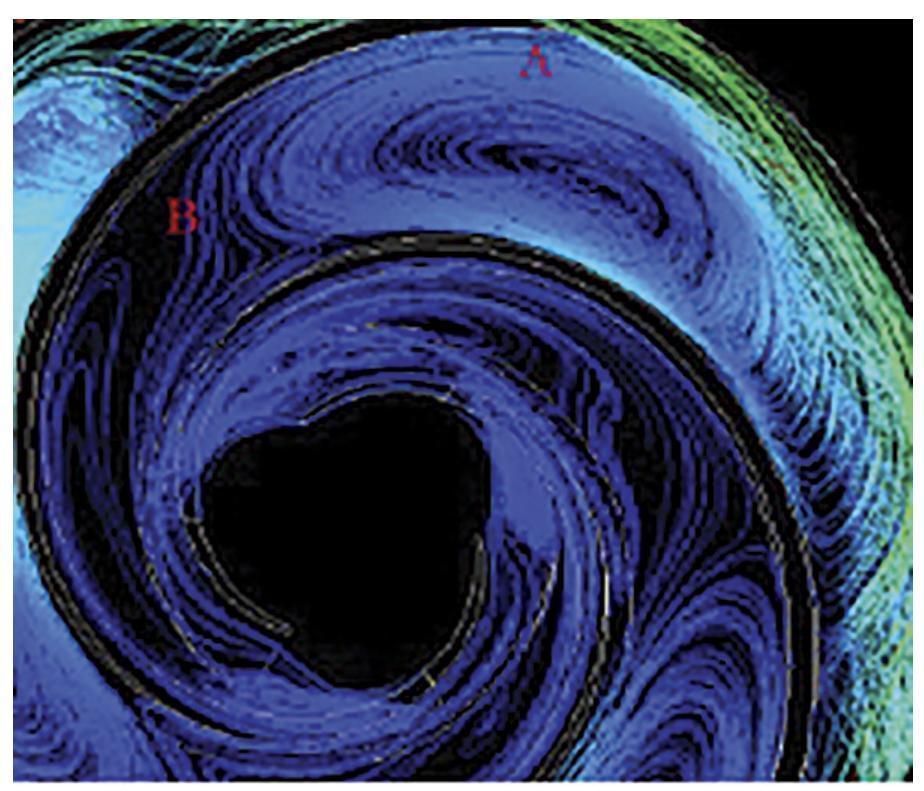
Figure 3 illustrates the complex nature of the flow that develops within the impeller when the pump operates at extreme part load. Point A illustrates the development of a discharge vortex that commences on the hub at the impeller discharge.

Point B illustrates the boundary of this interaction with the inlet backflow recirculation within the impeller eye. This inlet backflow recirculation is also illustrated in detail in Figure 4.

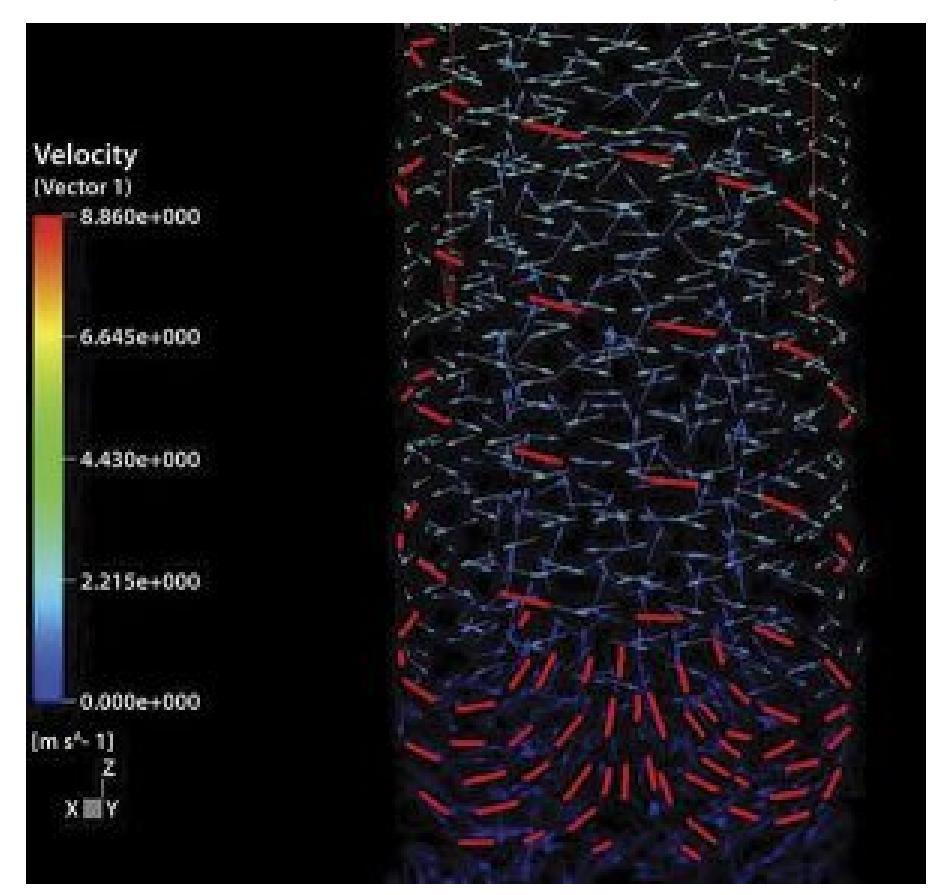
At partial capacity, the flow exits the impeller eye at the hub inlet angle and spirals down the suction channel impinging on splitters of the previous stage.

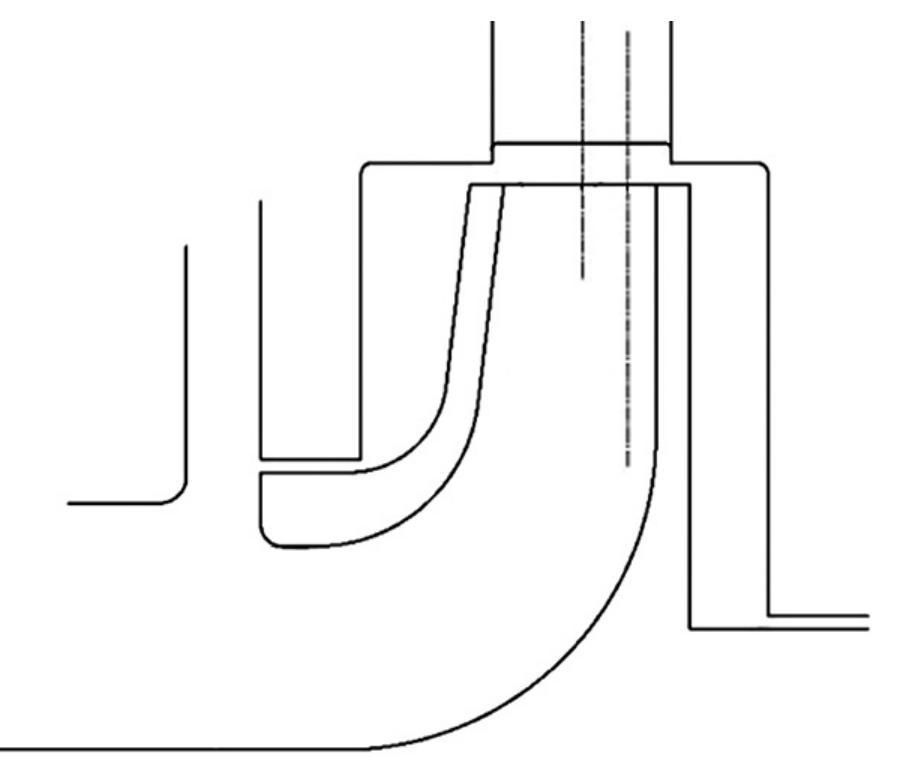
This machine has an adjustment ring behind the thrust collar that is used to account for build tolerances in the components stack. Fitting the new bearing assembly affected the rotor positioning. The adjustment ring had been refitted without ensuring that the rotor centralization had been carried out correctly.

- Oil temperature correction: A thermostatic valve was disabled during pump removal. On commissioning, this valve was left in an inoperable position, which kept the oil from passing through the cooler. The engineering services company identified the problem and returned the valve to the appropriate setting.
- Rotor centralization: The rotor centralization had been adjusted to off-center by the original equipment manufacturer to limit the thrust on the outer pads (see Figure 5). The engineering

services company restored the rotor to the correct position relative to the diffuser, which put the thrust bearing temperature within an acceptable range.

• Thrust compensation modification: The engineering services company is now suggesting modifications to the machine to correct the thrust balance based on the actual site operating conditions. This new thrust compensating modification will be designed to ensure the thrust is on the inner thrust pads, giving the bearing an extended operating range.
