# **Engineering a Long-Term Solution**

By way of example, this article will discuss a fertilizer plant in the Gulf of Mexico that had a boiler feedwater pump unit that was experiencing performance problems after a significant plant expansion project. Unfortunately, it was not the first time this particular unit had experienced a loss of capacity; the pump had been in operation only 18 months prior to the current issue.

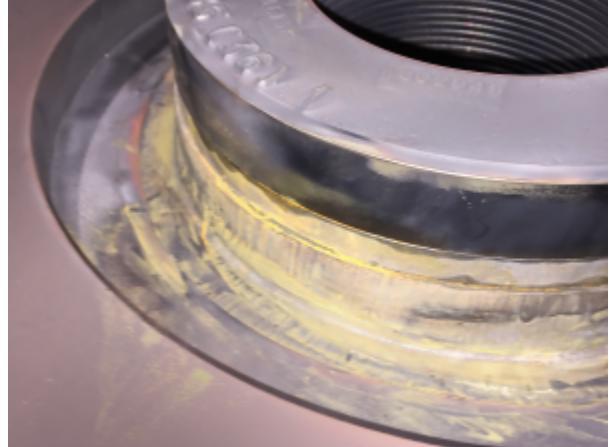
With this new information, the plant manager decided to proceed with the proposed forensic inspection plan. The service provider opted to have the pump sent to a service centre in Houston, Texas, US, for in-depth analysis and repair. The client agreed, and the entire unit, including the casing, was shipped for service (Figure 1).

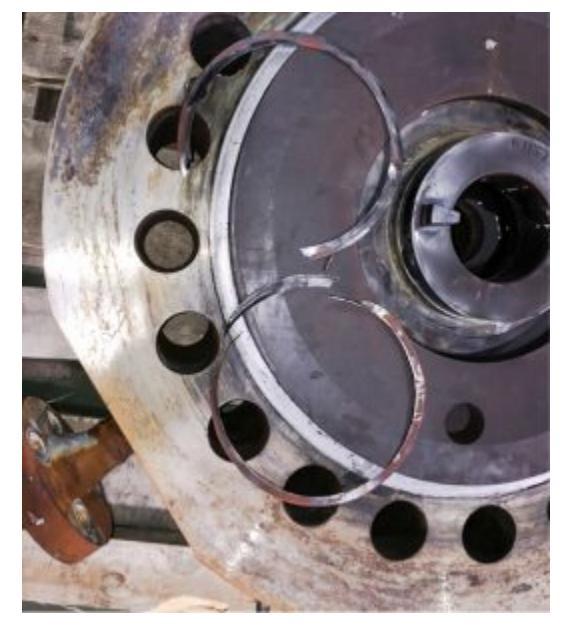
The in-depth inspection process uncovered a range of serious issues, including a damaged centring ring seat in the discharge cover (Figure 2). Most significantly, severe erosion of the suction pressure face was observed. It was determined that this erosion was due to insufficient gasket compression. The original design contained a shim compensation pack containing multiple shims (Figure 3). This shim pack was not sized correctly, leading to the failure of the internal suction head gasket.

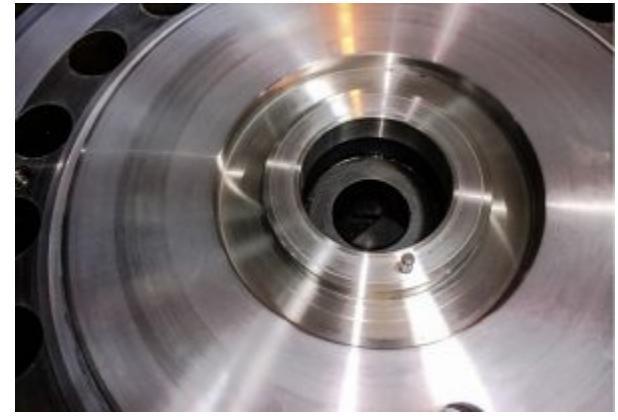
The dimensional analysis of the pump components revealed that the shim compensation pack was not thick enough to provide sufficient compression on the internal suction head gasket. The suction head gasket seals the face between the suction entry, at suction pressure, and the chamber surrounding the internal volute element, at discharge pressure. This high differential pressure makes it crucial to provide a sealing arrangement that prevents internal recirculation. Flow is driven from high pressure to low pressure areas and costly erosion damage occurs to the barrel.

The combination of the discharge head extension that protrudes into the casing, the shim compensator set, and the internal assembly determines the crush on the internal suction gasket. The insufficient thickness of the compensator shims resulted in an unloaded gasket, preventing the formation of an effective seal. The failure of this gasket allowed internal leakage from the high pressure discharge chamber back to suction.
