## Ahlstrom Makeup Liquor Pump

**Application: Make-Up Liquor**

**Pump Details: Ahlstrom Model 2LRS-20**

**Pump Type: 2-Stage Overhung**

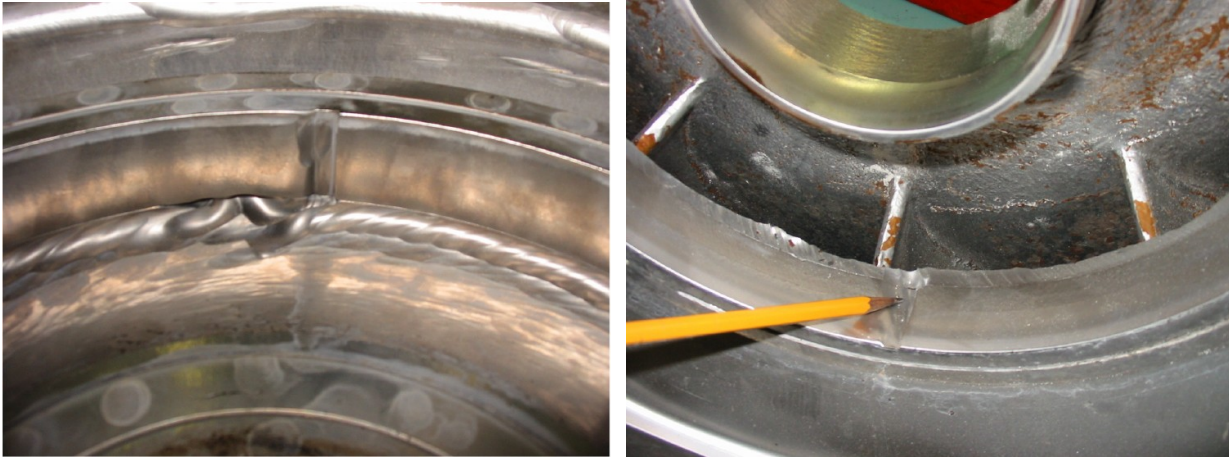
Hydro's standard disassembly and inspection process uncovered a path for abrasives to reach the wear rings. Heavy localized wear was identified at the casing, behind the casing wear ring.

Hydro manufactured new wear rings without slots to prevent the abrasive material from damaging the case and minimize wear behind the casing wear rings. The worn areas of the casing and a new sleeve were overlaid with tungsten carbide to prevent further damage.

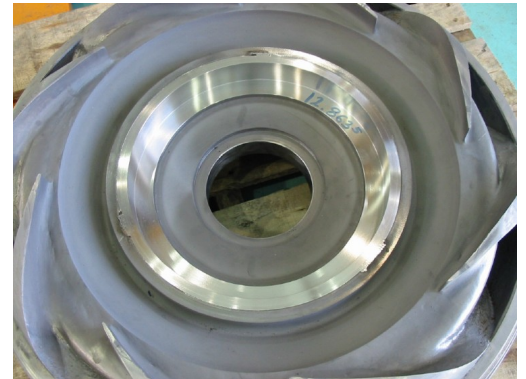
Additionally, the pump was experiencing excessive leakage of the seal water and black liquor. The millwrights were unable to properly adjust the packing gland because the 2-bolt packing gland follower was cocked on the studs due to the high pressure of the seal water. This misalignment also caused significant wear to the diffuser vane tips.

Hydro designed and machined a 4-bolt split packing gland follower to help maintain alignment of the packing gland follower with the stuffing box. A special material was installed to help cool and lubricate the seal to allow the proper distribution of seal water.

The diffuser vane tips were welded to restore them to their pre-wear length and the impellers were balanced to a stringent level of 2 W/N. The 2 stage pump was built vertically to ensure centerline compatibility of stationary components.
