## An Engineered Battle Against Cavitation

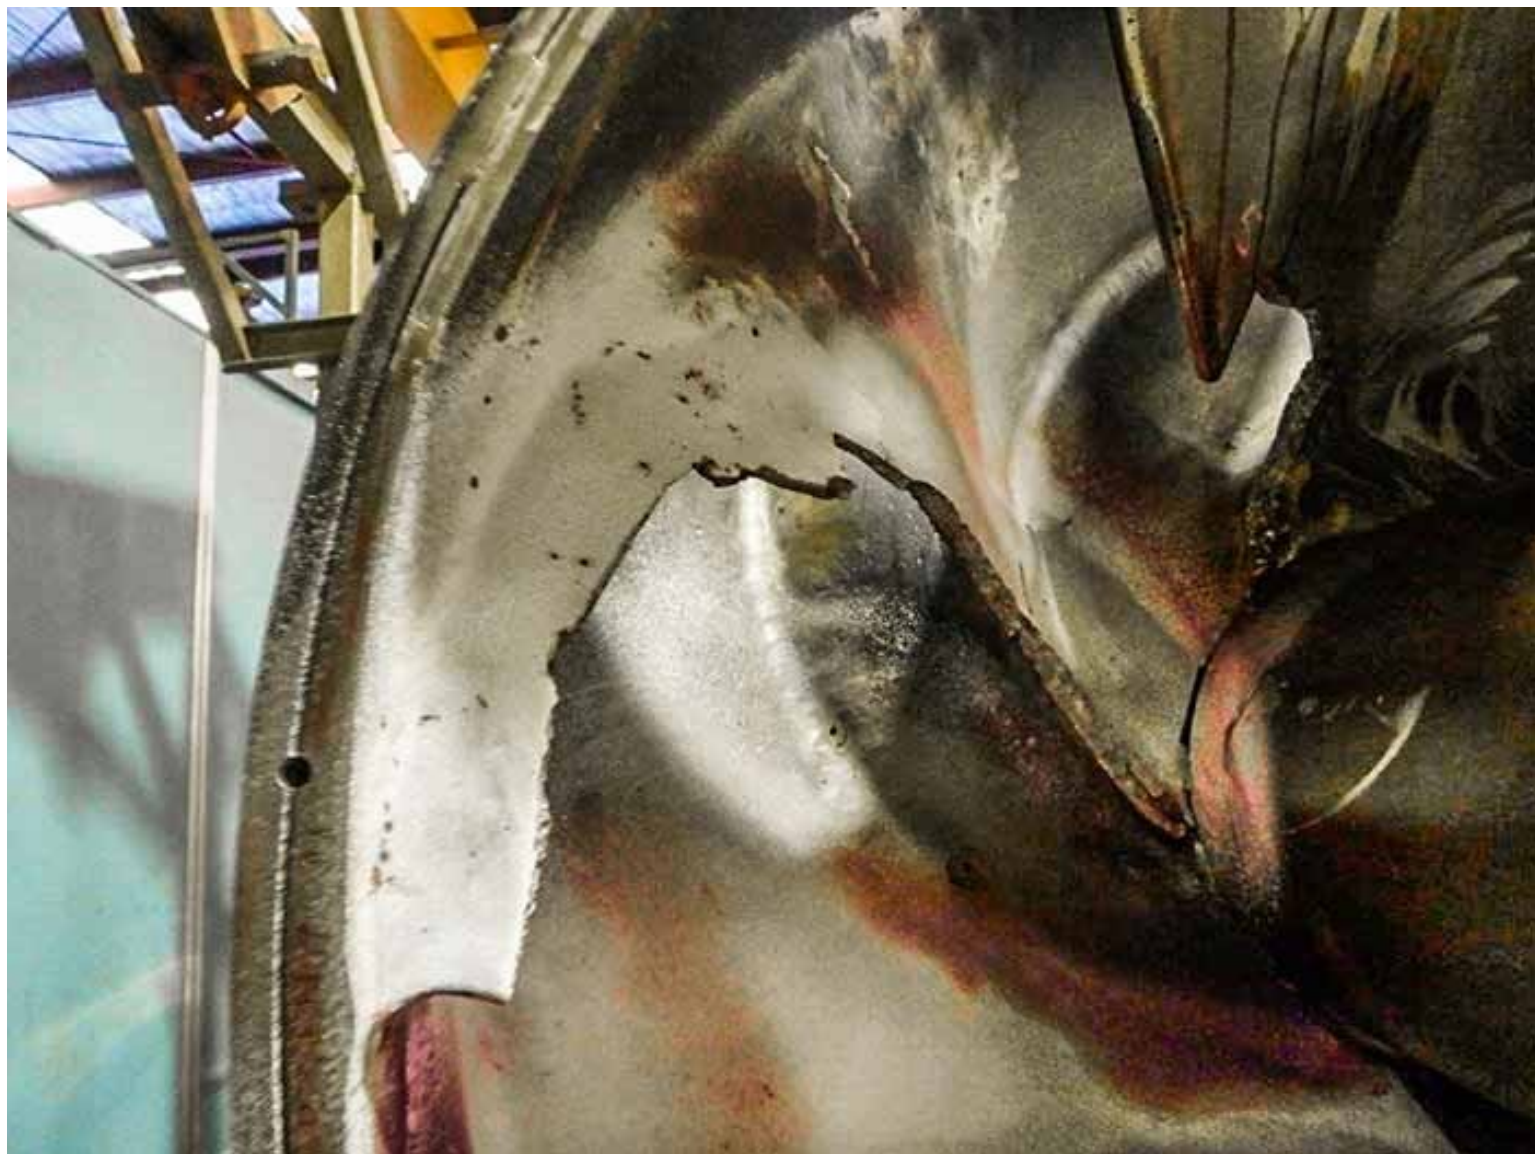
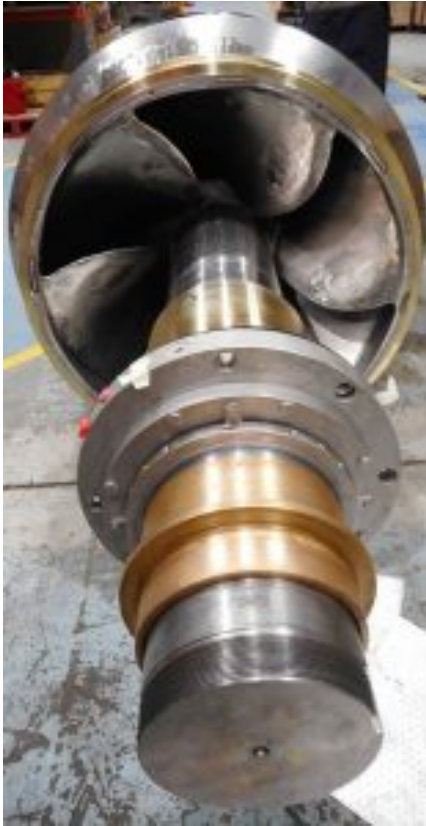
It was clear that something had to change as the station's pump reliability was now a major financial focus. The many vane cracks, cavitation and broken vane sections that were weld-repaired during inspections throughout the pumps' life cycles prompted the station to investigate a more permanent solution to the issue.

The results of the forensic analysis showed that the impeller blades were suffering cavitation to the low-pressure side of the vanes. Additionally, the cavitation and cracked vanes toward the eye also indicated that the sizing of the inlet and its associated blade angles may be active factors in the repeated failures.
