# Big Savings for Small Pumps

Alex Manchenkov, Hugh Sosbee and Jim Byrom Sr., Evans Hydro Inc., and Valero-Wilmington Refinery

Pumps & Systems

October, 2008

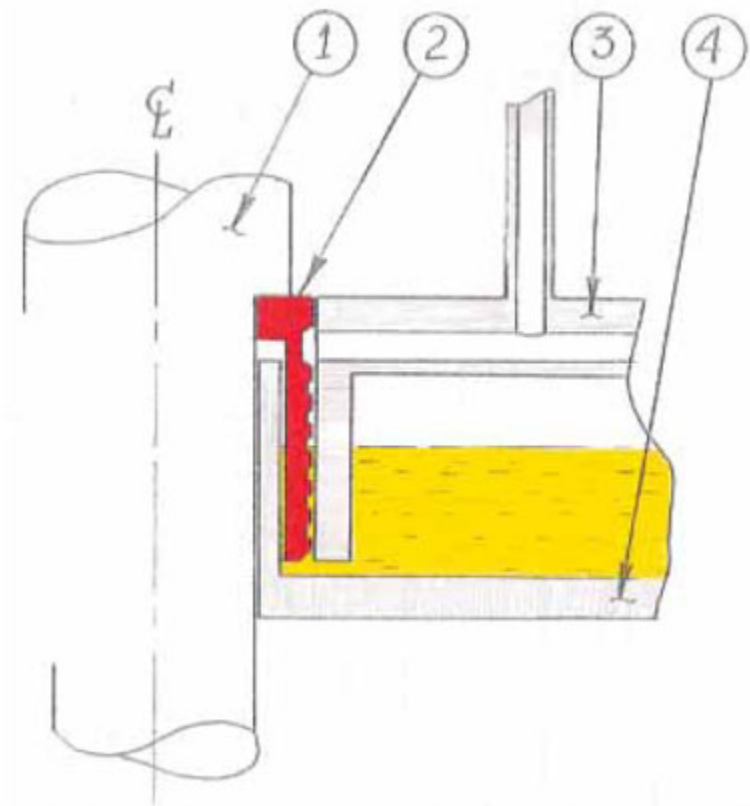
The engineers started looking at the shaft, pumping ring and oil sump housing as a whole assembly. The "pumping" principle was obvious-the pumping ring (Figure 2, Item 2) was submerged in oil. The outside diameter, with a tight diametrical clearance of .012-in to .014-in between the upper sump housing (Figure 2, Item 3), was producing a perfect pumping action and delivering approximately 5.85-oz/min of lubricating oil to the upper thrust bearings.

Figure 2. Second generation sump design in "static" condition

In theory, everything seemed perfect. The inside diameter of the pumping ring, riser pipe and pump shaft were designed to create a labyrinth to prevent oil from escaping. Once the pump is started, the pumping ring pumps lubricating oil into the drilled discharge manifold. Enough oil is delivered to lubricate and cool the upper thrust bearing.

If after only a few months the pump was suddenly losing all of the oil from the sump, then something had to be causing the oil to travel between the inside diameter of the pumping ring and outside diameter of the riser pipe, then between the pump shaft and the inside diameter of the riser pipe out to ambient.

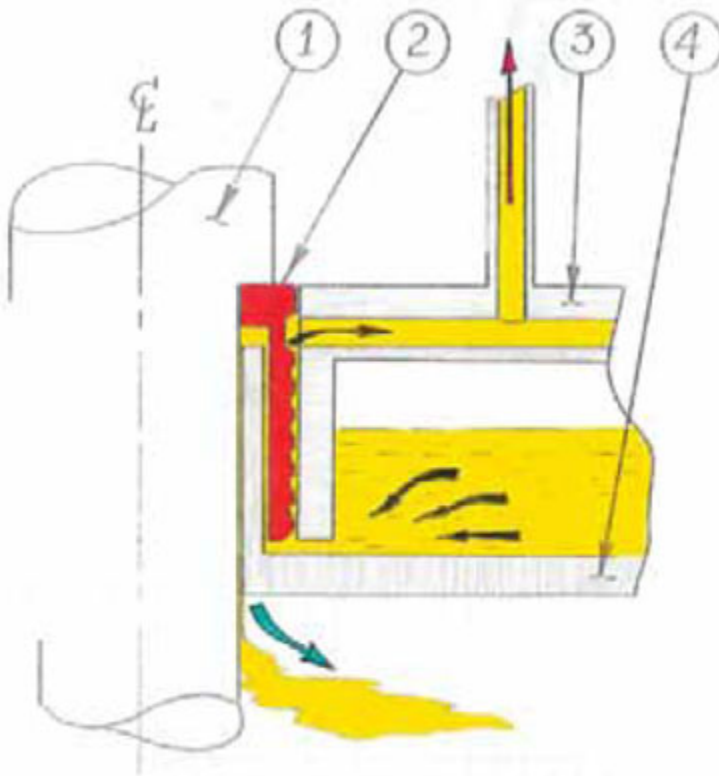
**Figure 3. Second generation sump design in "dynamic" condition illustrating oil leakage**

Since everything was making sense in a "static" condition, the engineers decided to consider the effects of the pump's design in a "dynamic" condition. Looking at the labyrinth (inside diameter of the pumping ring, riser pipe and pump shaft) and measuring clearances, the true cause of the oil leakage was discovered. During dynamic condition, the tight clearances and high air velocity caused a vacuum.

It was assumed that due to wear of the pumping ring, only  $\frac{1}{4}$  of the developed head would recirculate the lubricating oil back to the bottom of the sump. Eventually, with the help of the vacuum, oil would

travel upward to the top of the riser pipe. As it happened, the siphon effect can empty the entire sump within minutes into ambient.

Equipped with this knowledge, the engineers started looking at design modifications for the pump. Modifications to prevent oil from being siphoned out of the sump were very simple and quite inexpensive. The engineers modified the pump by increasing clearances, thus "breaking" the vacuum between the pumping ring and riser pipe. Spiral grooves were also implemented to introduce gentle air flow, providing pressure to counterbalance oil backflow from the pumping ring.
