Hydro Middle East performs swift re-build on fire-damaged circulating pumps

Published by: World Pumps

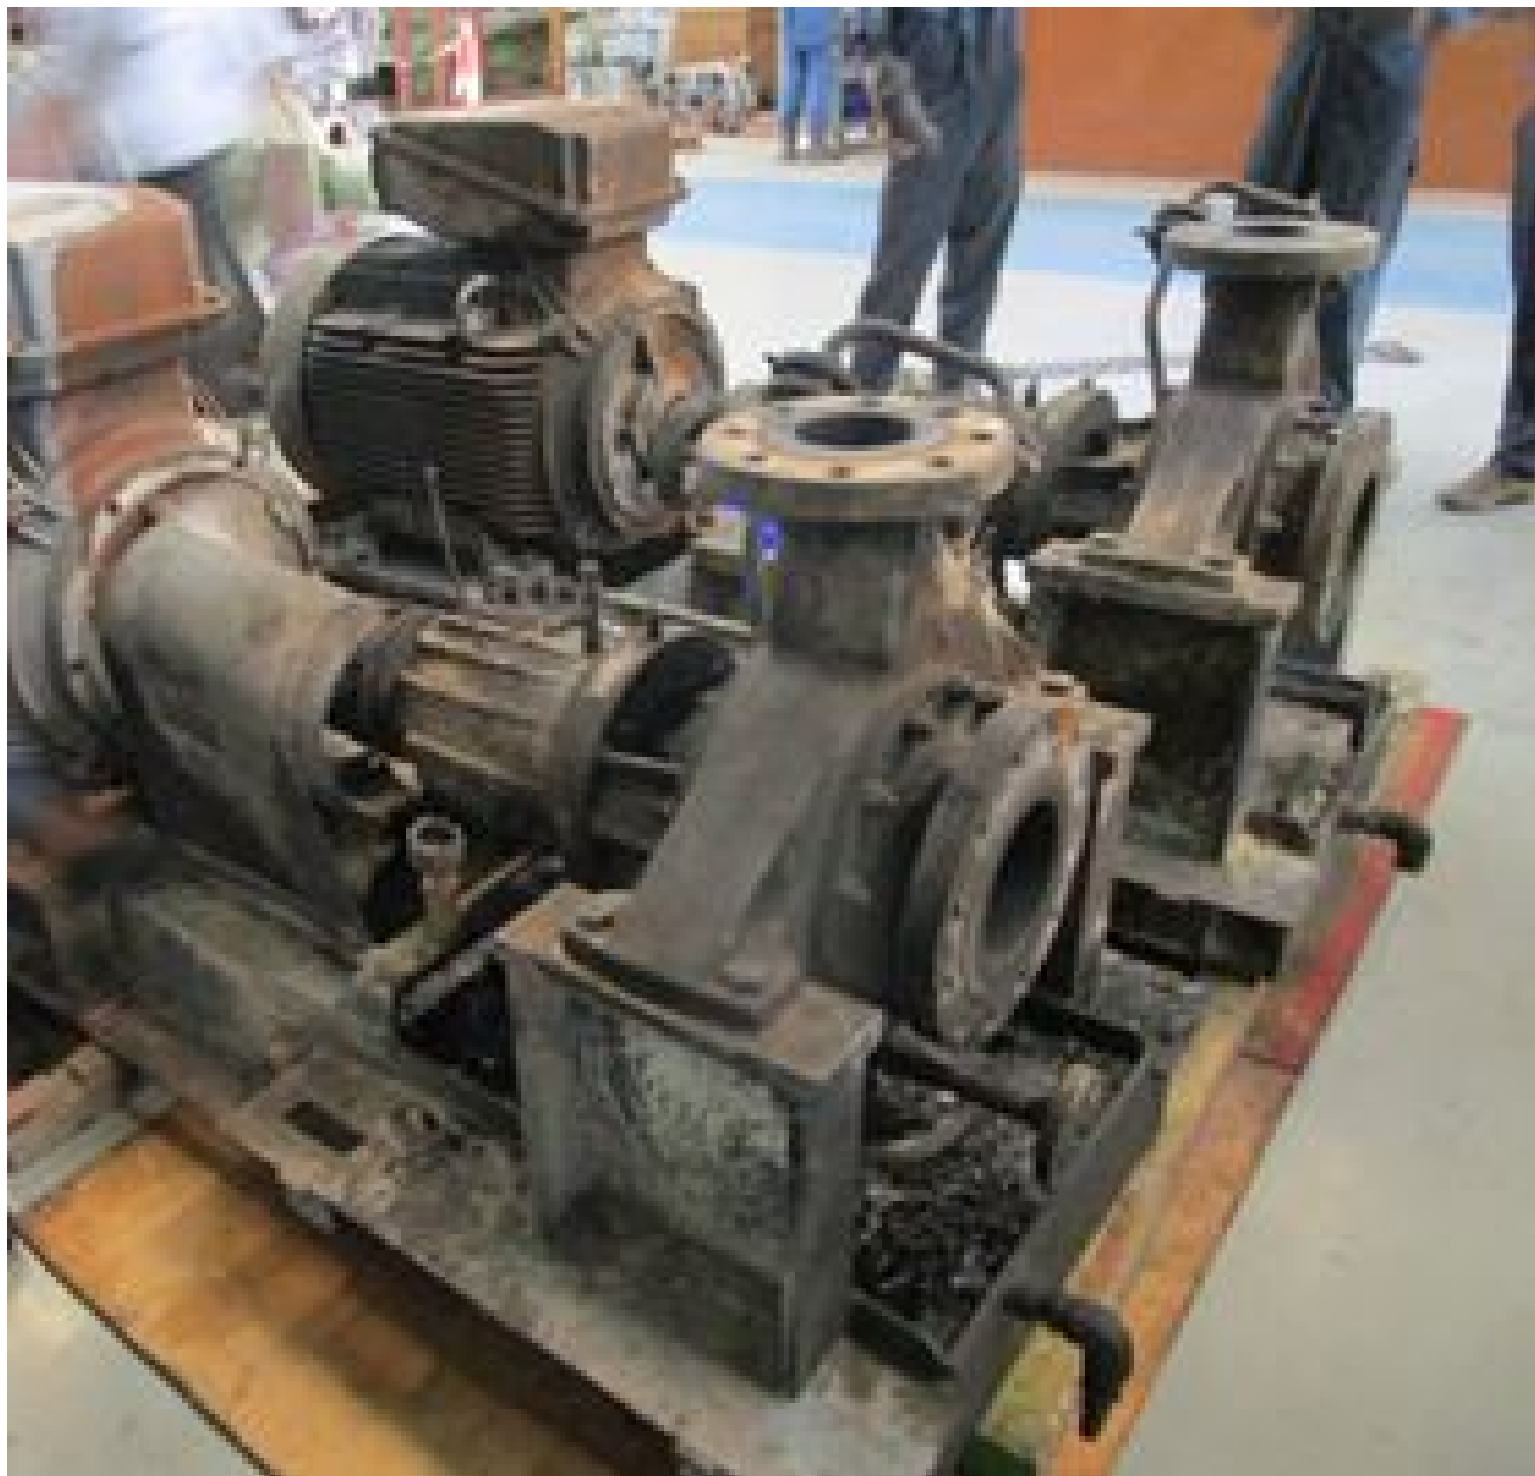
The engineers discovered that the fire had been so severe it had completely burned out all of the oil in the bearing housing. In addition, the baseplate was also warped because of the excessive heat. A turnaround of between two and three weeks for redesign and rebuild was proposed, subject to mechanical seal availability and the two hot oil circulating pumps, along with the baseplate and the motors were shipped to Hydro Middle East's facility in Dubai, U.A.E.

A complete inspection of the damaged pump and further root cause analysis revealed the possible cause of the fire could have been from the misalignment of the pump shaft to the motor shaft, which had apparently caused excessive vibration. When the axial movement increased and oscillated the shaft, the labyrinth seal broke. However, the pump did not shut down. This caused the containment of

the mechanical seal to fail. The leaking seal fuelled the heat, creating excessive friction and starting the fire.

Once they knew what had happened, Hydro Middle East's engineering department came up with a plan to redesign the pumps. The redesign included a newly upgraded shaft design and an upgraded power end, both of which needed to be manufactured within the already tight time frame. The badly deformed baseplate also needed a complete redesign and rebuild. The new designs were quickly and carefully drawn and approved.

to the cooling fan design, a larger bearing housing, better sealing of the housing, a sturdier shaft design, and an enhanced baseplate design. The pumps were up and running once more within an unprecedented fast turnaround.
