Using Latest Technology to Refurbish a 50-year-old Pump Element

Power pump performance improved with redesign of the first-stage, double-suction impeller and twin volute.

Written by: Dave Allard & Dr. Gary Dyson

Published by: Pumps & Systems

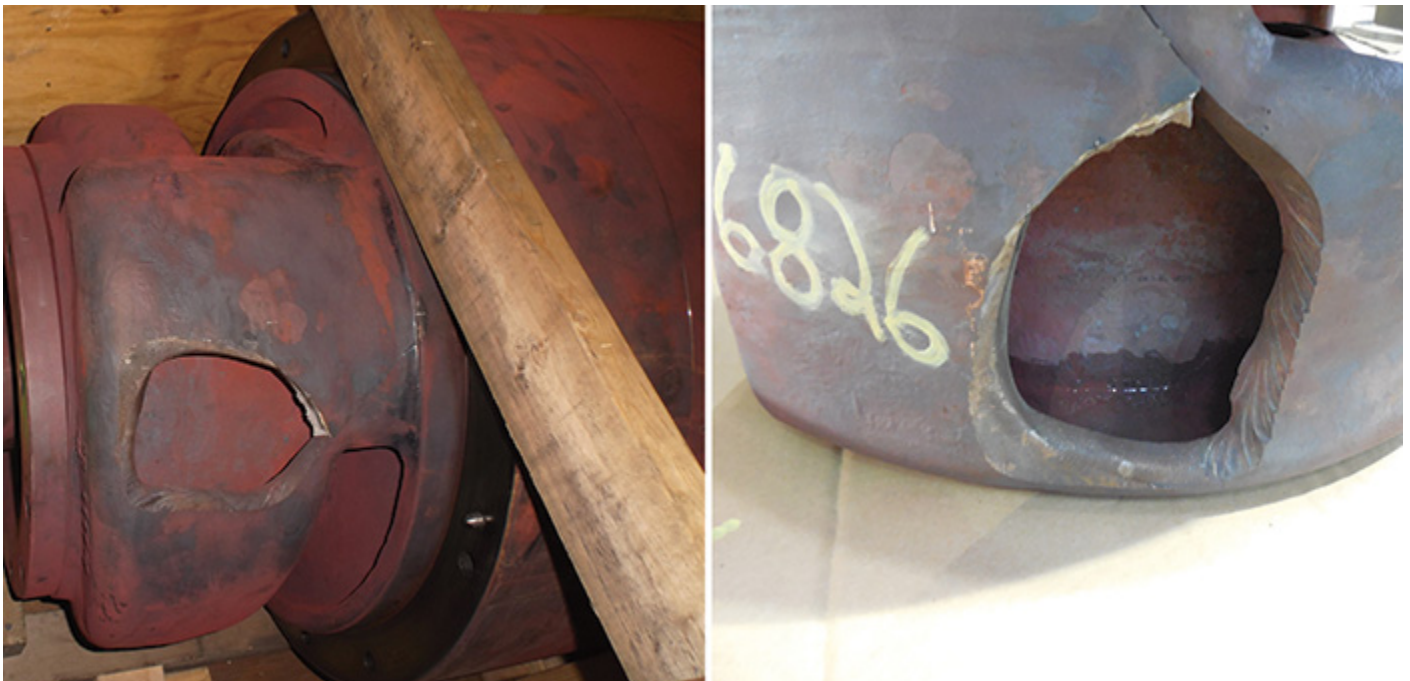
The first-stage twin volute is a complicated casting, which failed during operation as a result of poor design.

Hydro re-engineered the casting by using sophisticated engineering and 3-D modeling, along with simulation software and 3-D sand printing.

Hydro's aftermarket services capability provided a completely new replacement element for this high-energy boiler feed pump and also redesigned the castings to eliminate the original latent defect in the casting design.

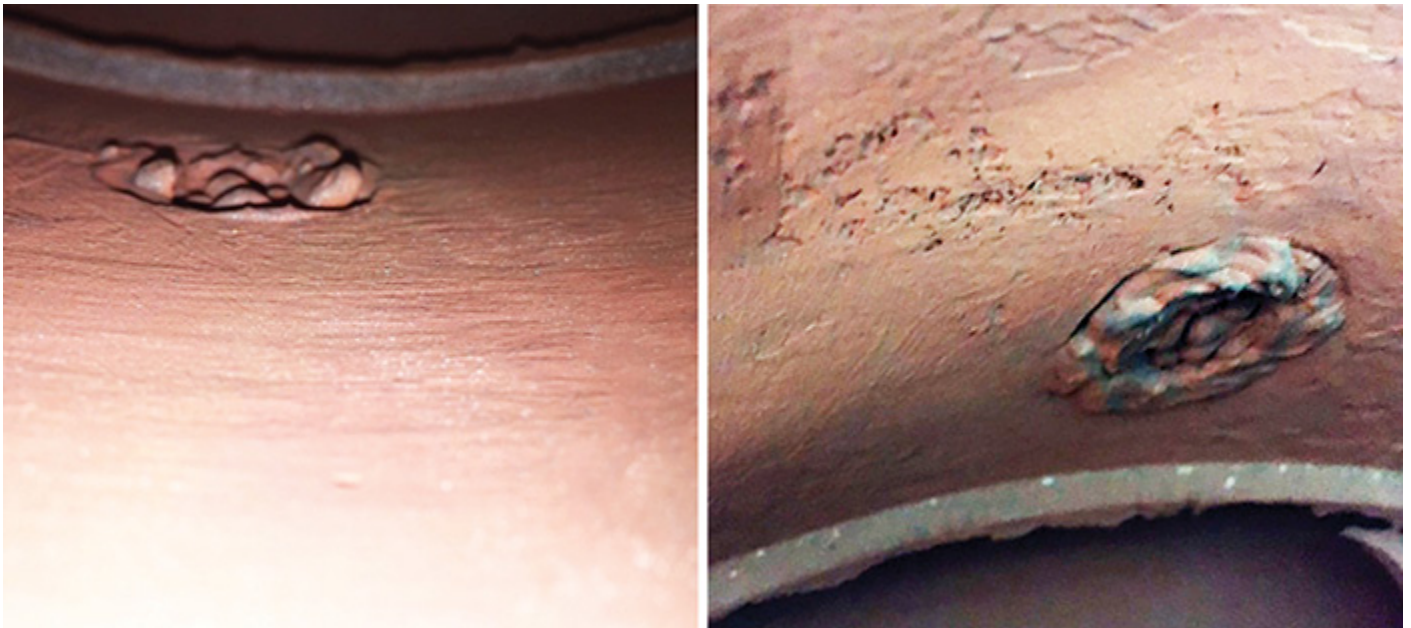
The end user came experienced an issue when the life expectancy of a pump case was not meeting expectations. The pump was removed from service due to performance deterioration manifested by increased vibration. The first-stage double suction volute had failed. A crack had developed on the volute initiating from the interface between a welded core plug and the volute casting.

Chaplets are usually comprised of different metallurgy from the metal being poured and can create a weak area if left in place. Image 2 shows areas that were either utilized for chaplets or are core sand clean-out plugs, which were excavated and welded.

The engineers eliminated the need for chaplets during the pouring process by using 3-D technology,

which allows for the manufacturing of the cores in a hybrid design that will lock them in place inside the mold. By using this method, the sophisticated technology averages the wall thickness, minimizes core shift and minimizes welding. The volute areas were examined by the bore scope and properly cleaned.

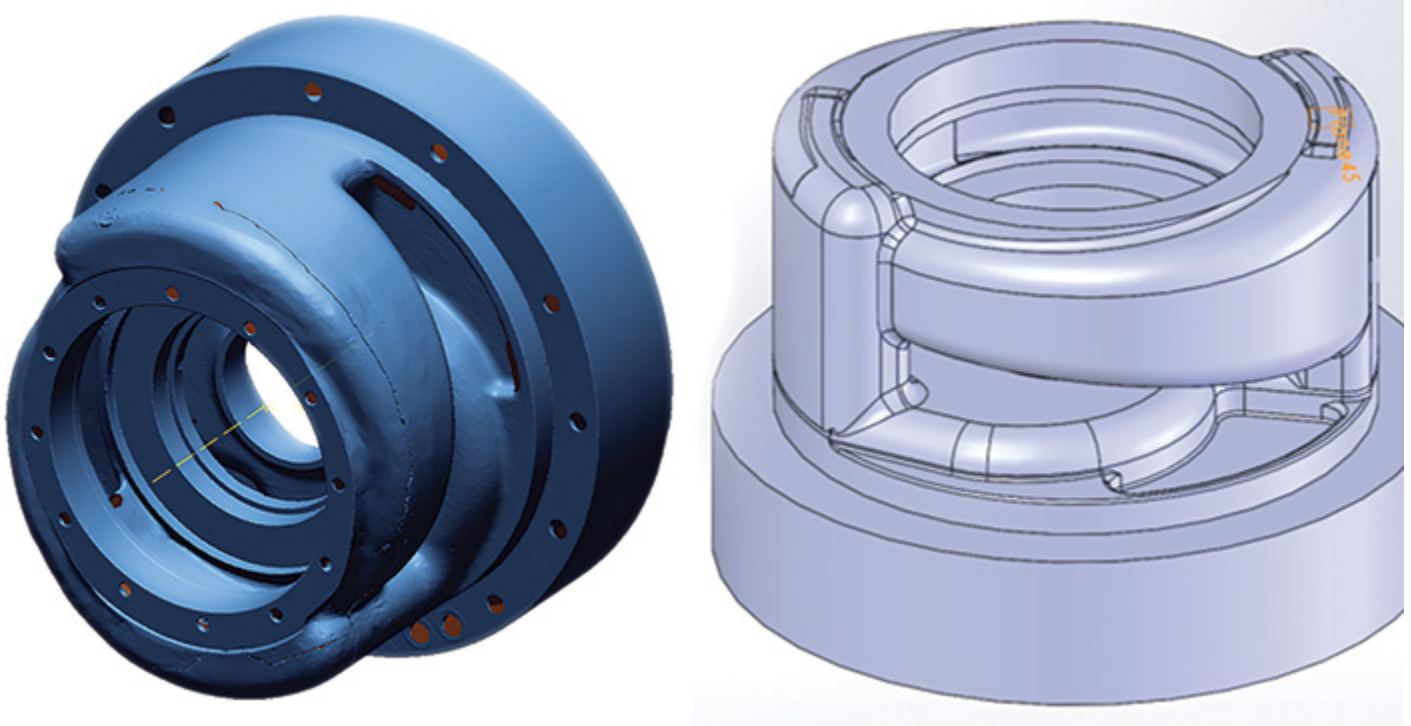
Casting Defects

In the volute crossover areas, Hydro noticed a significant amount of flash on both sides. This is created by core lift where two cores are joined together. While the 3-D printing method will not eliminate the need for separate cores, it allowed Hydro to move the core split to an area that is accessible for grinding. The 3-D printed cores were 0.005-0.20-inch accurate dimensionally in the x, y, and z axis. This gave the engineers precision core filament during the mold building process.

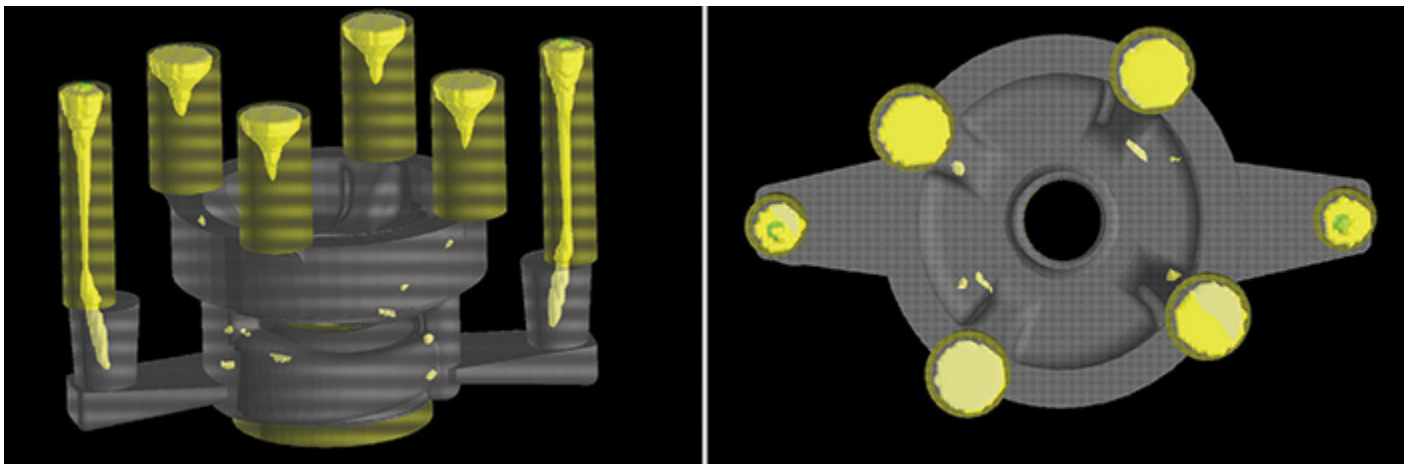
CFD Solidification Analysis

Initial analysis of the raw material identified the areas of concern to help direct the design of the riser pattern and also highlight the preferred area of the in-gates. Risers are cylindrical tubes insulated by exothermic sleeves to generate heat once they are filled with liquid metal.

Two major feed areas were addressed by adding risers and chills to help direct the solidification of the metal. Risers were placed to direct solidification impurities from the base metal.

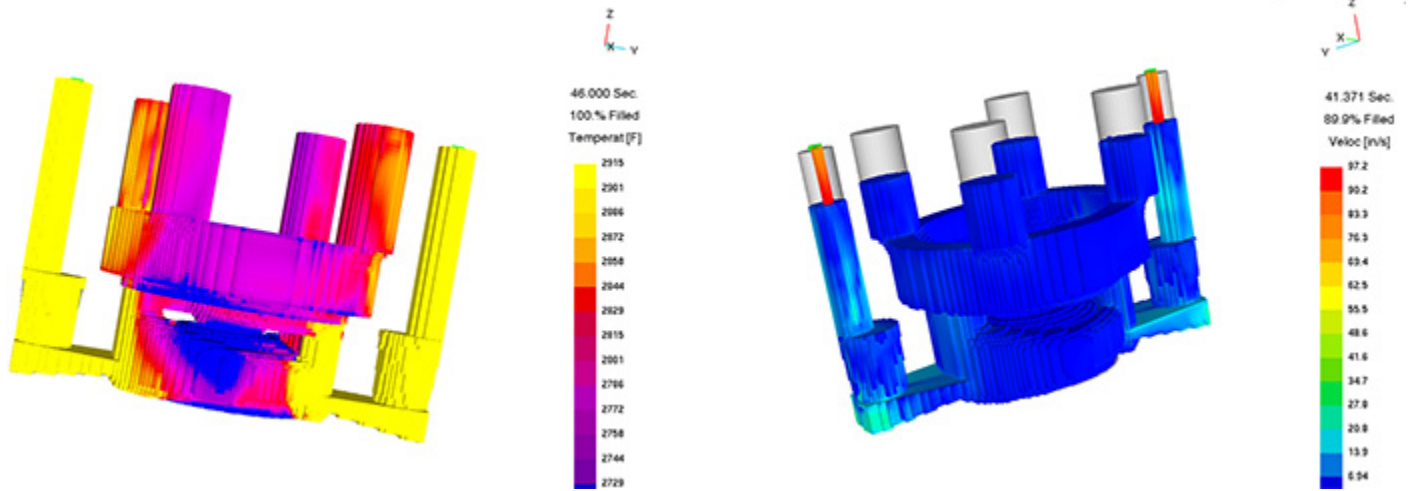
Temperature Gradient Analysis

When studying the flow of metal, one must find a balance that allows the metal to enter the mold fast enough to fill it before it begins the solidification process. At the same time, it must minimize turbulence. The main area of concern in this case was placing the risers where they would stay hot the longest. Hydro used a dual Sprue method to bring the metal in equally on both sides during the pouring process. This fed the critical geometry areas quickly and minimized turbulence as the feed was operating from two directions.

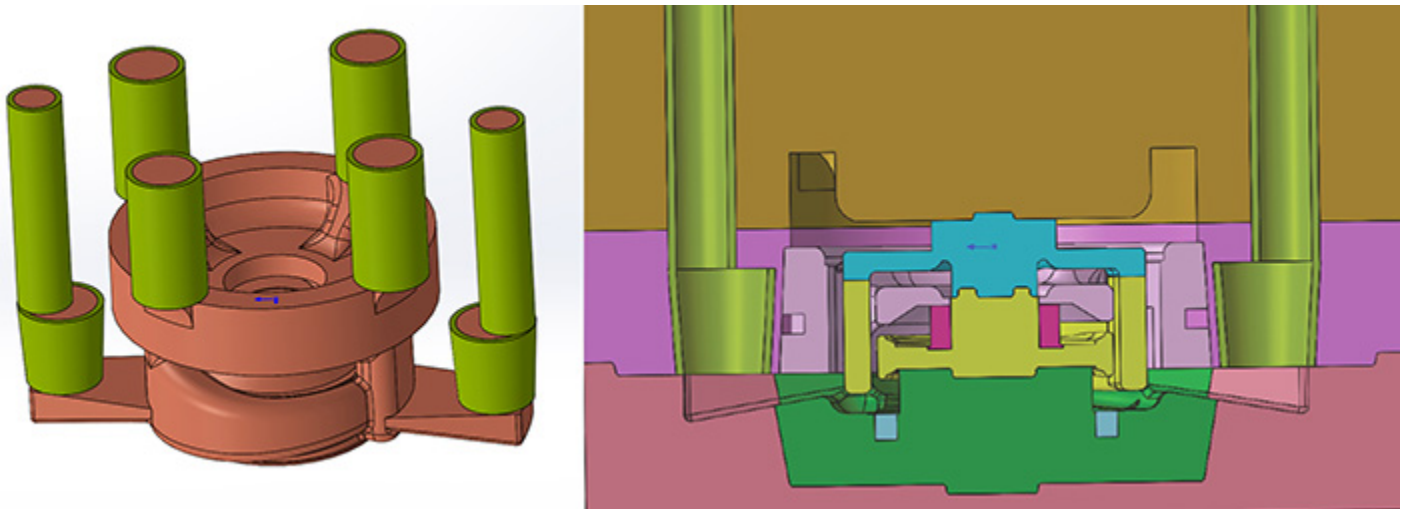
Velocity Analysis

Velocity control is critical in all aspects of pouring. High velocity triggers gas reactions, premature freezing of metal fragments and inconsistent feeding. This is a critical step to ensure that the gating has the proper choke to minimize turbulence during the pouring process. Typically, it is important to keep the velocity below 30 inches per second. Choke points are how foundry workers control the speed of metal. The software package has a program to help design choke points when creating the gating system.

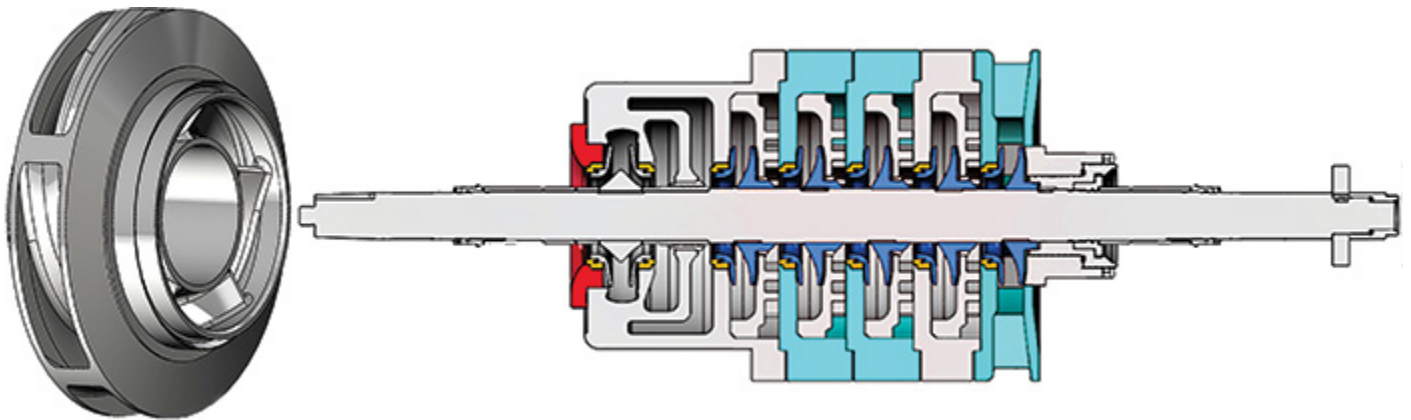
Pressure Pulsations at Vane Frequency

Pressure pulsations at vane frequency are initiated by each of the vanes of the impeller passing close to the volute cutwater lip. These pulsations can affect vibration of the machine. Traditional methods to reduce these pressure pulsations involve increasing the distance between the impeller vanes and lips to allow time, distance and viscosity to smooth out this pressure wave. Unfortunately, this technique does not come without penalty and affects both pump head and efficiency.

In addition, Hydro identified the opportunity to improve the performance of the pump by redesigning the first-stage double-suction impeller. To improve vane passing frequency, the first-stage double suction impeller was redesigned with staggered and split vanes.

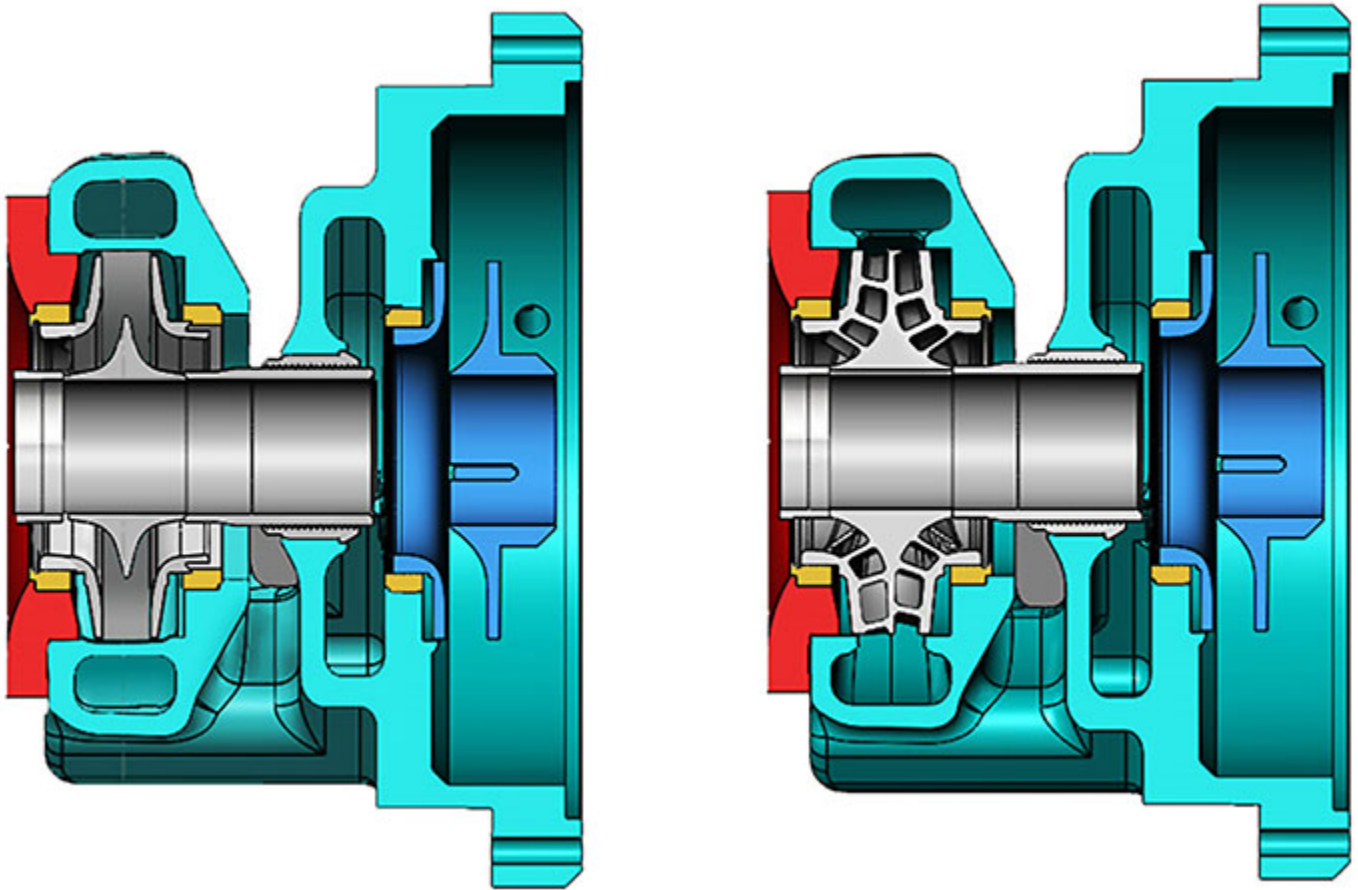
To reduce the pressure pulsation without adversely impacting the machine's hydraulic performance, Hydro designed and installed staggered and raked vanes to the impeller. This required a center rib to be designed into the impeller around which the impeller vanes can be staggered.

This means that the vane tip width passing the cutwater is halved lengthwise and the rake angle of the blade spreads this passing over a greater time/distance.

Vibration is an important indicator of future pump reliability. When analyzing vibration data, it can be important to work with a company that also has hydraulic design experience. When vibration data indicates that a vane pass frequency problem exists, their engineering experience can not only diagnose the problem but also design an impeller to improve the pump's reliability. In this case the vane passing pulsations were dramatically reduced by providing a staggered, split-vane design.
