## Fully Equipped & On the Move

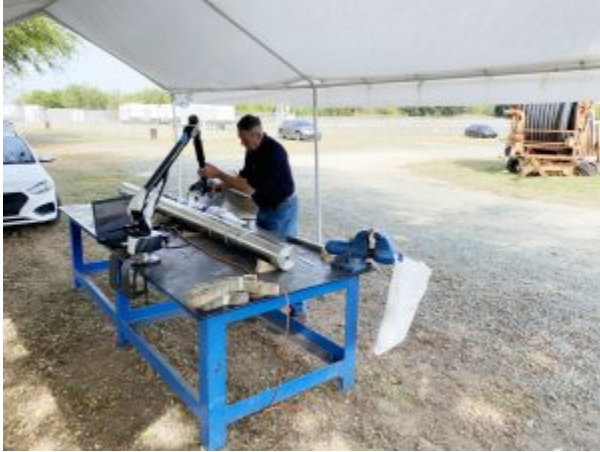
Hydro was called on to reverse engineer a large circulating water pump in the Caribbean to supply parts for refurbishment. The lead times for receiving parts from the original equipment manufacturer (OEM) were excessive. More concerning, the suction bell provided by the OEM had failed during service. All internal ribs were lost, and the bearing holder was found loose within the assembly.

When Hydro reviewed the design of the suction bell, it was clear that low manufacturing cost was prioritized over reliability. Instead of providing a cast component, the suction bell was fabricated and had an excessively thin wall thickness.

Hydro reverse engineered the suction bell and created a model for a cast component, establishing the rib design and bearing holder location based on design experience. Exterior ribs were added to strengthen the bell and the wall thickness at the suction bell skirt was increased from 3/8" to 2". The part was scanned on-site within 1 day, with the engineering analysis, modified casting design, and quote for manufacture being
