Big Savings for Small Pumps

Pumps & Systems

October, 2008

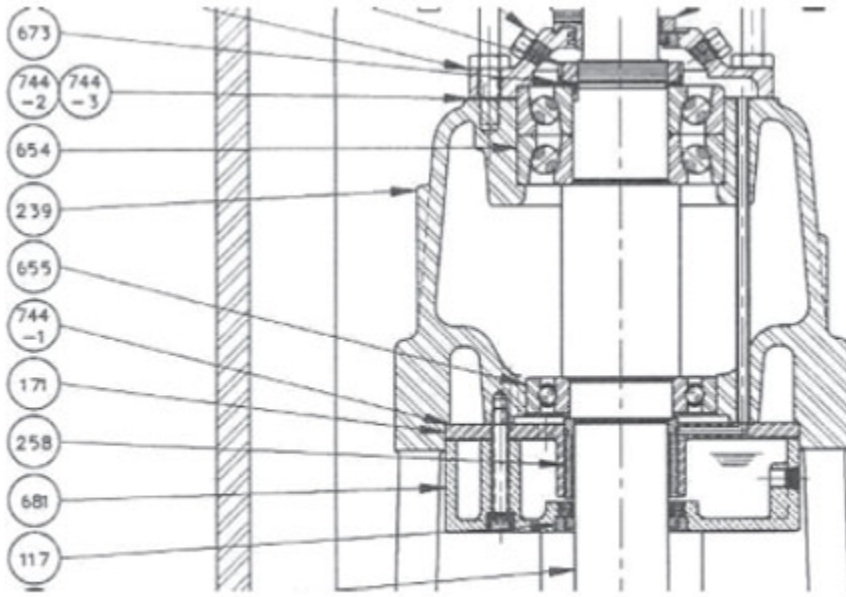
In January 2007, Valero-Wilmington sent one of these pumps to Evans Hydro with a request to investigate the failures. To determine the root cause of the problem, the engineers started by reviewing the original sump design. The original oil sump design had a magnetic seal at the bottom (see Figure 1, Item 117). The second-generation design had eliminated the magnetic seal and added the riser pipe-the significance of which will be illustrated in the discovery of the problem.

Figure 1. First generation sump design showing the magnetic seal at Item 117.

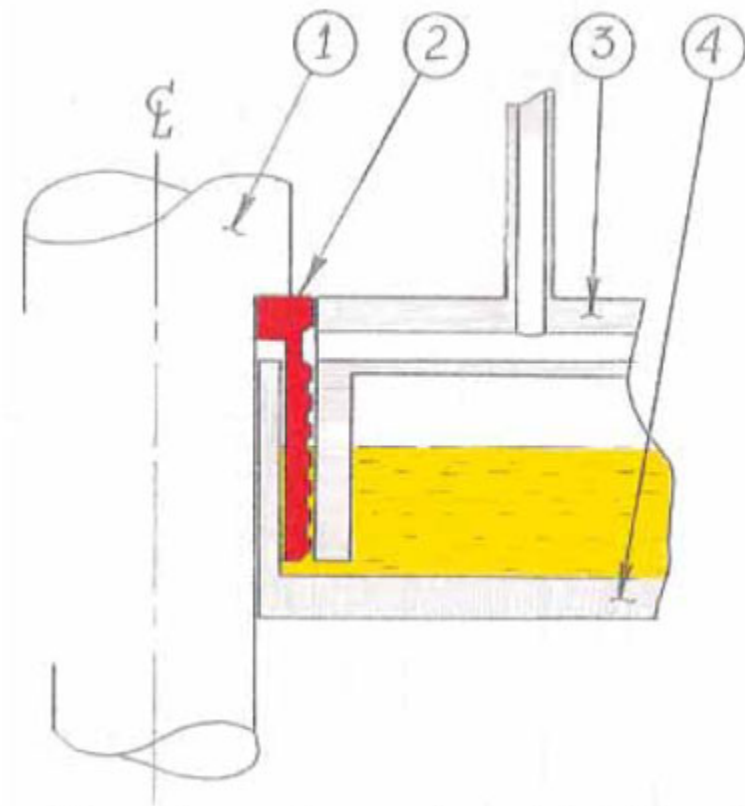
The engineers started looking at the shaft, pumping ring and oil sump housing as a whole assembly. The "pumping" principle was obvious-the pumping ring (Figure 2, Item 2) was submerged in oil. The outside diameter, with a tight diametrical clearance of .012-in to .014-in between the upper sump housing (Figure 2, Item 3), was producing a perfect pumping action and delivering approximately 5.85-oz/min of lubricating oil to the upper thrust bearings.

Figure 2. Second generation sump design in "static" condition

In theory, everything seemed perfect. The inside diameter of the pumping ring, riser pipe and pump shaft were designed to create a labyrinth to prevent oil from escaping. Once the pump is started, the pumping ring pumps lubricating oil into the drilled discharge manifold. Enough oil is delivered to lubricate and cool the upper thrust bearing.

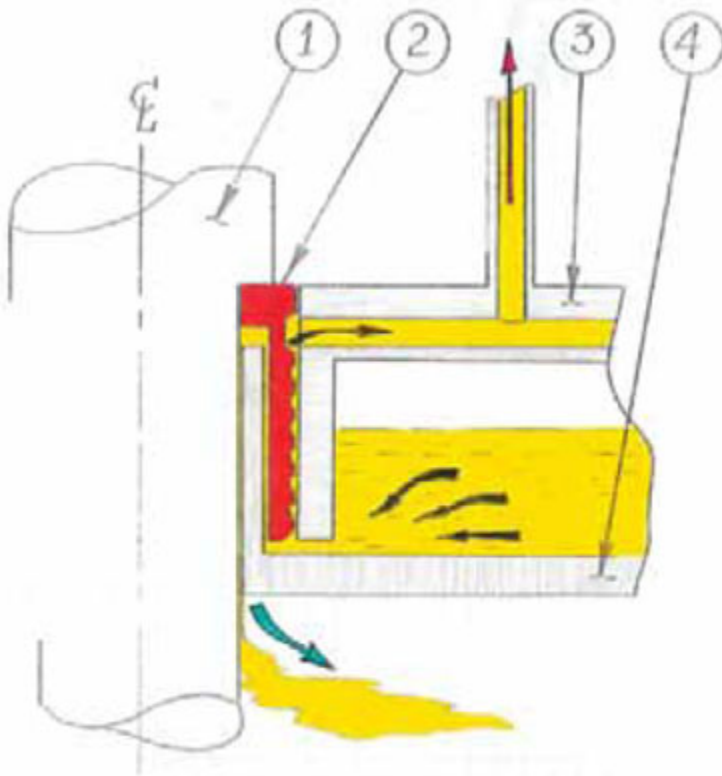
Figure 3. Second generation sump design in "dynamic" condition illustrating oil leakage

If after only a few months the pump was suddenly losing all of the oil from the sump, then something had to be causing the oil to travel between the inside diameter of the pumping ring and outside diameter of the riser pipe, then between the pump shaft and the inside diameter of the riser pipe out to ambient.

Since everything was making sense in a "static" condition, the engineers decided to consider the effects of the pump's design in a "dynamic" condition. Looking at the labyrinth (inside diameter of the pumping ring, riser pipe and pump shaft) and measuring clearances, the true cause of the oil leakage was discovered. During dynamic condition, the tight clearances and high air velocity caused a vacuum.

It was assumed that due to wear of the pumping ring, only $\frac{1}{4}$ of the developed head would recirculate the lubricating oil back to the bottom of the sump. Eventually, with the help of the vacuum, oil would

travel upward to the top of the riser pipe. As it happened, the siphon effect can empty the entire sump within minutes into ambient.

Equipped with this knowledge, the engineers started looking at design modifications for the pump. Modifications to prevent oil from being siphoned out of the sump were very simple and quite inexpensive. The engineers modified the pump by increasing clearances, thus "breaking" the vacuum between the pumping ring and riser pipe. Spiral grooves were also implemented to introduce gentle air flow, providing pressure to counterbalance oil backflow from the pumping ring.
