Big Savings for Small Pumps

Pumps & Systems

October, 2008

Valero-Wilmington, a midsize refinery (135-kb/d) located in Los Angeles, Calif., was experiencing problems with oil lubricated vertical in-line pumps (API type OH3). Though Valero-Wilmington uses the vertical in-line pumps for multiple applications, several are used as internal transfer pipeline pumps that operate within the refinery.

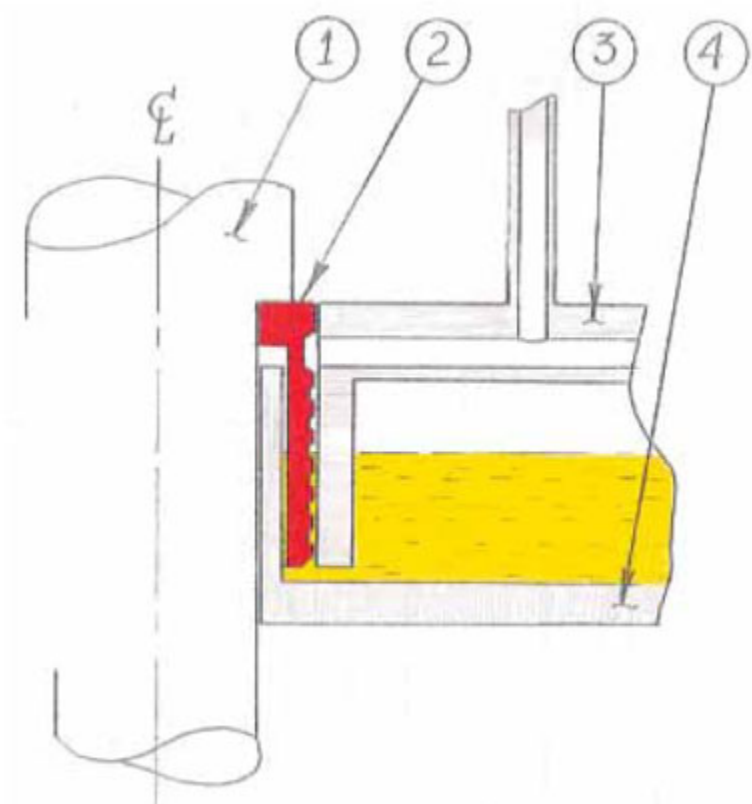
The engineers started looking at the shaft, pumping ring and oil sump housing as a whole assembly. The "pumping" principle was obvious—the pumping ring (Figure 2, Item 2) was submerged in oil. The outside diameter, with a tight diametrical clearance of .012-in to .014-in between the upper sump housing (Figure 2, Item 3), was producing a perfect pumping action and delivering approximately 5.85-oz/min of lubricating oil to the upper thrust bearings.

Figure 2. Second generation sump design in "static" condition

In theory, everything seemed perfect. The inside diameter of the pumping ring, riser pipe and pump shaft were designed to create a labyrinth to prevent oil from escaping. Once the pump is started, the pumping ring pumps lubricating oil into the drilled discharge manifold. Enough oil is delivered to lubricate and cool the upper thrust bearing.

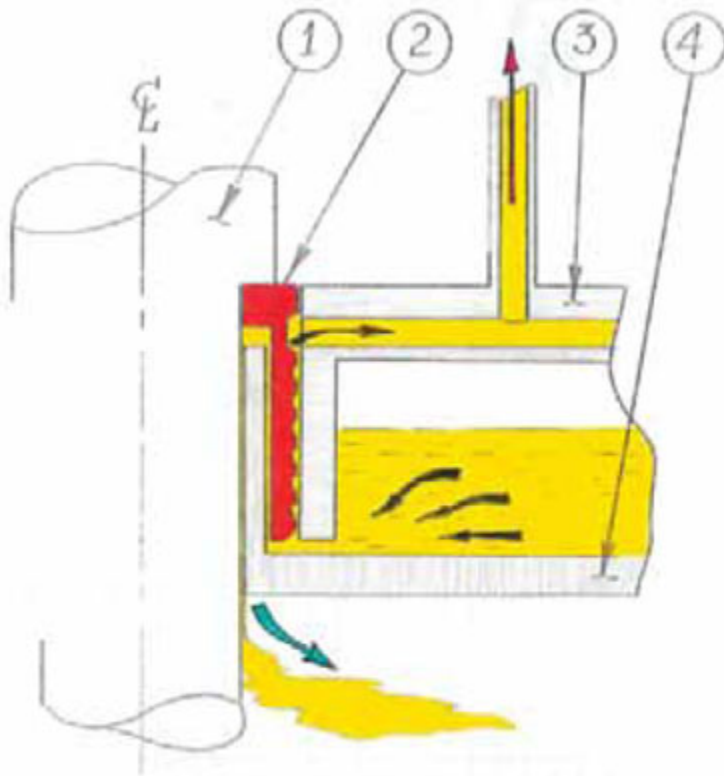
Figure 3. Second generation sump design in "dynamic" condition illustrating oil leakage

If after only a few months the pump was suddenly losing all of the oil from the sump, then something had to be causing the oil to travel between the inside diameter of the pumping ring and outside diameter of the riser pipe, then between the pump shaft and the inside diameter of the riser pipe out to ambient.

Since everything was making sense in a "static" condition, the engineers decided to consider the effects of the pump's design in a "dynamic" condition. Looking at the labyrinth (inside diameter of the pumping ring, riser pipe and pump shaft) and measuring clearances, the true cause of the oil leakage was discovered. During dynamic condition, the tight clearances and high air velocity caused a vacuum.

It was assumed that due to wear of the pumping ring, only $\frac{1}{4}$ of the developed head would recirculate the lubricating oil back to the bottom of the sump. Eventually, with the help of the vacuum, oil would

travel upward to the top of the riser pipe. As it happened, the siphon effect can empty the entire sump within minutes into ambient.

Equipped with this knowledge, the engineers started looking at design modifications for the pump. Modifications to prevent oil from being siphoned out of the sump were very simple and quite inexpensive. The engineers modified the pump by increasing clearances, thus "breaking" the vacuum between the pumping ring and riser pipe. Spiral grooves were also implemented to introduce gentle air flow, providing pressure to counterbalance oil backflow from the pumping ring.
