Big Savings for Small Pumps

Alex Manchenkov, Hugh Sosbee and Jim Byrom Sr., Evans Hydro Inc., and Valero-Wilmington Refinery

Pumps & Systems

October, 2008

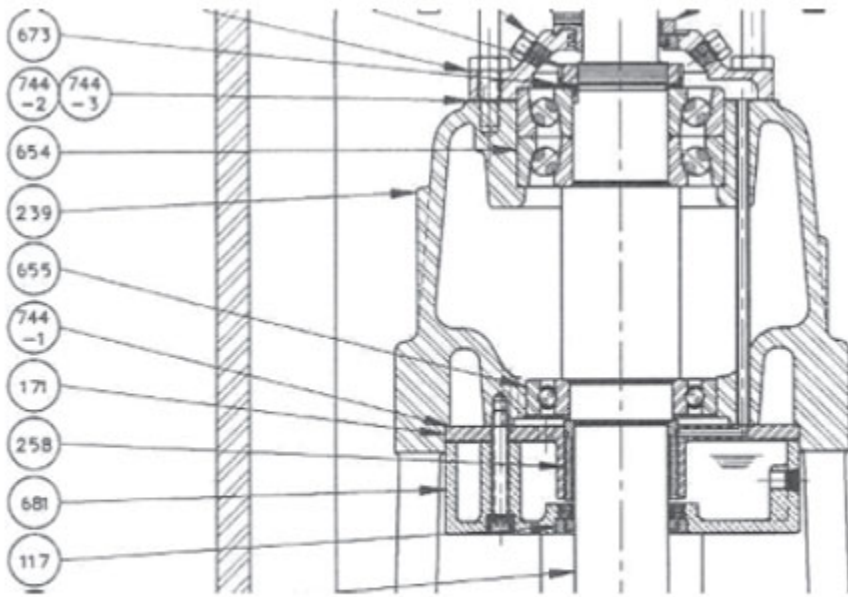
In January 2007, Valero-Wilmington sent one of these pumps to Evans Hydro with a request to investigate the failures. To determine the root cause of the problem, the engineers started by reviewing the original sump design. The original oil sump design had a magnetic seal at the bottom (see Figure 1, Item 117). The second-generation design had eliminated the magnetic seal and added the riser pipe—the significance of which will be illustrated in the discovery of the problem.

Figure 1. First generation sump design showing the magnetic seal at Item 117.

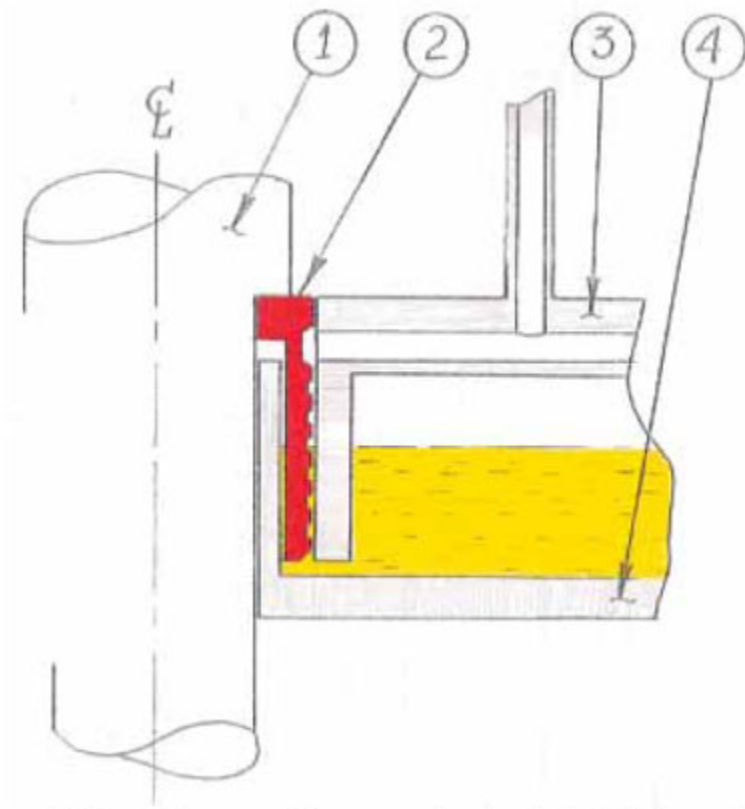
The engineers started looking at the shaft, pumping ring and oil sump housing as a whole assembly. The "pumping" principle was obvious-the pumping ring (Figure 2, Item 2) was submerged in oil. The outside diameter, with a tight diametrical clearance of .012-in to .014-in between the upper sump housing (Figure 2, Item 3), was producing a perfect pumping action and delivering approximately 5.85-oz/min of lubricating oil to the upper thrust bearings.

Figure 2. Second generation sump design in "static" condition

In theory, everything seemed perfect. The inside diameter of the pumping ring, riser pipe and pump shaft were designed to create a labyrinth to prevent oil from escaping. Once the pump is started, the pumping ring pumps lubricating oil into the drilled discharge manifold. Enough oil is delivered to lubricate and cool the upper thrust bearing.

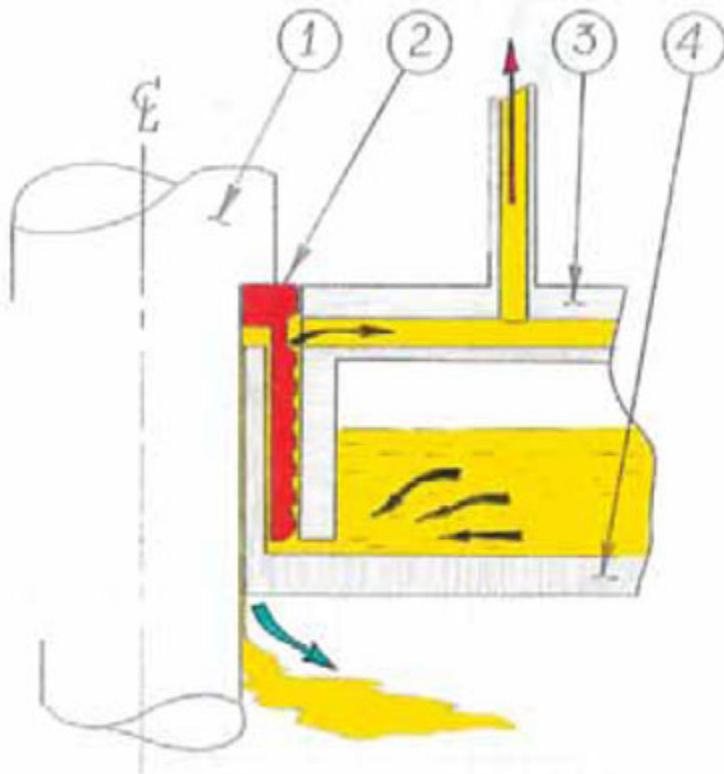
Figure 3. Second generation sump design in "dynamic" condition illustrating oil leakage

If after only a few months the pump was suddenly losing all of the oil from the sump, then something had to be causing the oil to travel between the inside diameter of the pumping ring and outside diameter of the riser pipe, then between the pump shaft and the inside diameter of the riser pipe out to ambient.

Since everything was making sense in a "static" condition, the engineers decided to consider the effects of the pump's design in a "dynamic" condition. Looking at the labyrinth (inside diameter of the pumping ring, riser pipe and pump shaft) and measuring clearances, the true cause of the oil leakage was discovered. During dynamic condition, the tight clearances and high air velocity caused a vacuum.

It was assumed that due to wear of the pumping ring, only $\frac{1}{4}$ of the developed head would recirculate the lubricating oil back to the bottom of the sump. Eventually, with the help of the vacuum, oil would

travel upward to the top of the riser pipe. As it happened, the siphon effect can empty the entire sump within minutes into ambient.

Equipped with this knowledge, the engineers started looking at design modifications for the pump. Modifications to prevent oil from being siphoned out of the sump were very simple and quite inexpensive. The engineers modified the pump by increasing clearances, thus "breaking" the vacuum between the pumping ring and riser pipe. Spiral grooves were also implemented to introduce gentle air flow, providing pressure to counterbalance oil backflow from the pumping ring.
