Cost Reductions Through Life Cycle Improvements

George Harris, Hydro Inc. and Ken Babusiak, HydroAire Inc.

Pumps & Systems

February, 2010

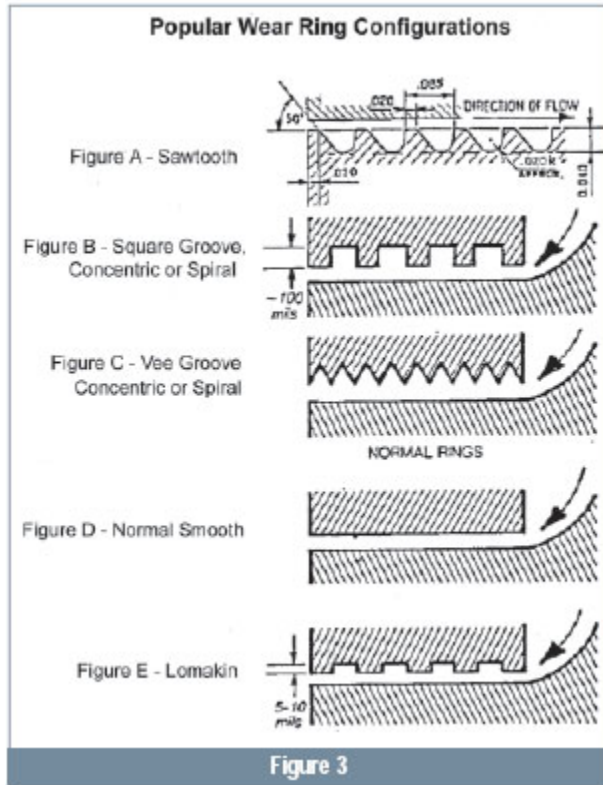
The original pump was furnished with "saw tooth" grooves on the stationary wear components: case wear rings, diffuser bushings and break down bushings. The saw tooth geometry disrupts flow, causing high turbulence and increased friction coefficient.

Past experience with the saw toothed grooving in abrasive service applications indicates that saw tooth grooves trap and locally increase the concentration of abrasive particles. Coupled with high turbulence, this results in an accelerated wear rate and larger running clearances.

The aftermarket provider upgraded the stationary wear components by furnishing Lomakin grooves (see Figure 3). This improvement helps extend a centrifugal pump's wear cycle by damping the vibration.

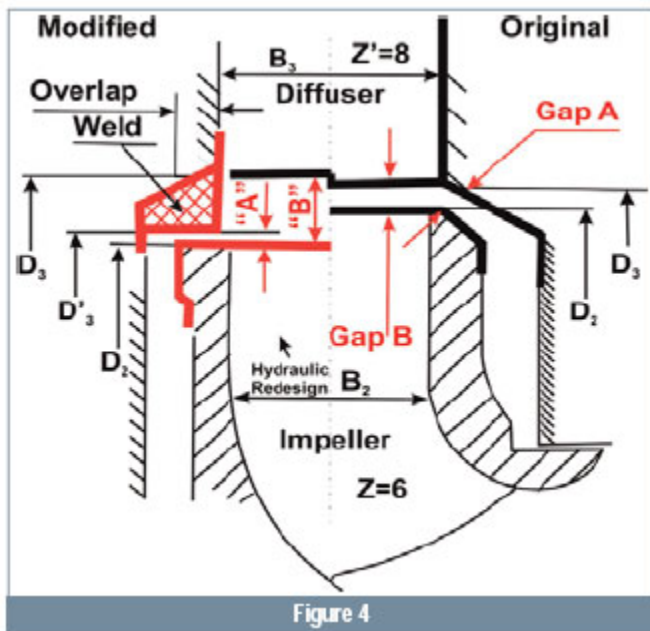
Figure 4 shows the geometry associated with the A and B Gap modifications, which Dr. Makay

pioneered in the 1970s for high-energy boiler feed pumps.

Coupled together, these modifications improve the shape of the head capacity curve at part load, stabilize axial thrust developed by the impellers, provide positive rotor dynamic damping and increase pump efficiency.

As descale pumps are in severe service, operating continuously between minimum and rated flows, these improvements usually result in longer life. It was thought that the A and B gap modifications would also reduce vibration.

While vibration levels were reduced, the high vibration at three times running speed did not decrease as anticipated. This led to a phase 3 improvement.
