Cost Reductions Through Life Cycle Improvements

Pumps & Systems

February, 2010

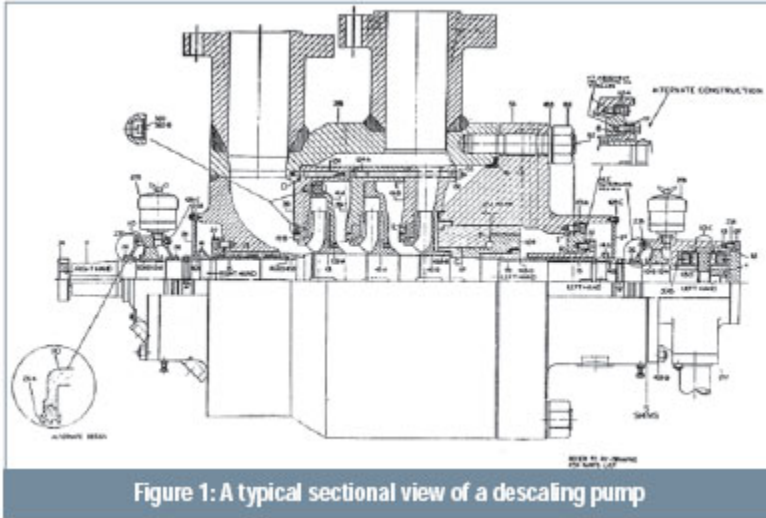
The first step was to comprehensively analyze the pump rotor in a process called Rotor Condition Analysis. The Rotor Condition Analysis report, coupled with analysis of field operating conditions, provided the forensic evidence to identify the root causes of pump problems. This data, when analyzed in conjunction with the operational data, vibration readings and other field information, enables the aftermarket provider's engineers to troubleshoot the pump and develop recommendations to solve the identified problems.

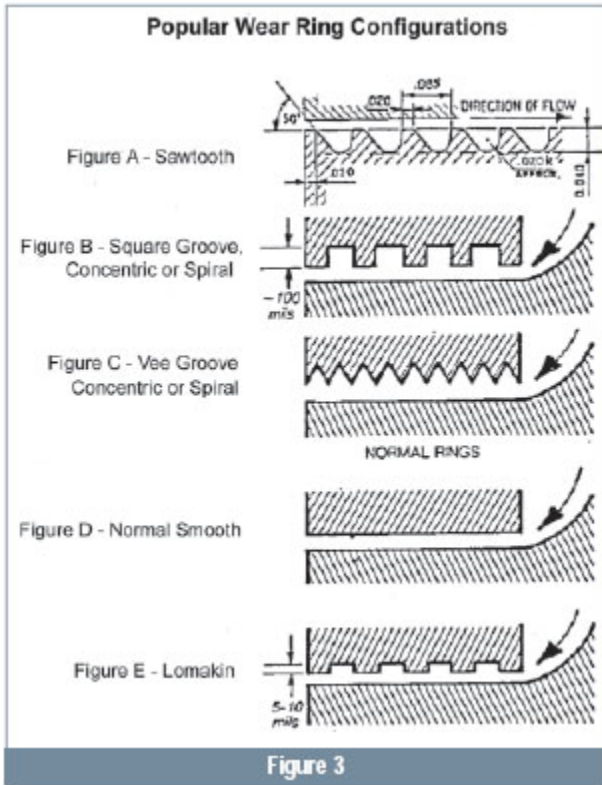
The aftermarket provider upgraded the stationary wear components by furnishing Lomakin grooves (see Figure 3). This improvement helps extend a centrifugal pump's wear cycle by damping the vibration.

The original pump was furnished with "saw tooth" grooves on the stationary wear components: case wear rings, diffuser bushings and break down bushings. The saw tooth geometry disrupts flow, causing high turbulence and increased friction coefficient.

Past experience with the saw toothed grooving in abrasive service applications indicates that saw tooth grooves trap and locally increase the concentration of abrasive particles. Coupled with high turbulence, this results in an accelerated wear rate and larger running clearances.

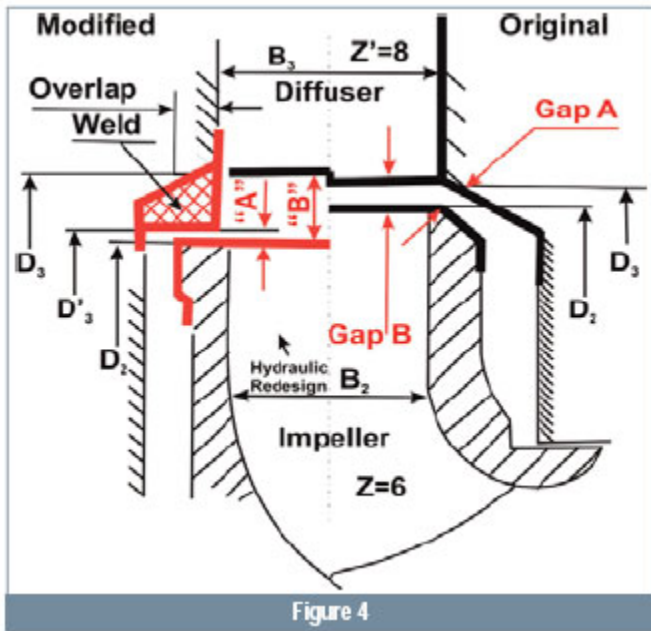
Figure 4 shows the geometry associated with the A and B Gap modifications, which Dr. Makay

pioneered in the 1970s for high-energy boiler feed pumps.

Coupled together, these modifications improve the shape of the head capacity curve at part load, stabilize axial thrust developed by the impellers, provide positive rotor dynamic damping and increase pump efficiency.

As descale pumps are in severe service, operating continuously between minimum and rated flows, these improvements usually result in longer life. It was thought that the A and B gap modifications would also reduce vibration.

While vibration levels were reduced, the high vibration at three times running speed did not decrease as anticipated. This led to a phase 3 improvement.
